Sea Tiger Report

Report on comparative tests of “Sea Tiger” sea kayak and other sea kayaks on behalf of the British Canoe Union

**Presented by Duncan R. Winning O.B.E.
22 Brisbane Glen Road,
Largs,
Ayrshire,
Scotland,
KA30 8QX.**

Twelfth June 1990

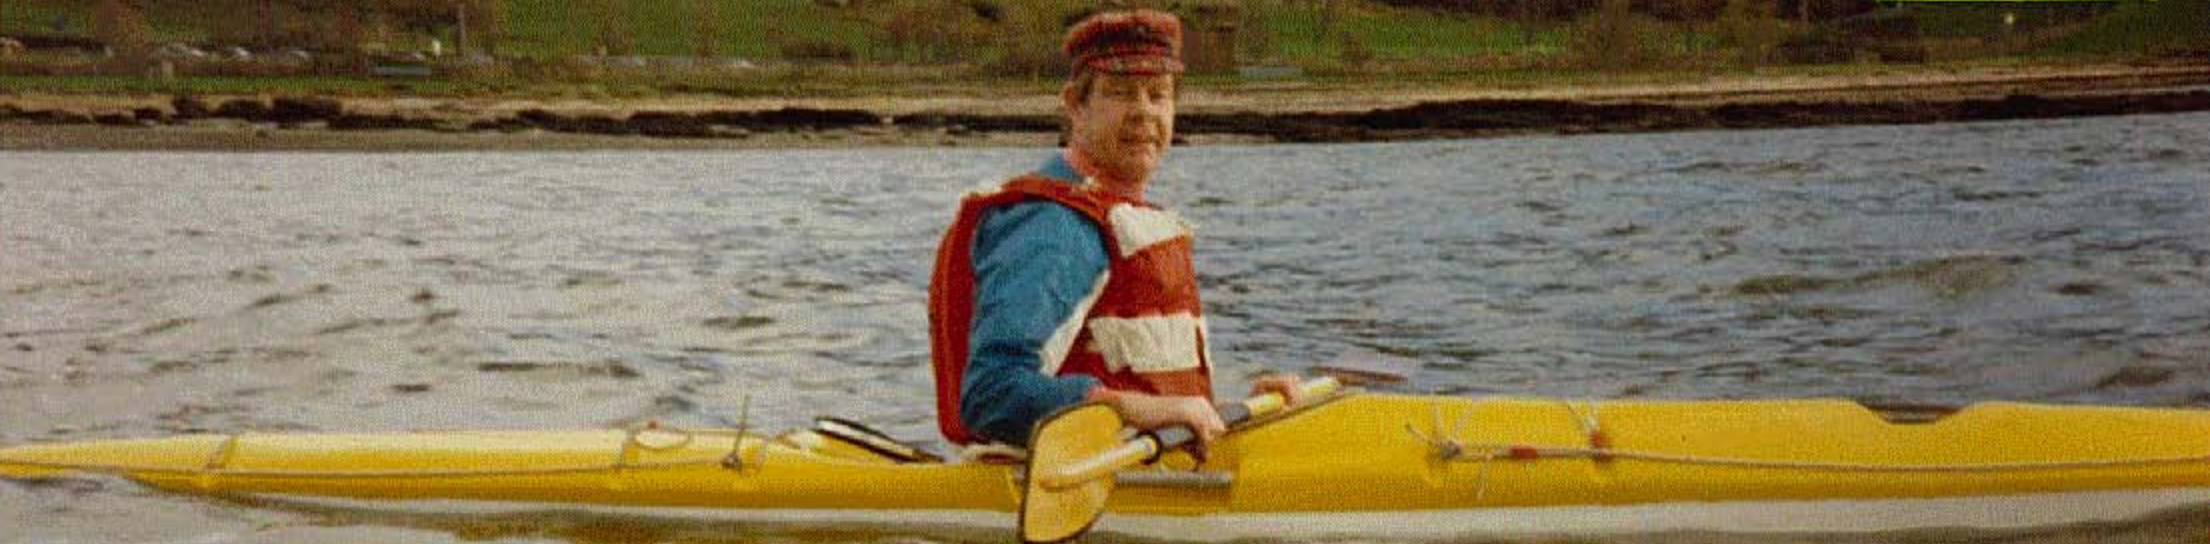
Fig. 1 Winning 1990

- 0 litres [Fig. 1](#), kayak fairly heavy. Handled quite satisfactorily. Paddling hard into a head sea brought water up deck into pod (no spraydeck).
- 40 litres [Fig. 2](#), kayak stayed level. Entrapped water caused a slight roll but not bad.

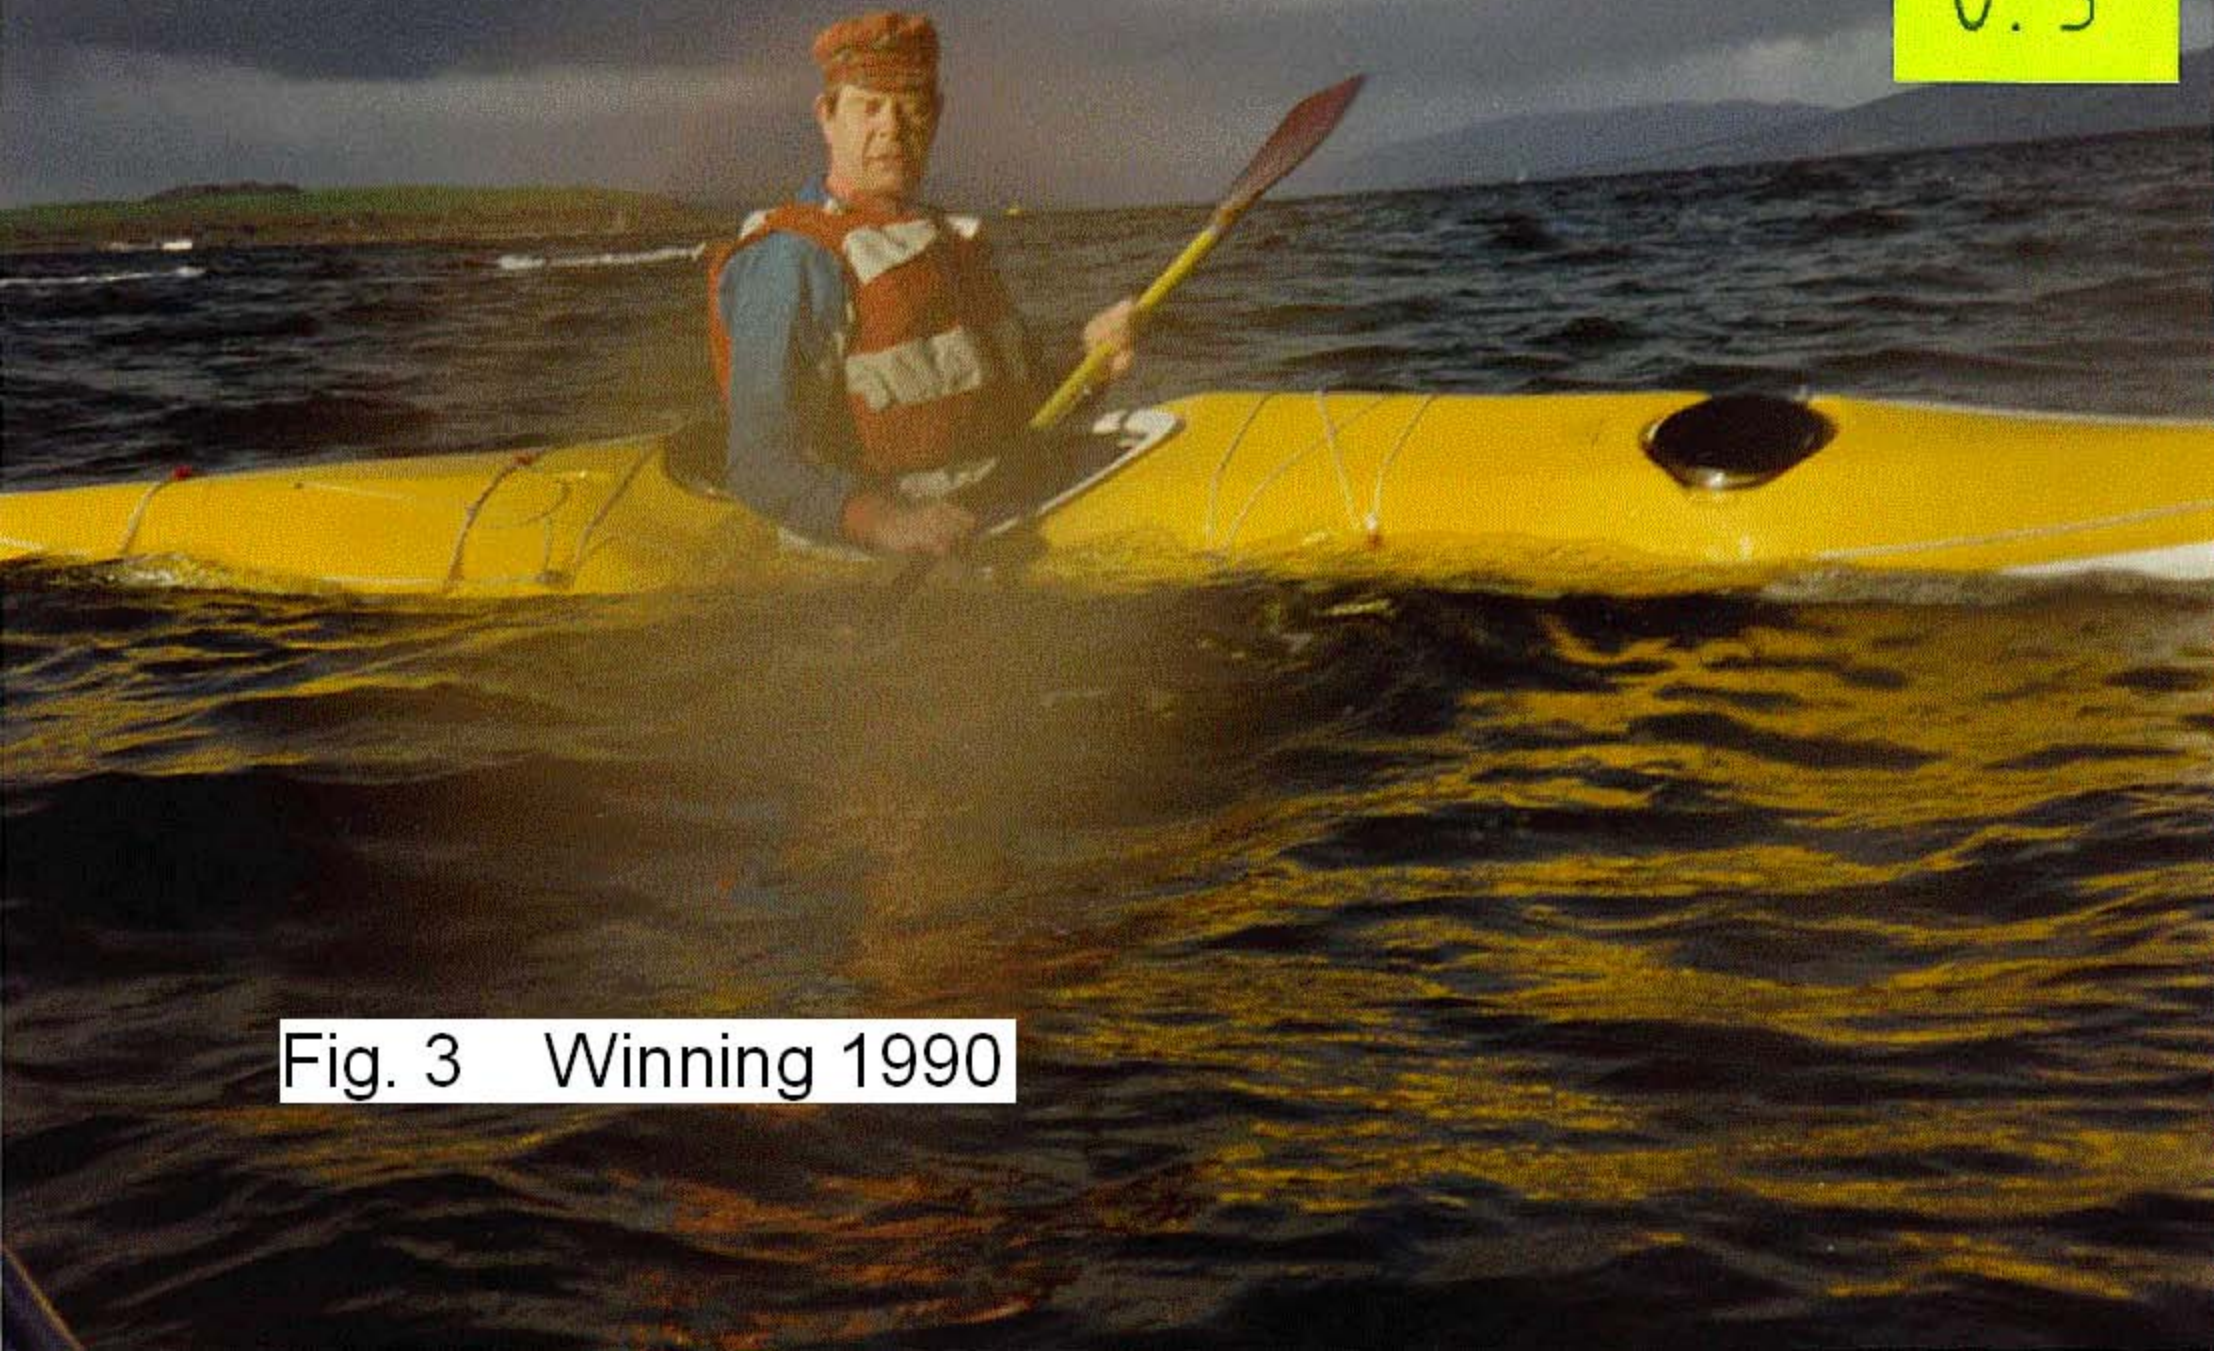
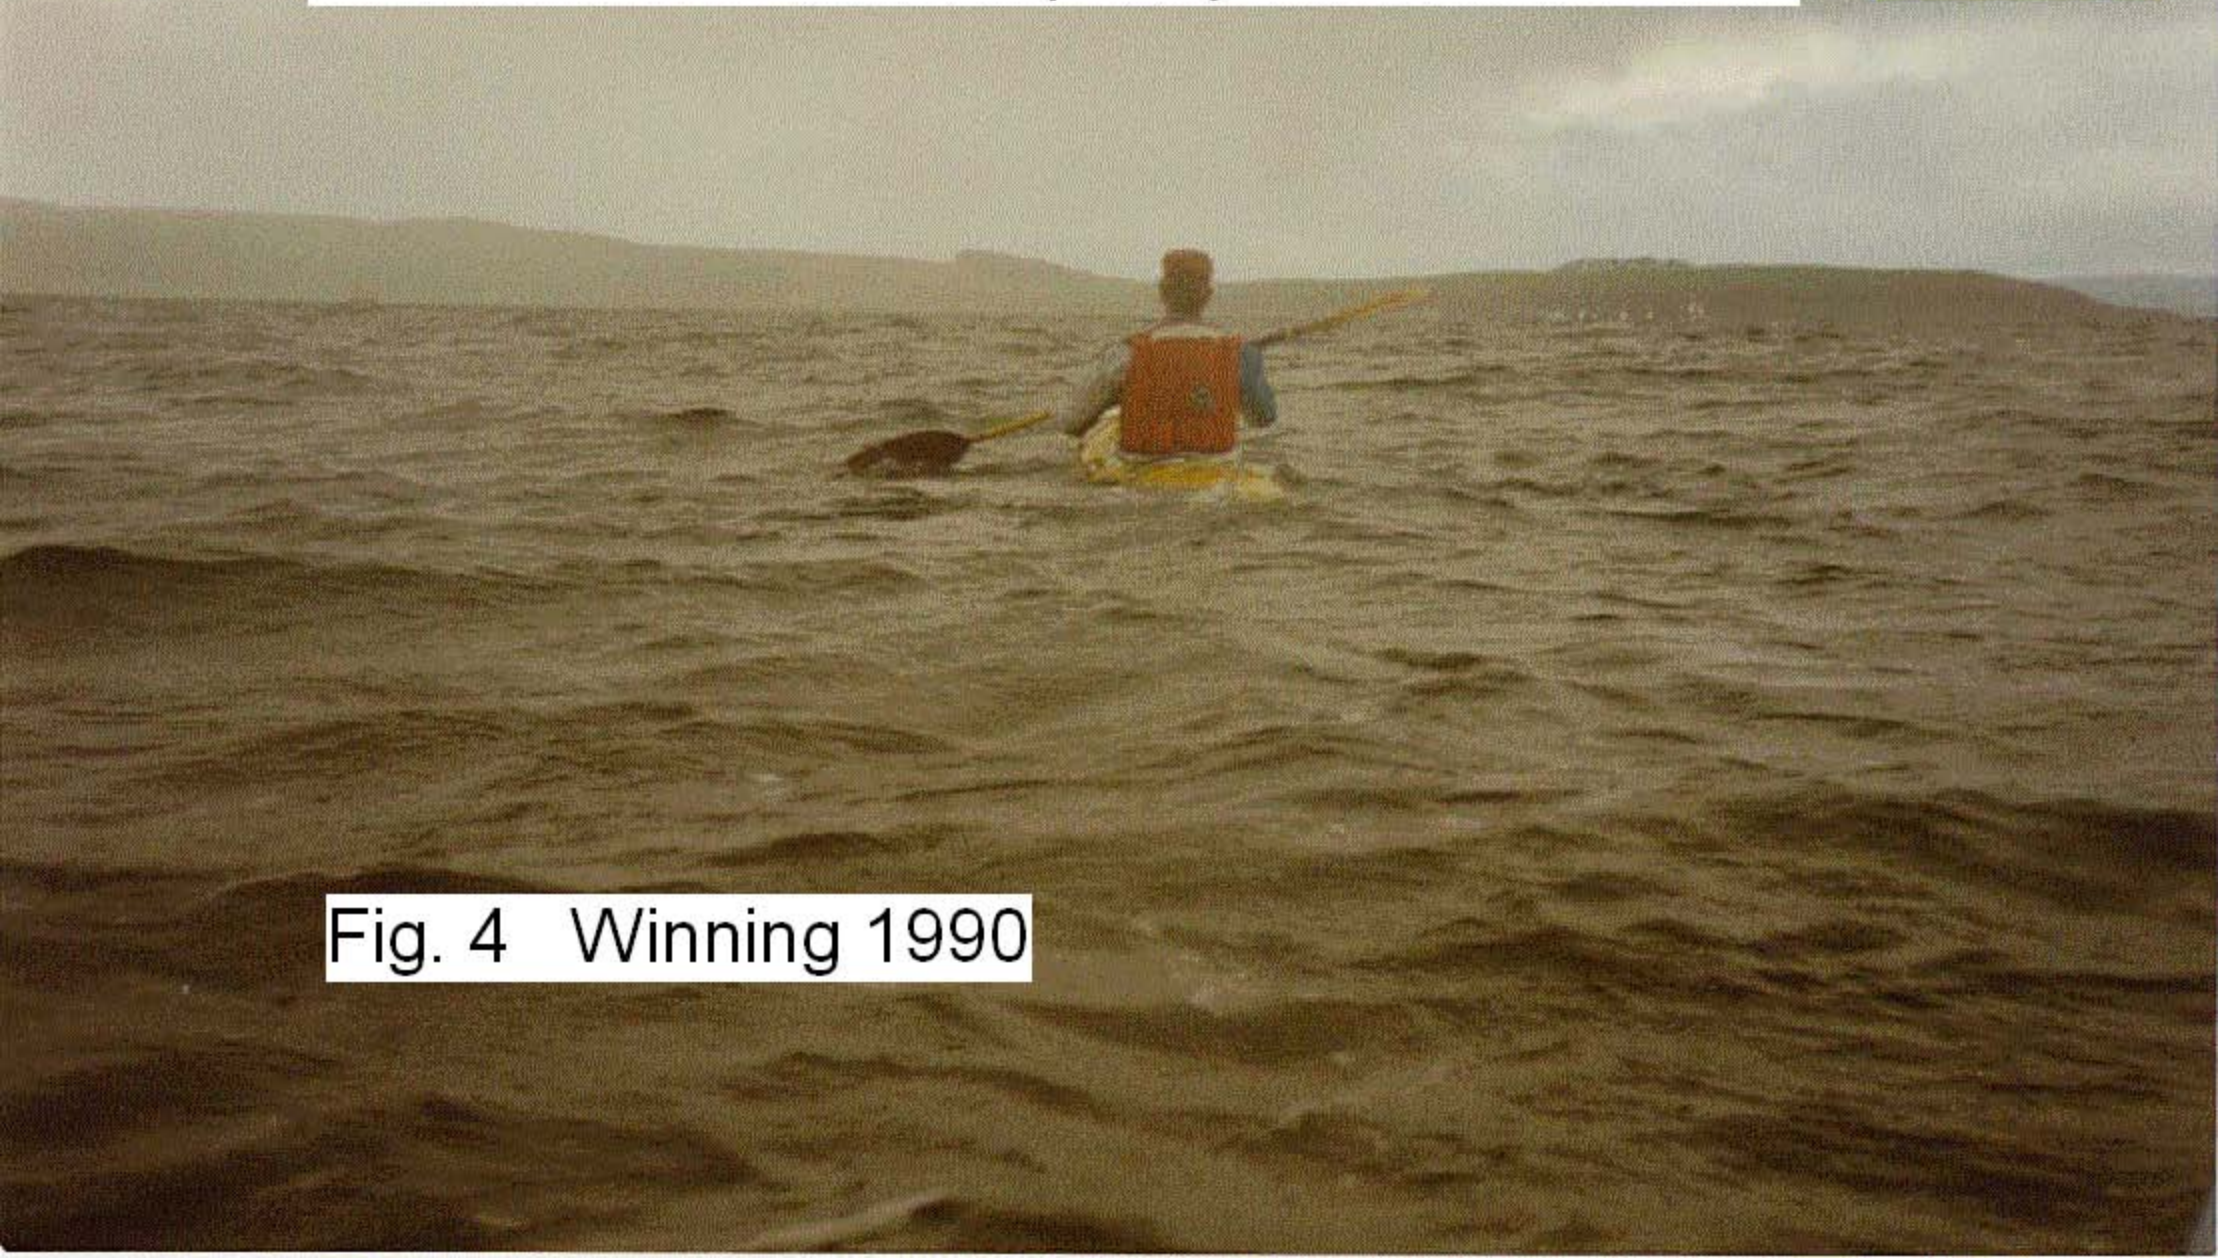
- 60 litres [Figs. 3 and 4](#), "Cargoe" moving about with the wave action accentuating the roll but controllable.
- 80 litres [Fig. 5](#), same as stage 3 (60 litres) only stronger roll.

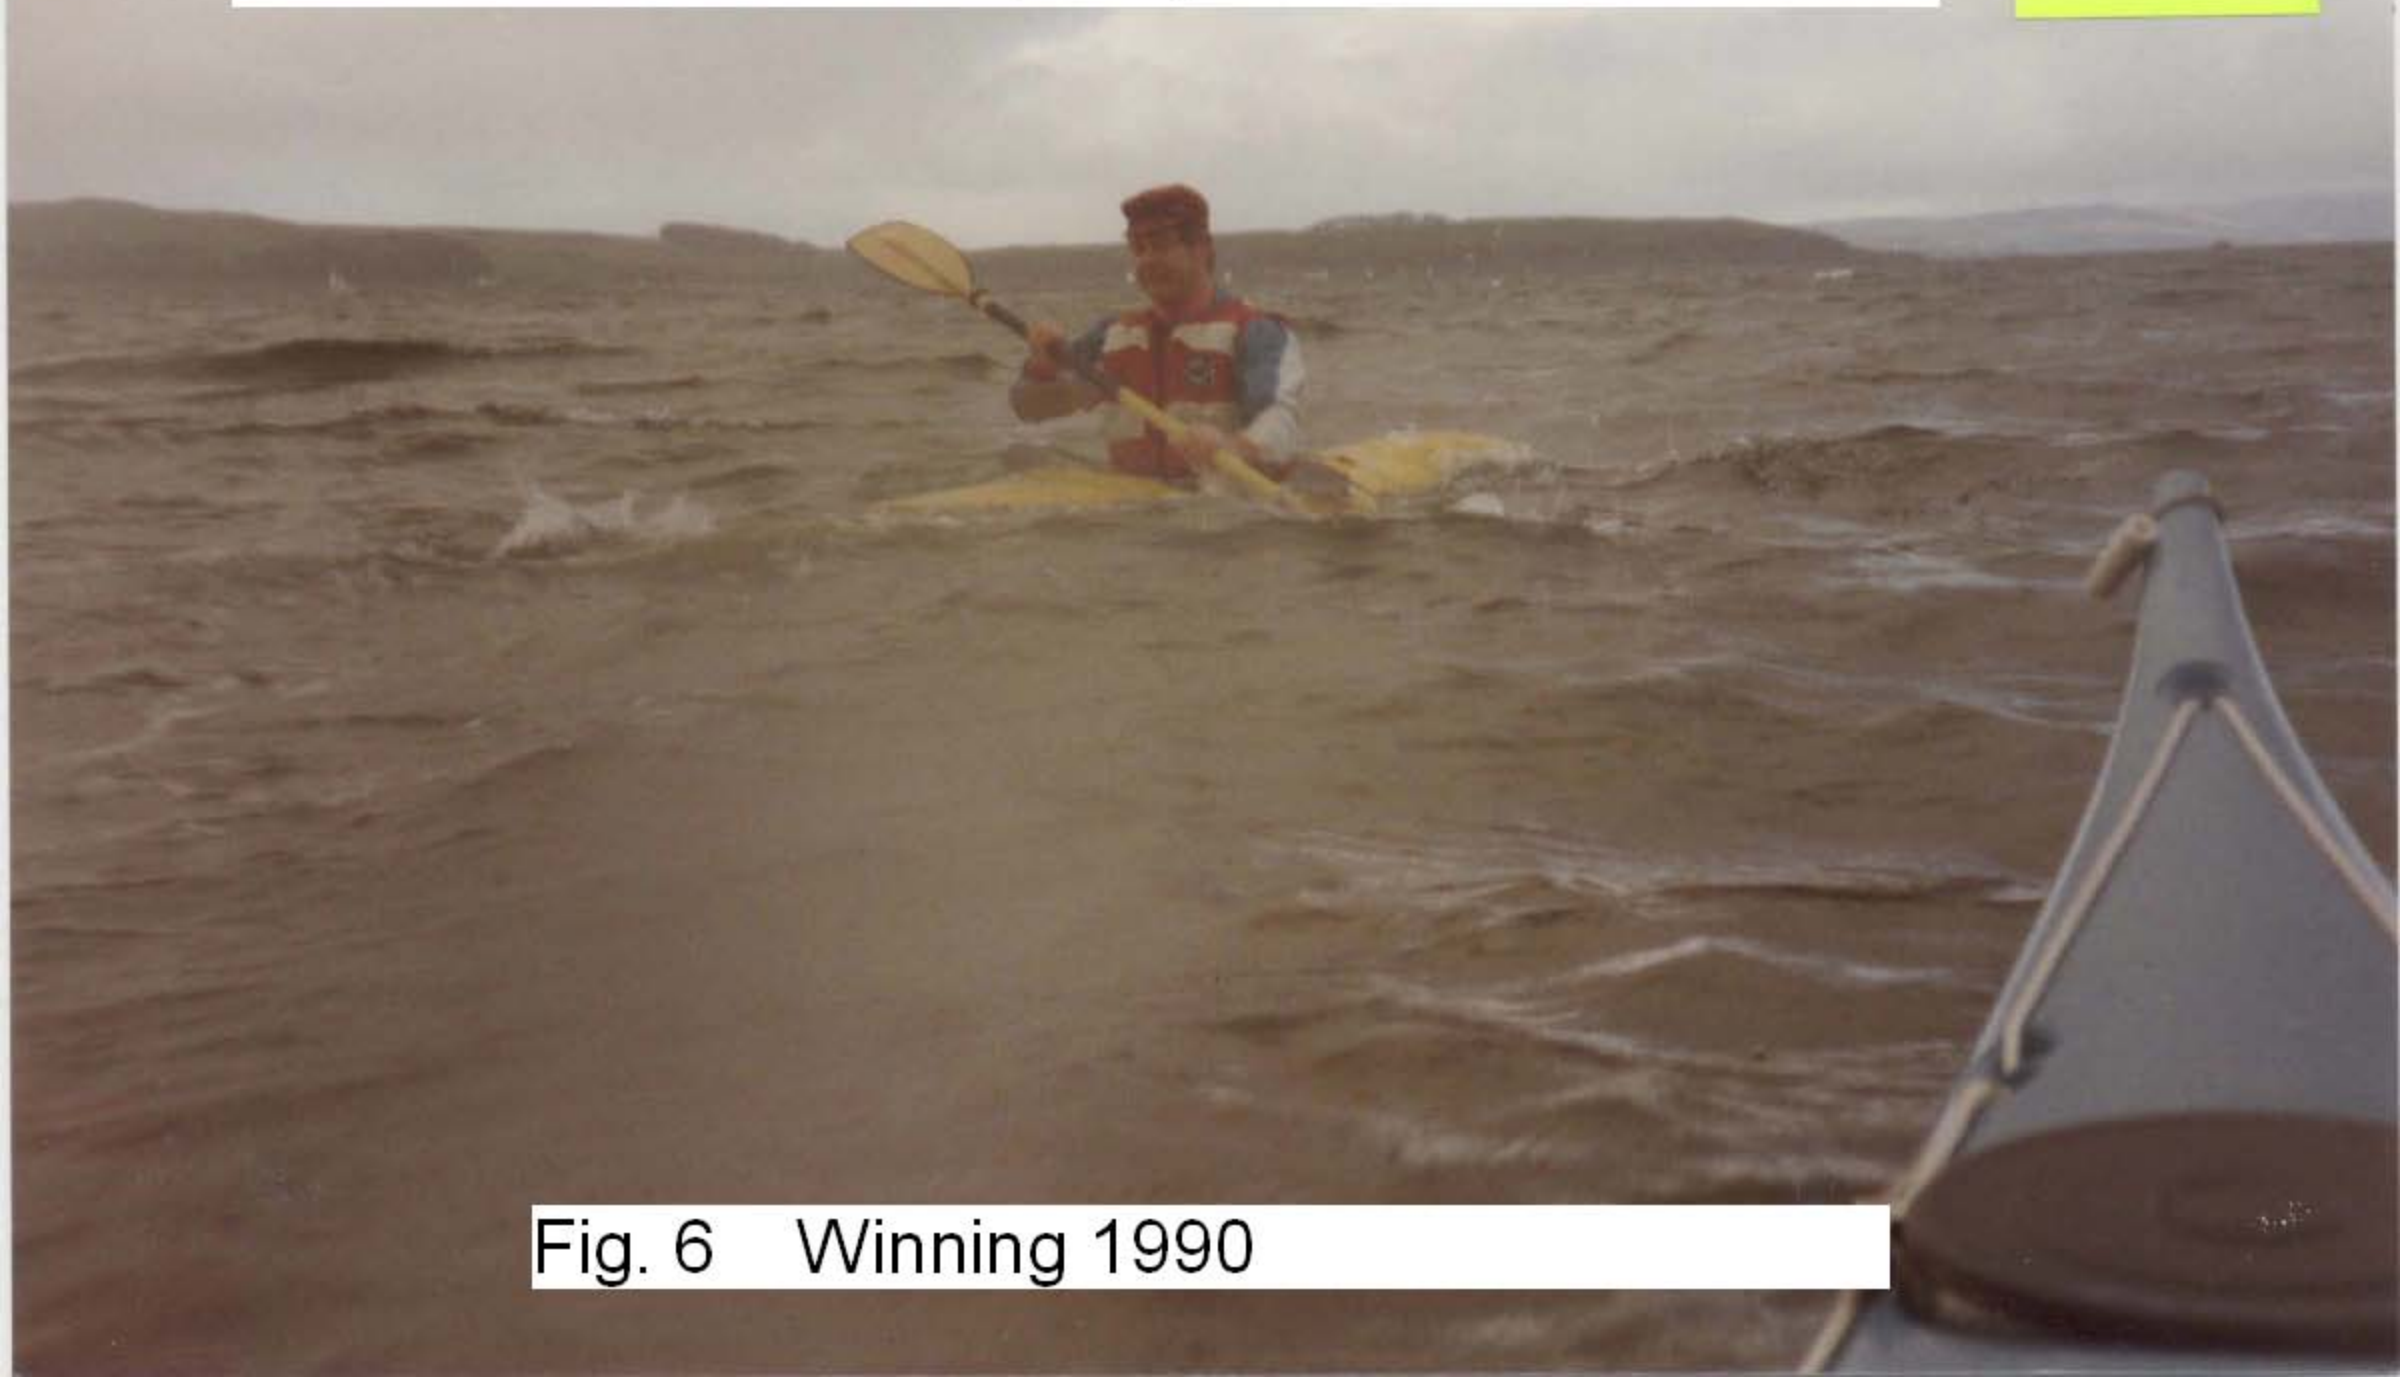
Fig. 6 Winning 1990

- 100 litres [Fig 6](#), same comment as stage 4 (80 litres).
- 120 litres +C [Fig 7](#), definitely tippy after the pod had flooded balance had to be given some thought, especially when turning. When running down a wave the water movement to the bow carried the bow under and it stayed there with the stern in the air ([Fig. 8](#)). Balance had to be worked at and although the kayak could be paddled it was not really going anywhere. The kayak was recovered, not easily as it was heavy, by two canoeists using the "Hatches off" recovery method advocated by Nick Padwick.

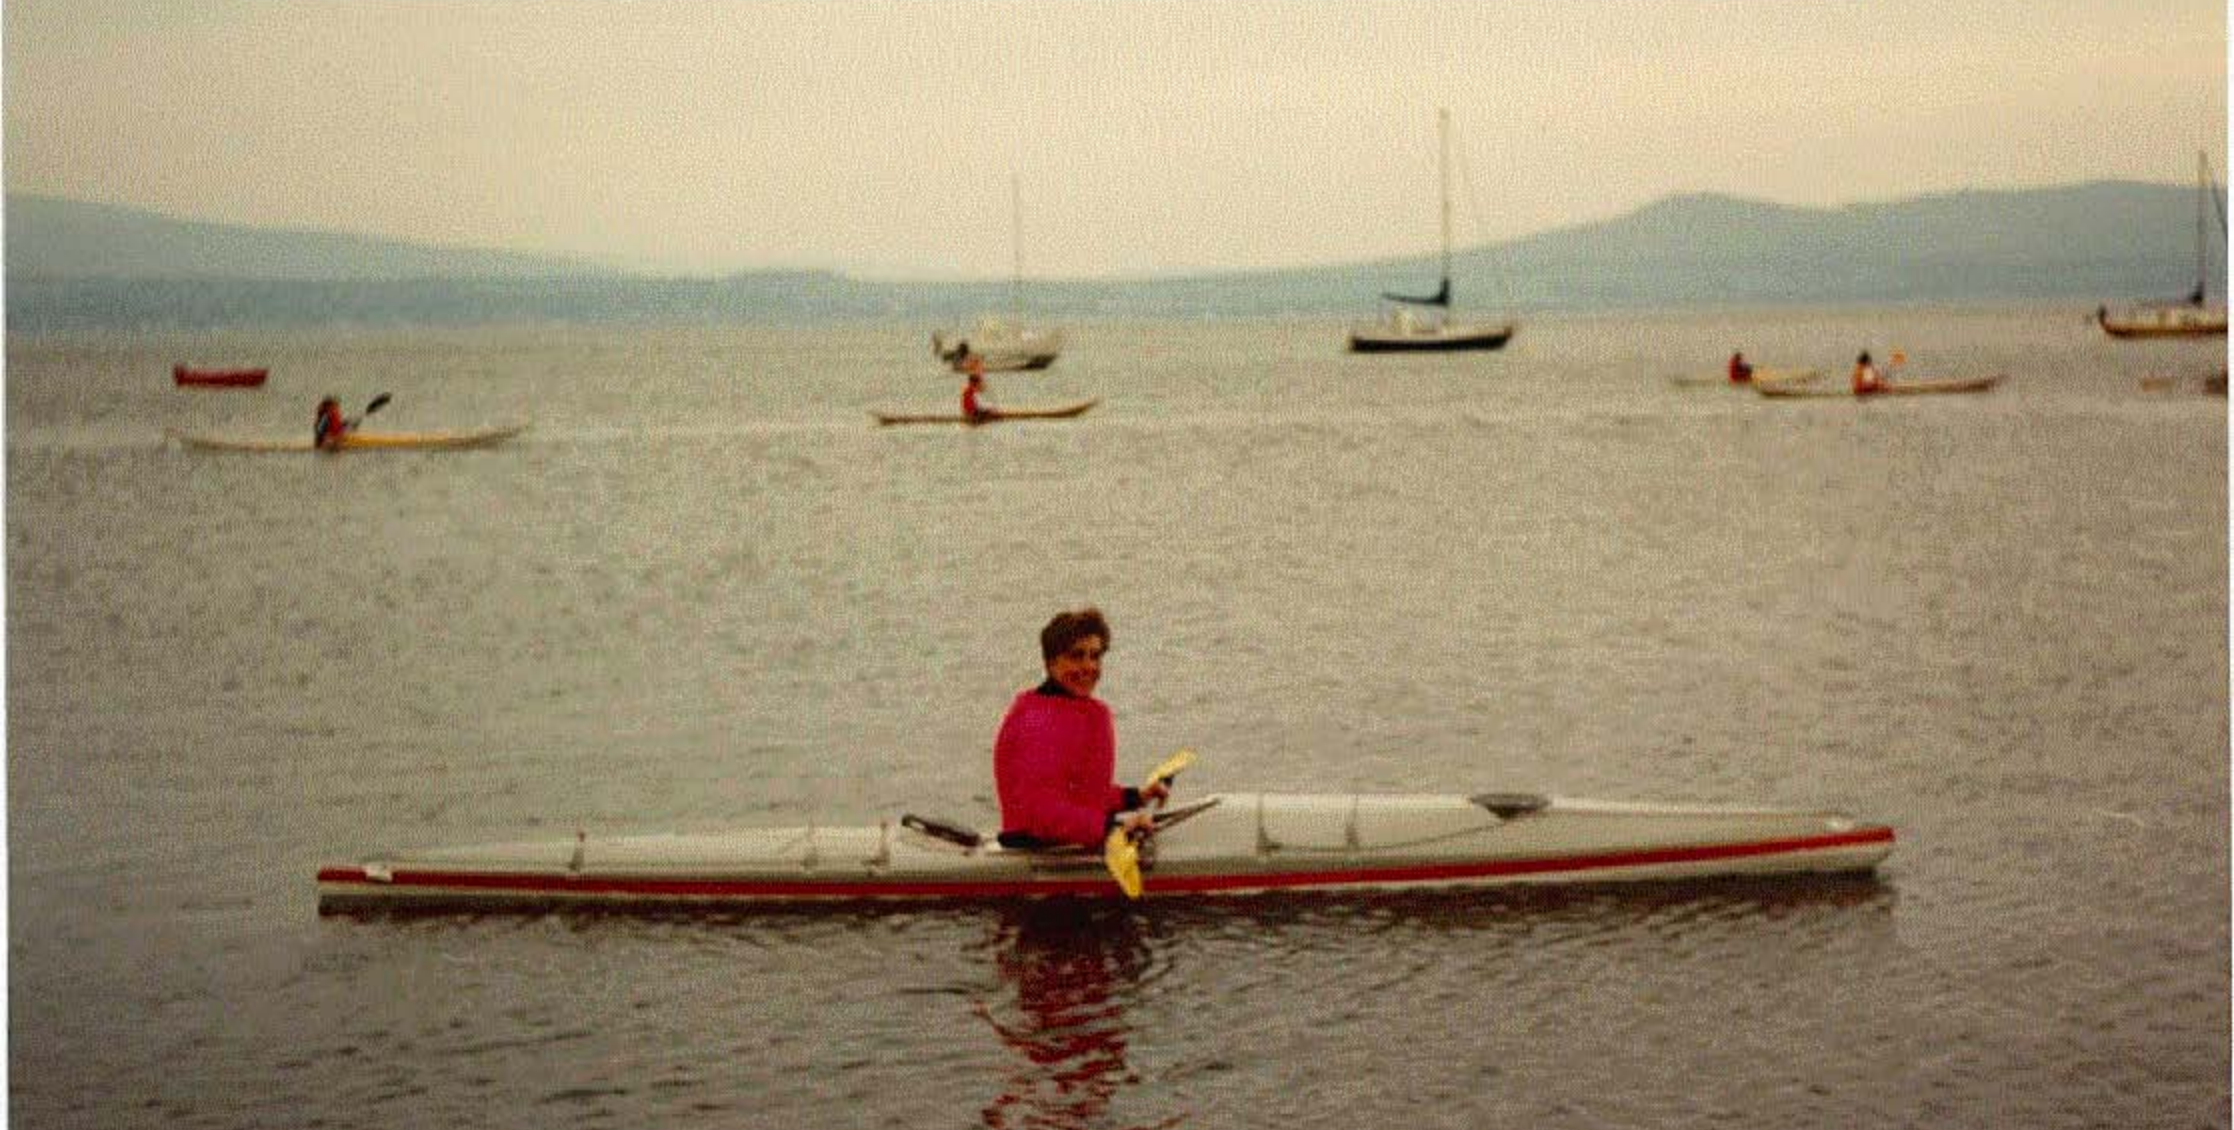
Fig. 10 Winning 1990

60 litres [Fig. 10](#), less stable but quite manageable.

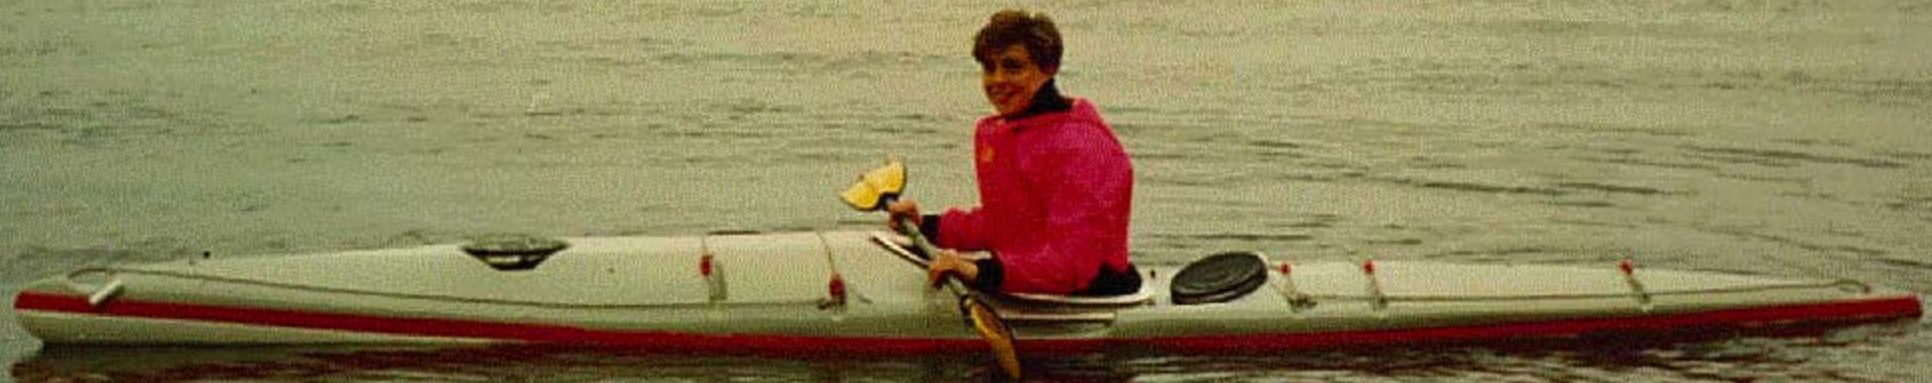
Fig. 11 Winning 1990

80 litres [Fig. 11](#), as stage 2 but heavier to paddle.

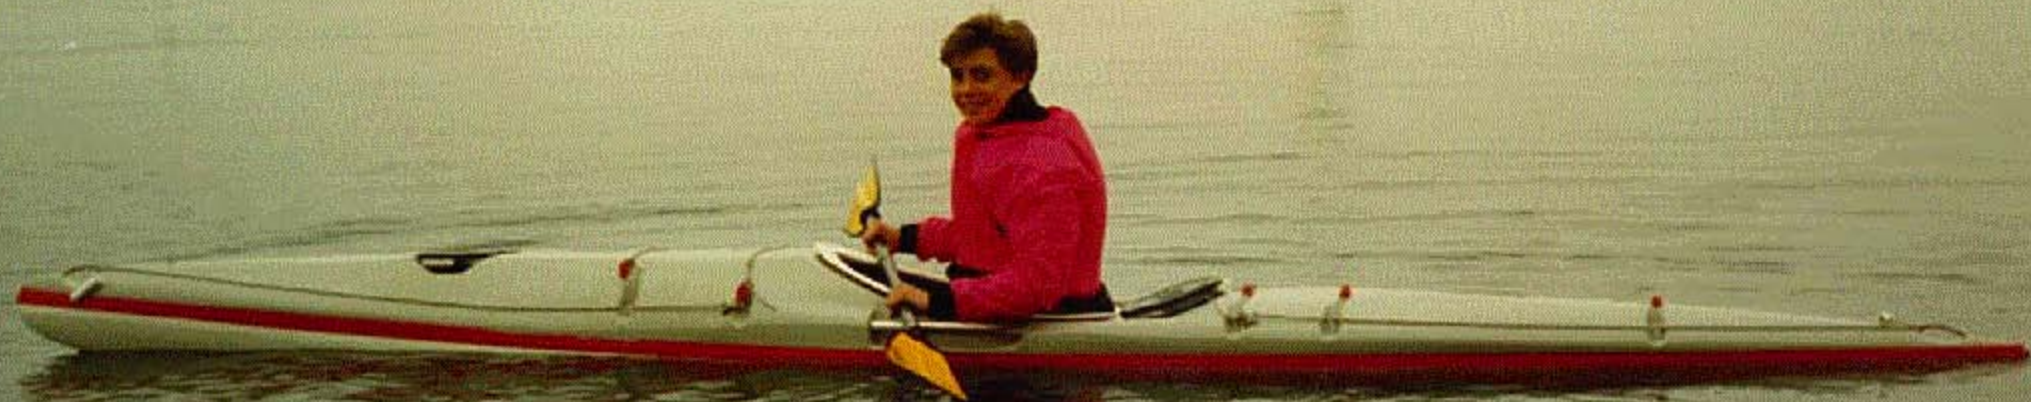
Fig. 12 Winning 1990

100 litres [Fig. 12](#), still paddles OK. Not rolling as much but rolls further and with more force.

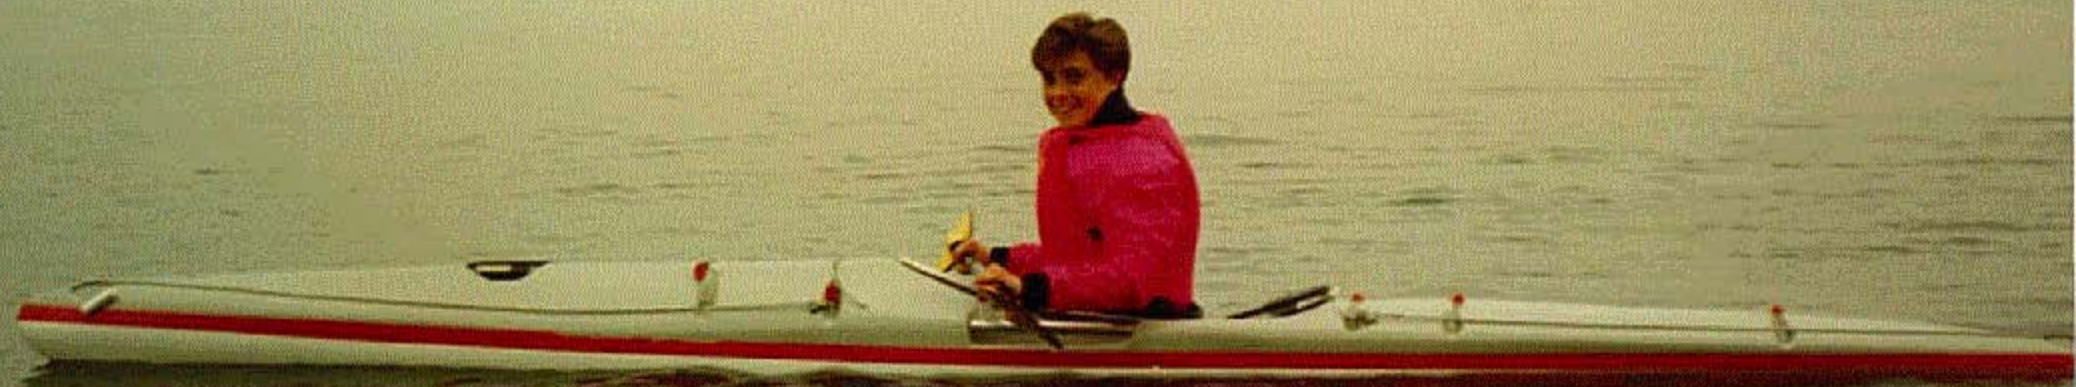
Fig. 13 Winning 1990

120 litres [Fig. 13](#), when paddled water is level with stern. A lot less stable. Paddler must concentrate.

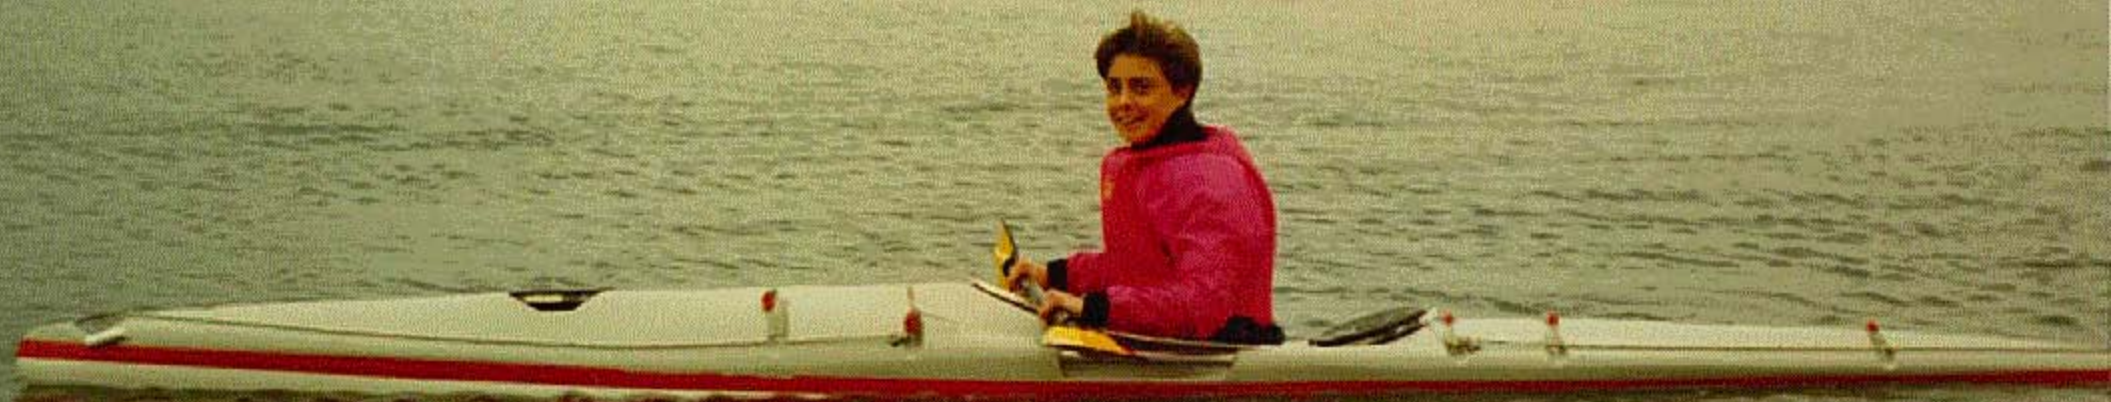
Fig. 14 Winning 1990

140 litres [Fig. 14](#), when paddled 18" of stern deck is under water. Felt very tippy. Took approximately 1 gallon of water in pod.

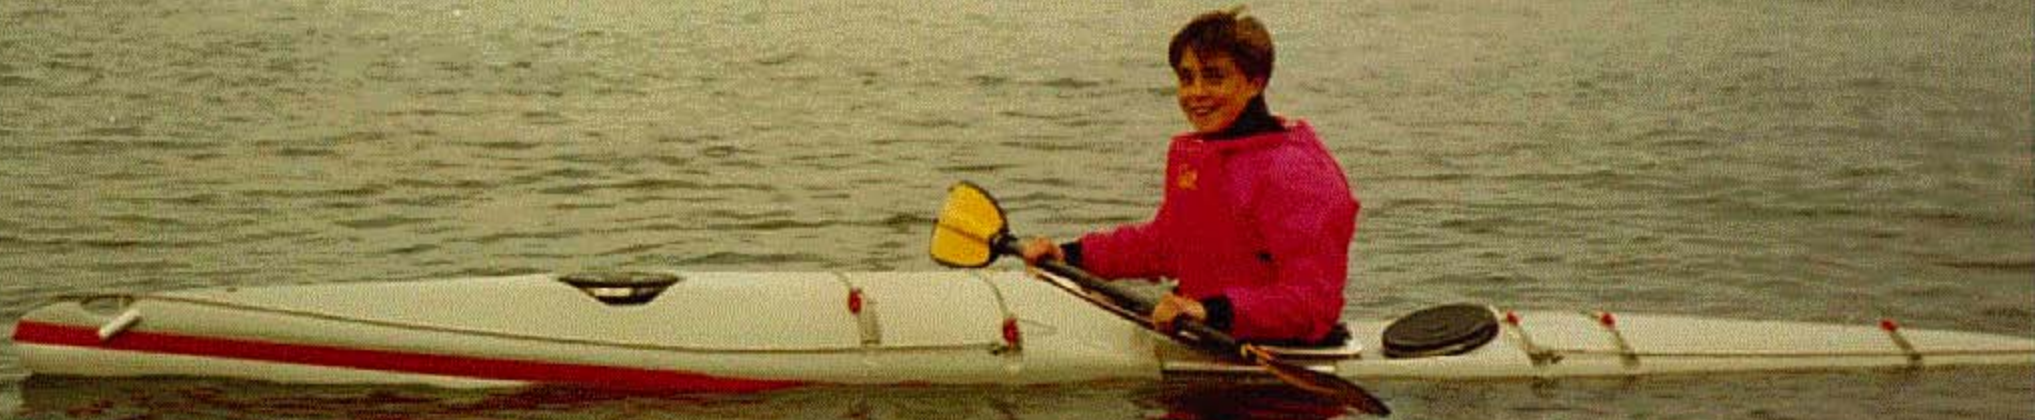
Fig. 15 Winning 1990

160 litres [Fig. 15](#), same as stage 6 only more so.

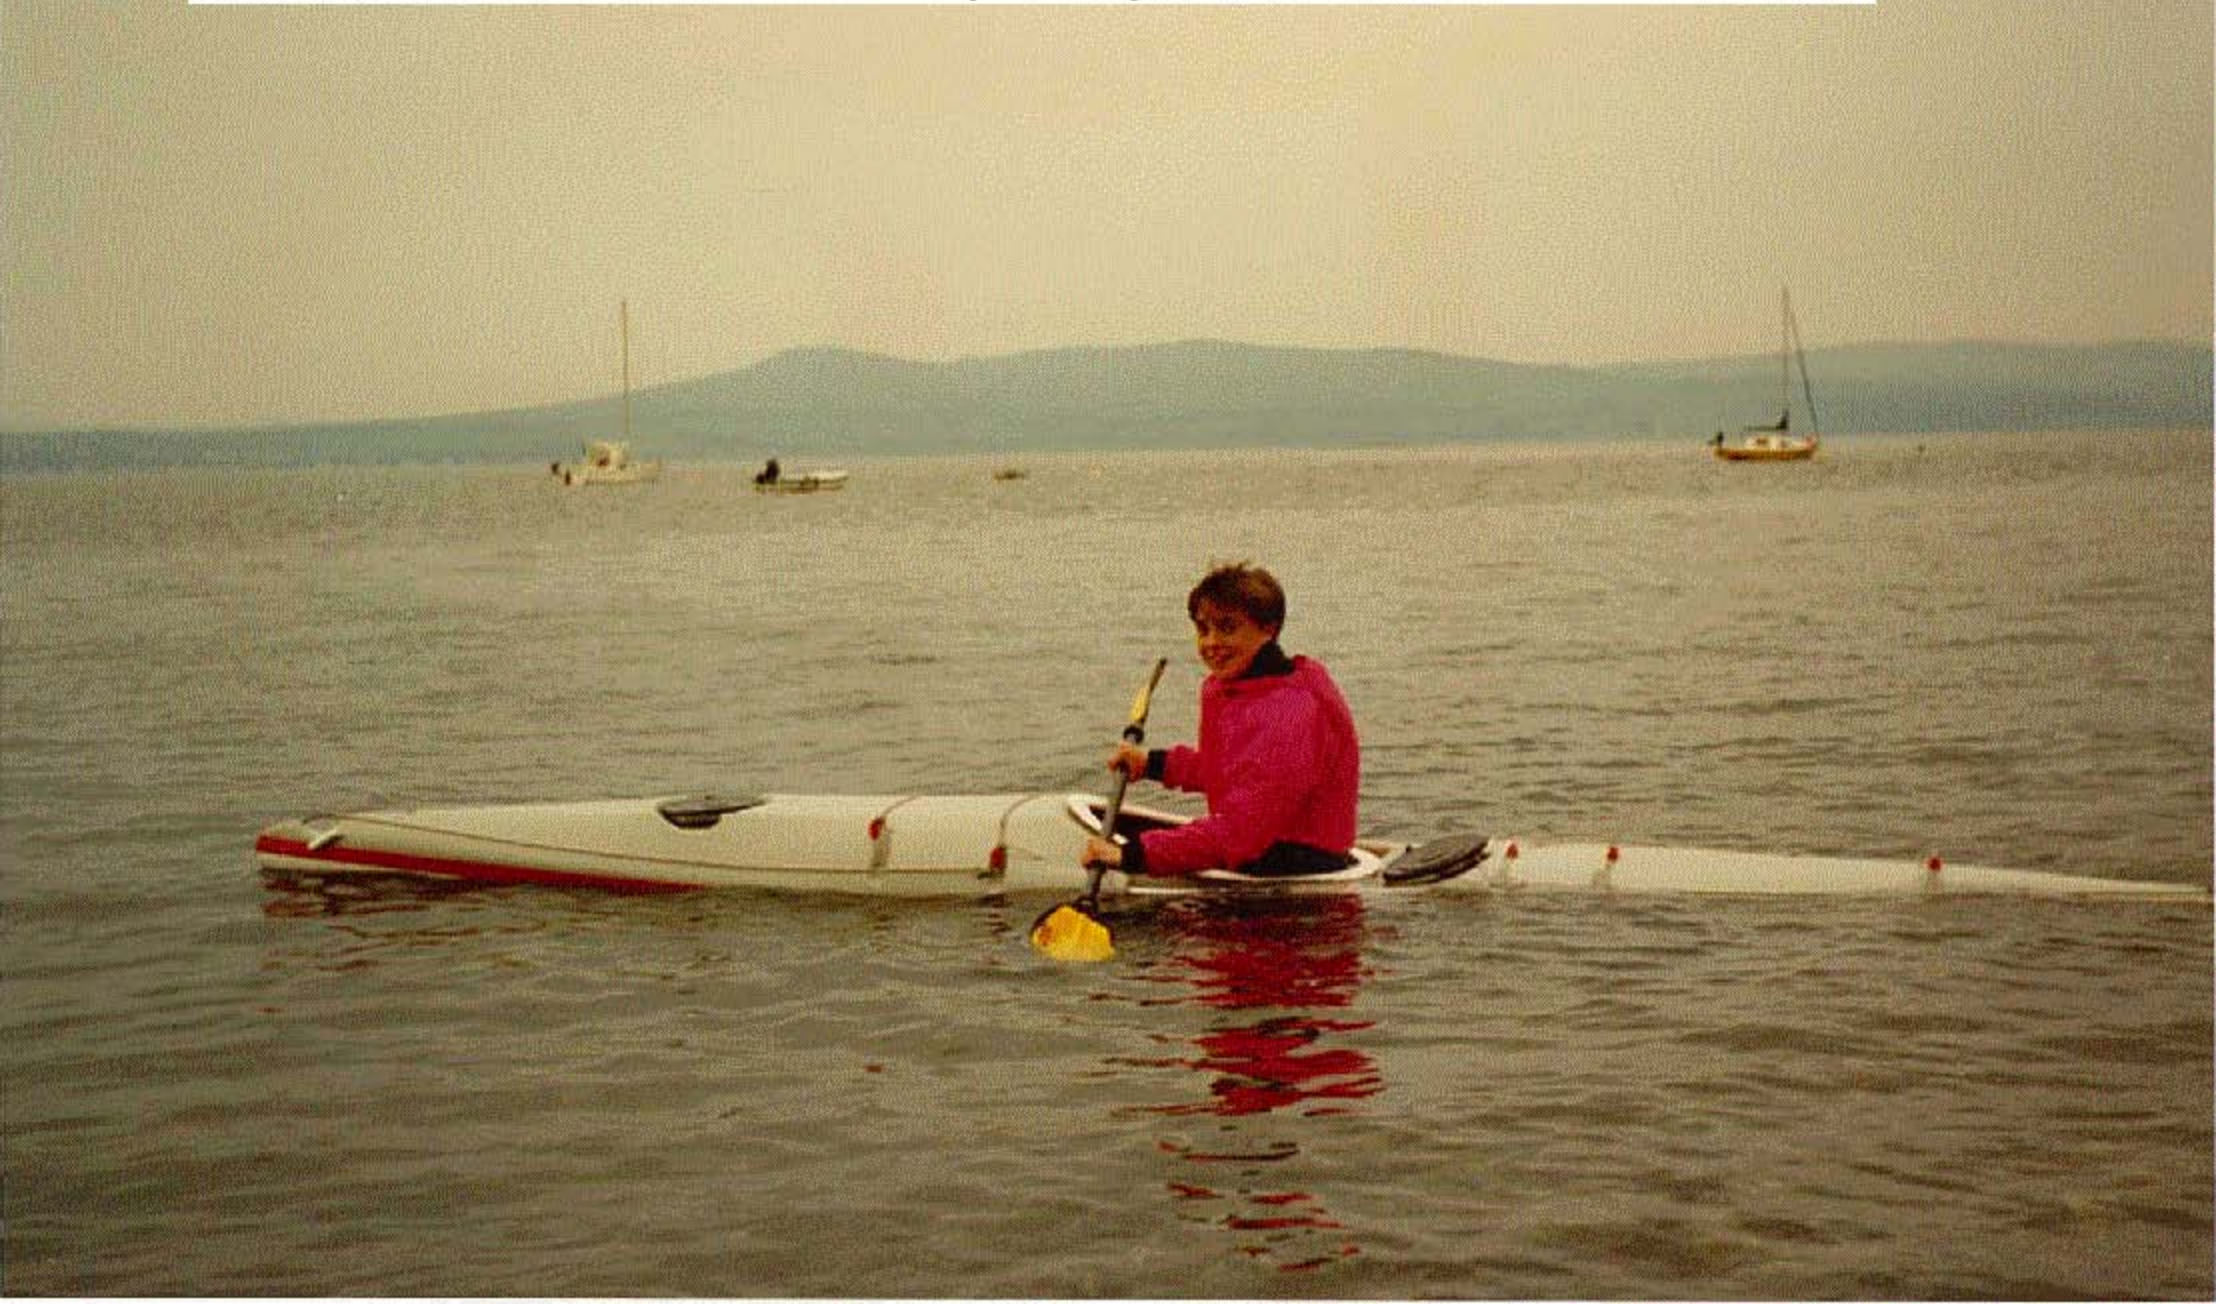
180 litres +C [Fig 16](#), at this point the pod was very close to flooding so it was helped to do so. With the pod flooded the boat was fairly stable but not really going anywhere. So Helen exited the cockpit. She was able to stop paddling and place her hands on the cockpit rim, push herself out rearwards and keep her hair dry. No photo is available of the flooded position but 30" (76 cm) of bottom were showing at bow and the boat was under from the cockpit aft i.e. not with as high an inclination as in Peter Lamont's paper, [Fig. 11](#).

180 litres in hull
+ cockpit flooded
