Sea Tiger Report

Report on comparative tests of “Sea Tiger” sea kayak and other sea kayaks on behalf of the British Canoe Union

**Presented by Duncan R. Winning O.B.E.
22 Brisbane Glen Road,
Largs,
Ayrshire,
Scotland,
KA30 8QX.**

Twelfth June 1990

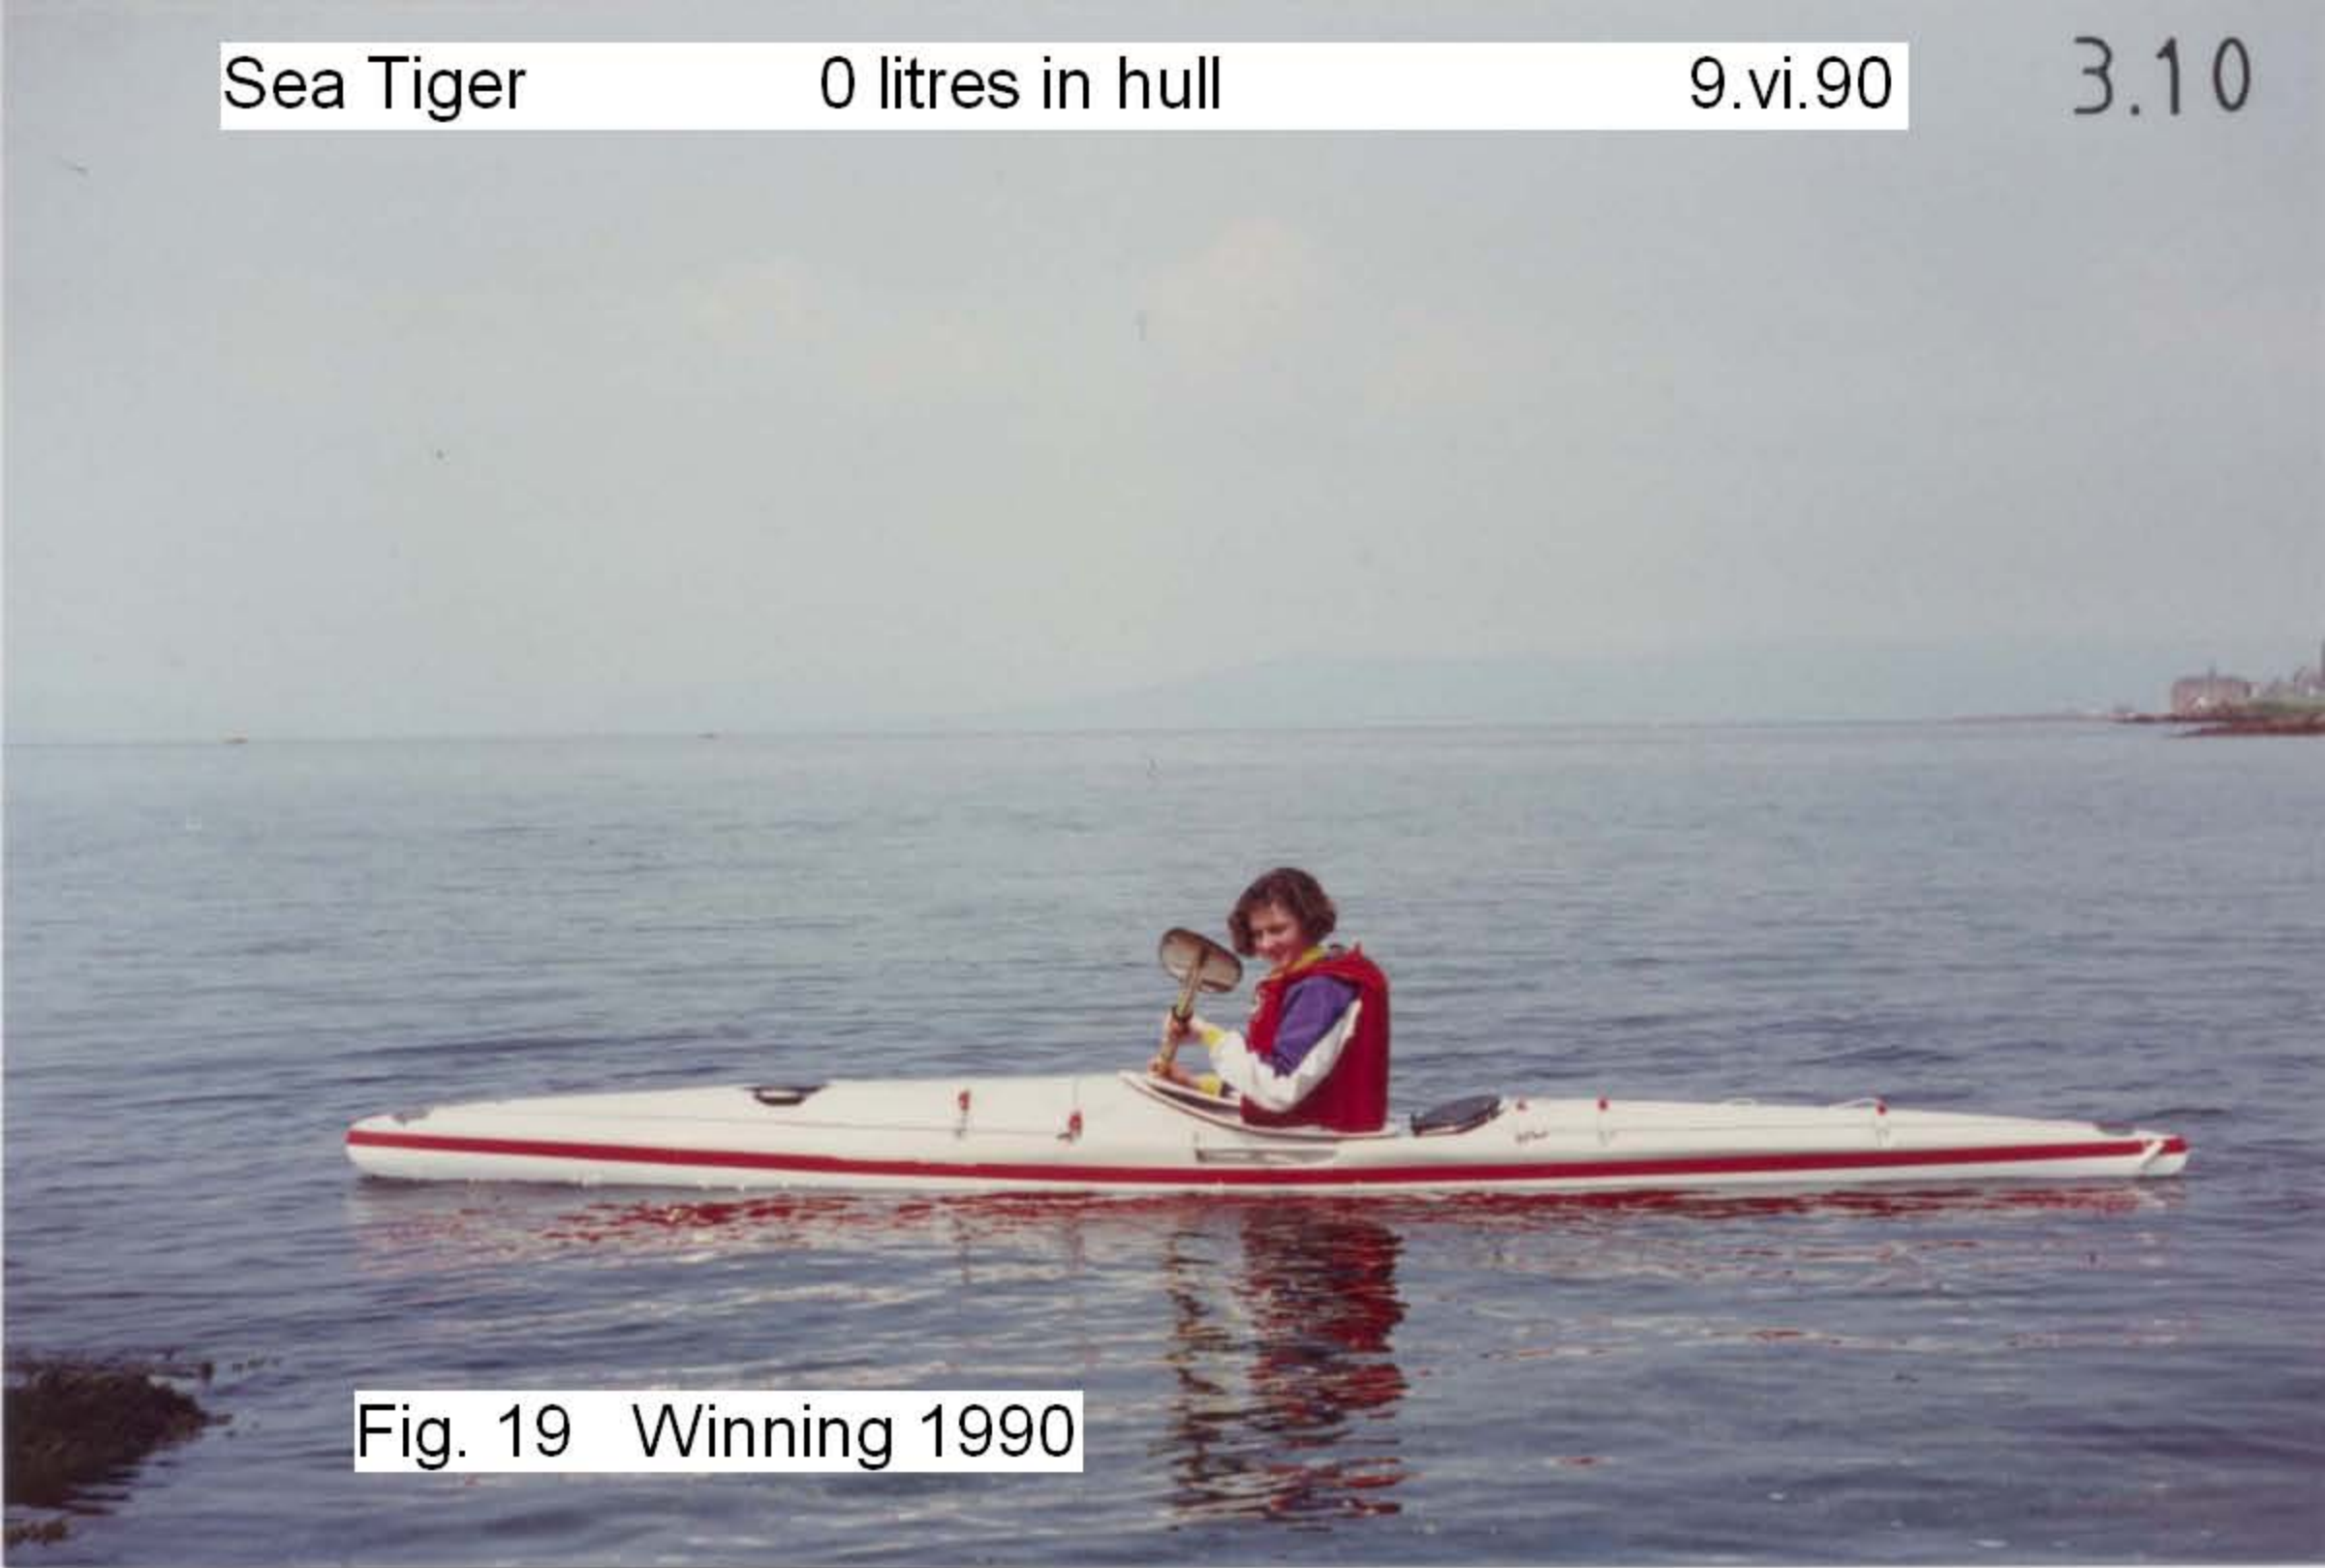
Fig. 19 Winning 1990

- 0 litres Fig. 19, easy to paddle, comfortable, dislike skeg rattle.
- 40 litres Fig.20, stable.
- 60 litres Fig. 21, slightly less stable.
- 80 litres Fig. 22, no change in stability, tins rattling.

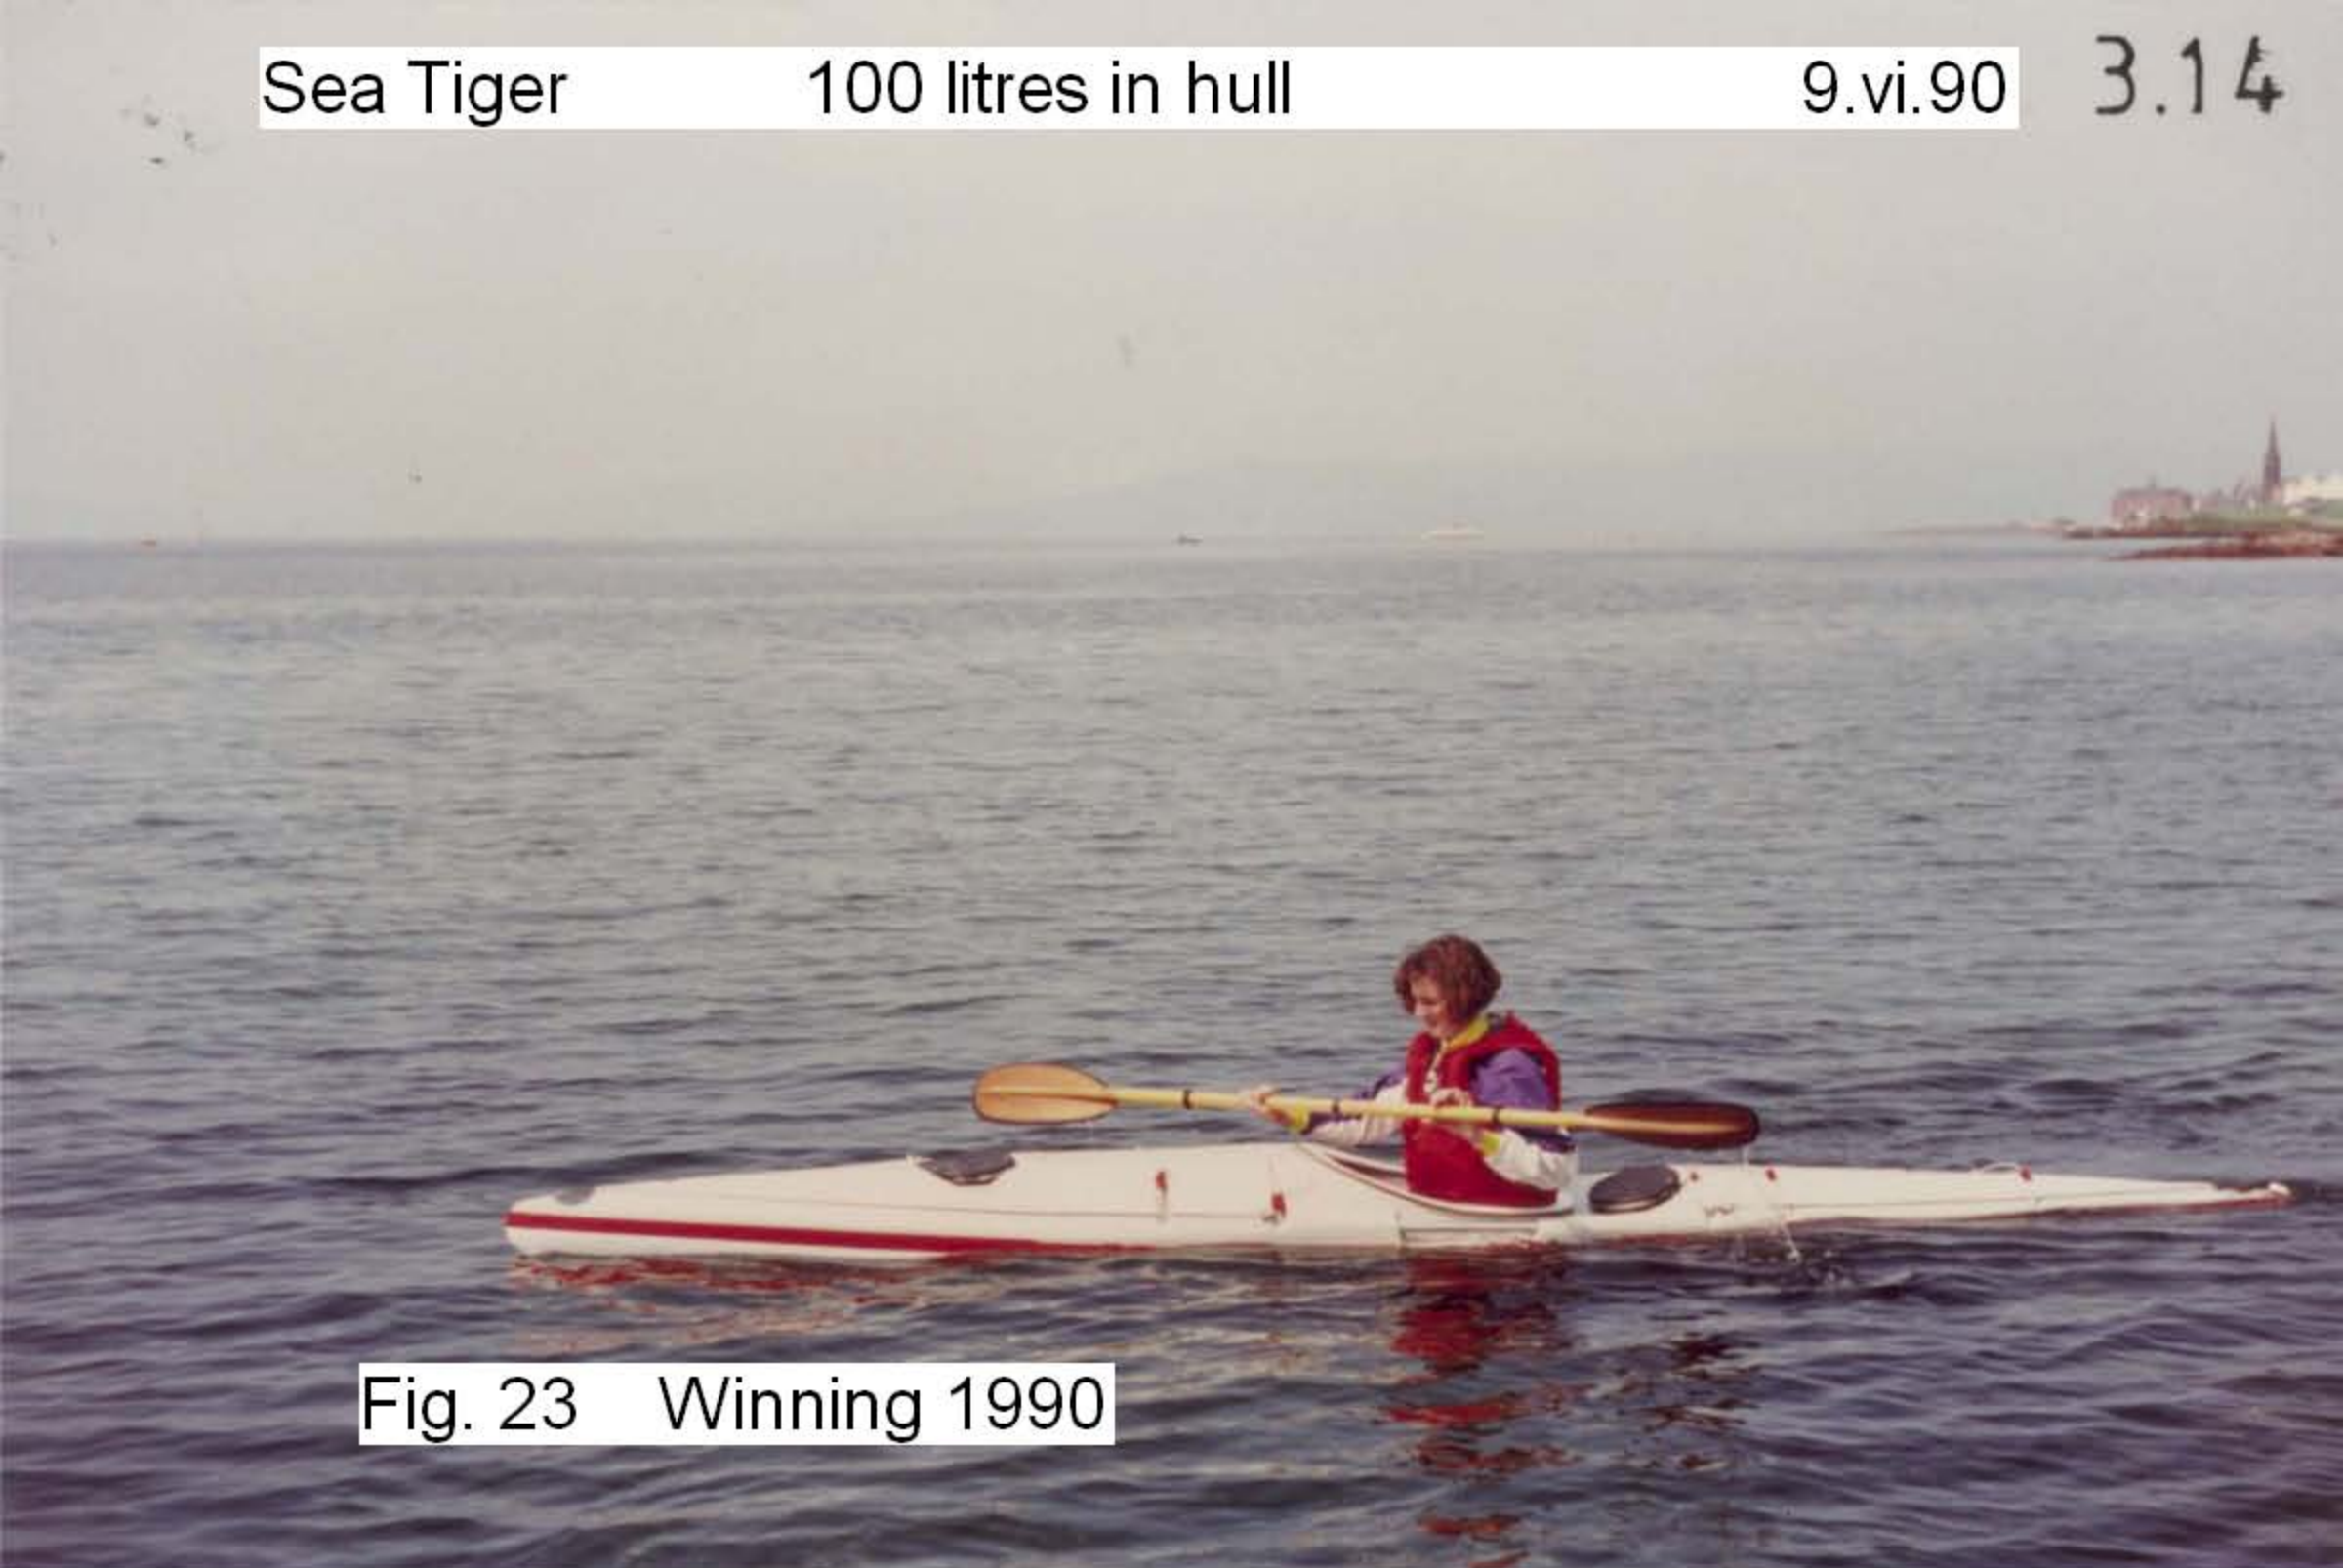
Fig. 23 Winning 1990

- 100 litres Fig. 23, no change in stability.
- 120 litres Fig. 24, heavy to paddle, slightly less stable again. Spray sheet on.
140 litres, as for 120 litres.

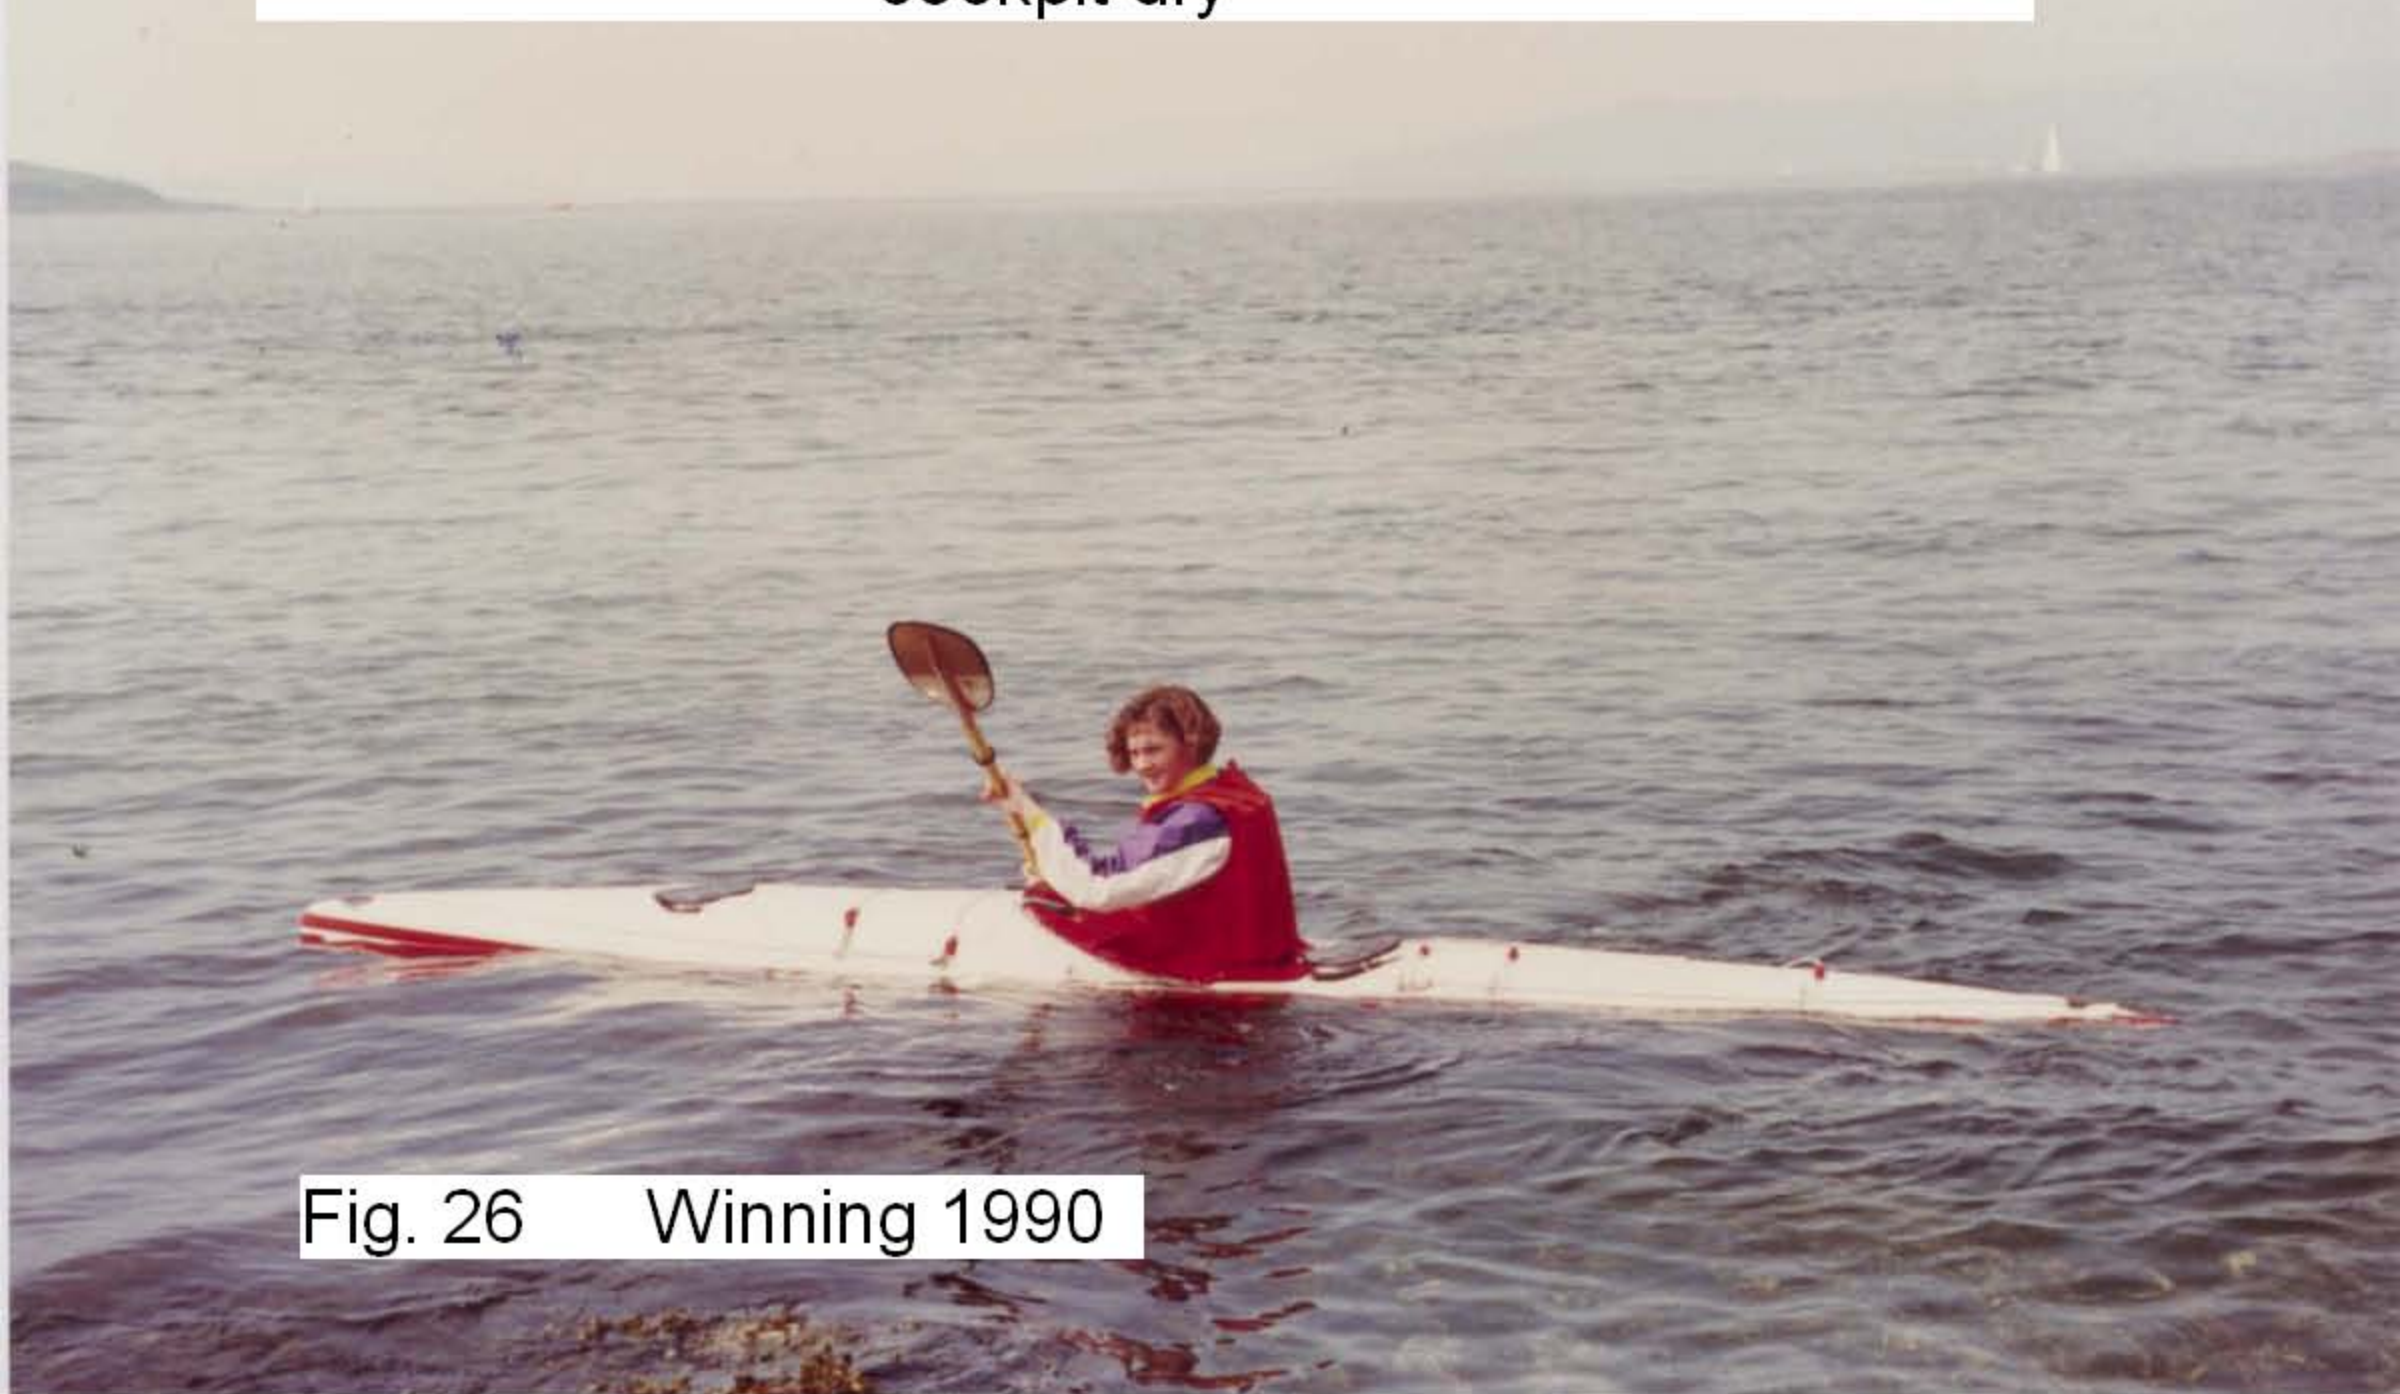
Fig. 26 Winning 1990

- 160 litres Fig. 26, water level inside equals water level outside. Slightly less stable again.
- 180 litres, water level inside slightly higher than outside.

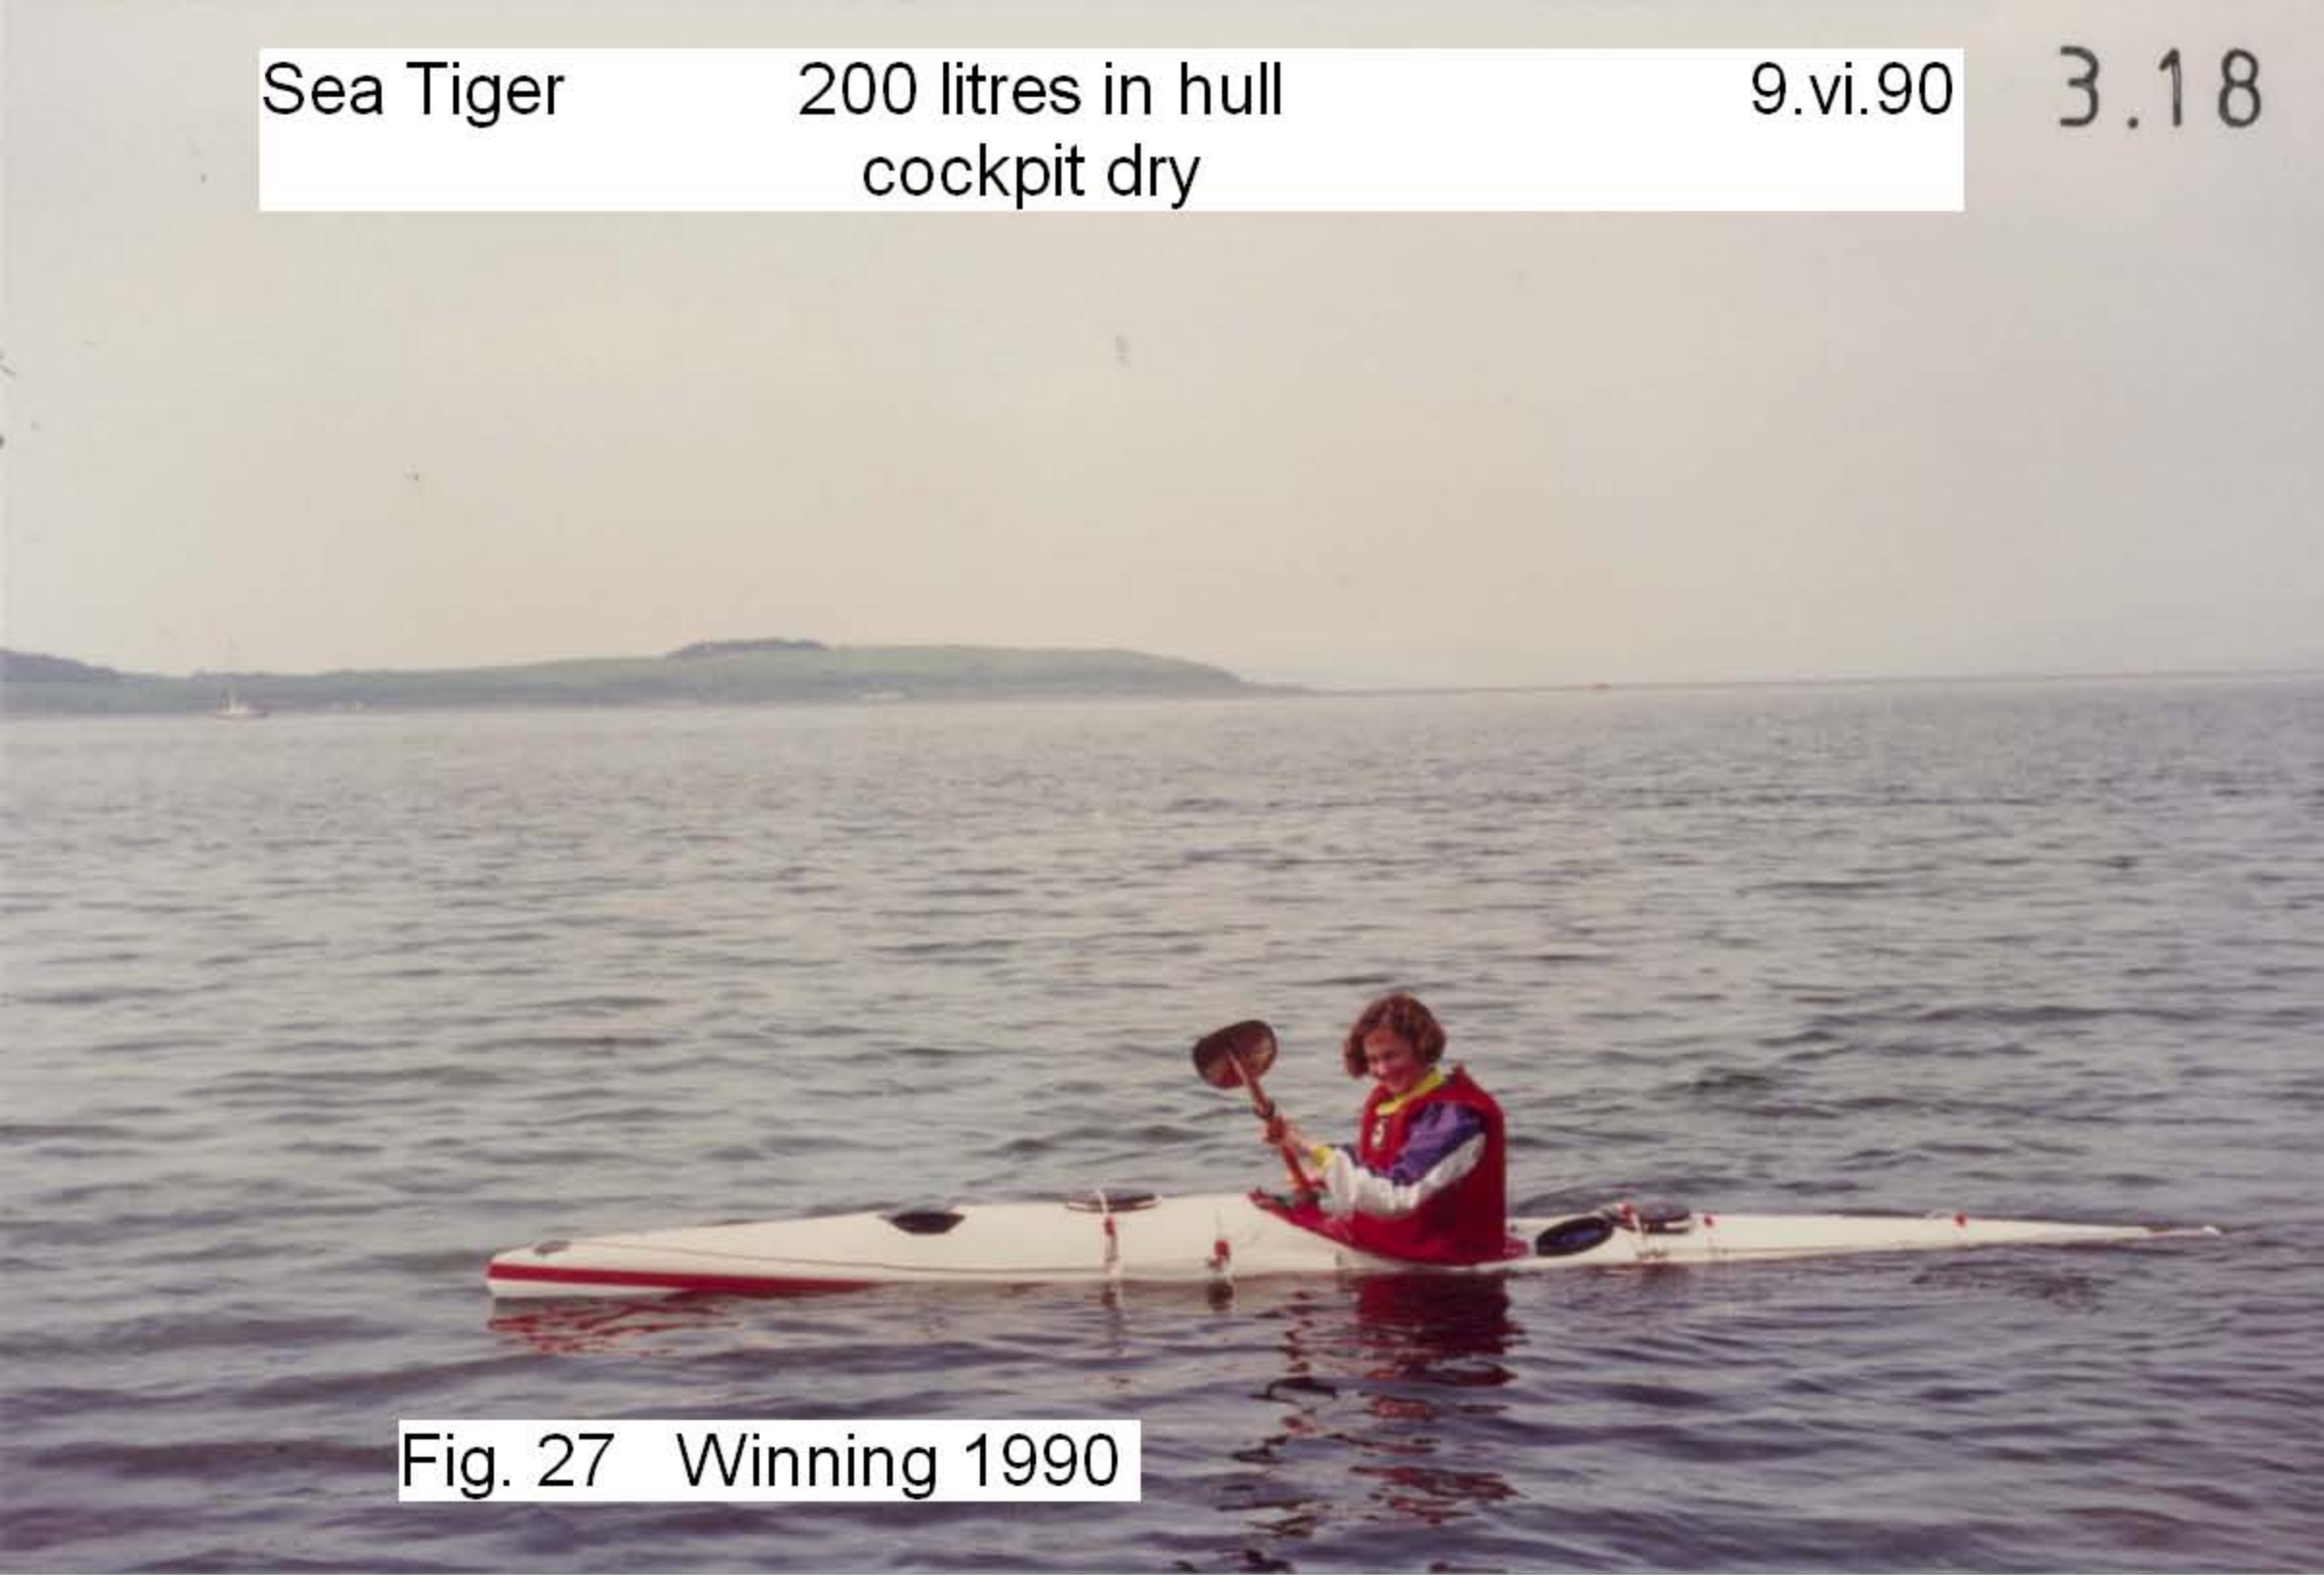
Fig. 27 Winning 1990

- 200 litres Fig. 27, difficult to fill to top of aft hatch. Surprisingly stable.
Hatches left off.
- 200 litres +C Fig. 28, pod flooded. In pic. water is flowing out of aft hatch.

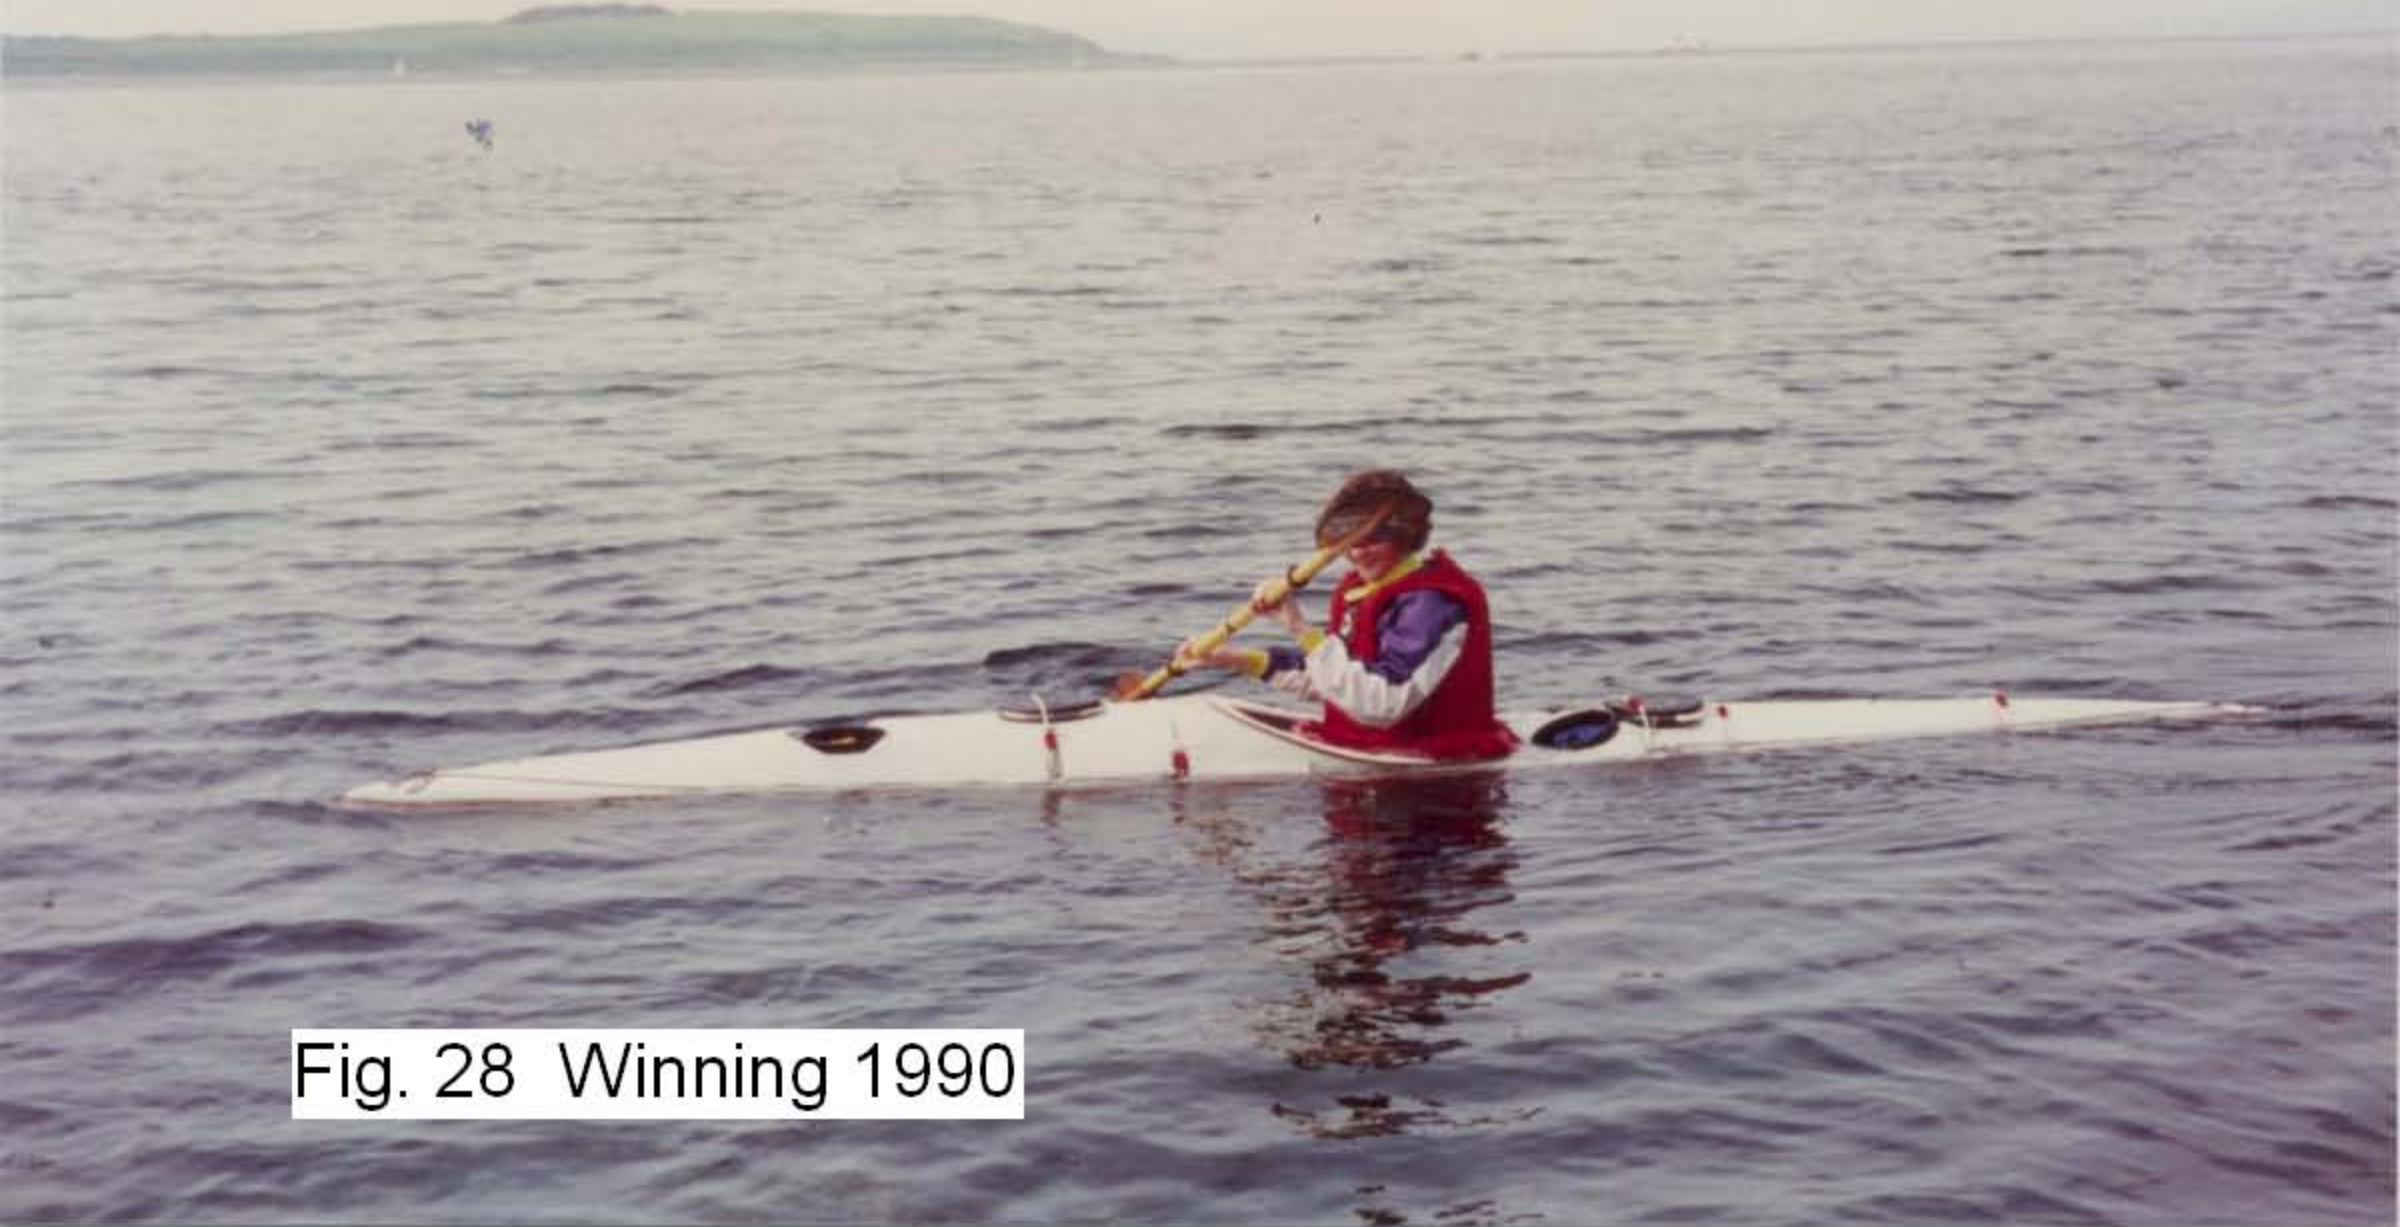
Fig. 28 Winning 1990

+ pod cockpit flooded, water flowing out of aft hatch

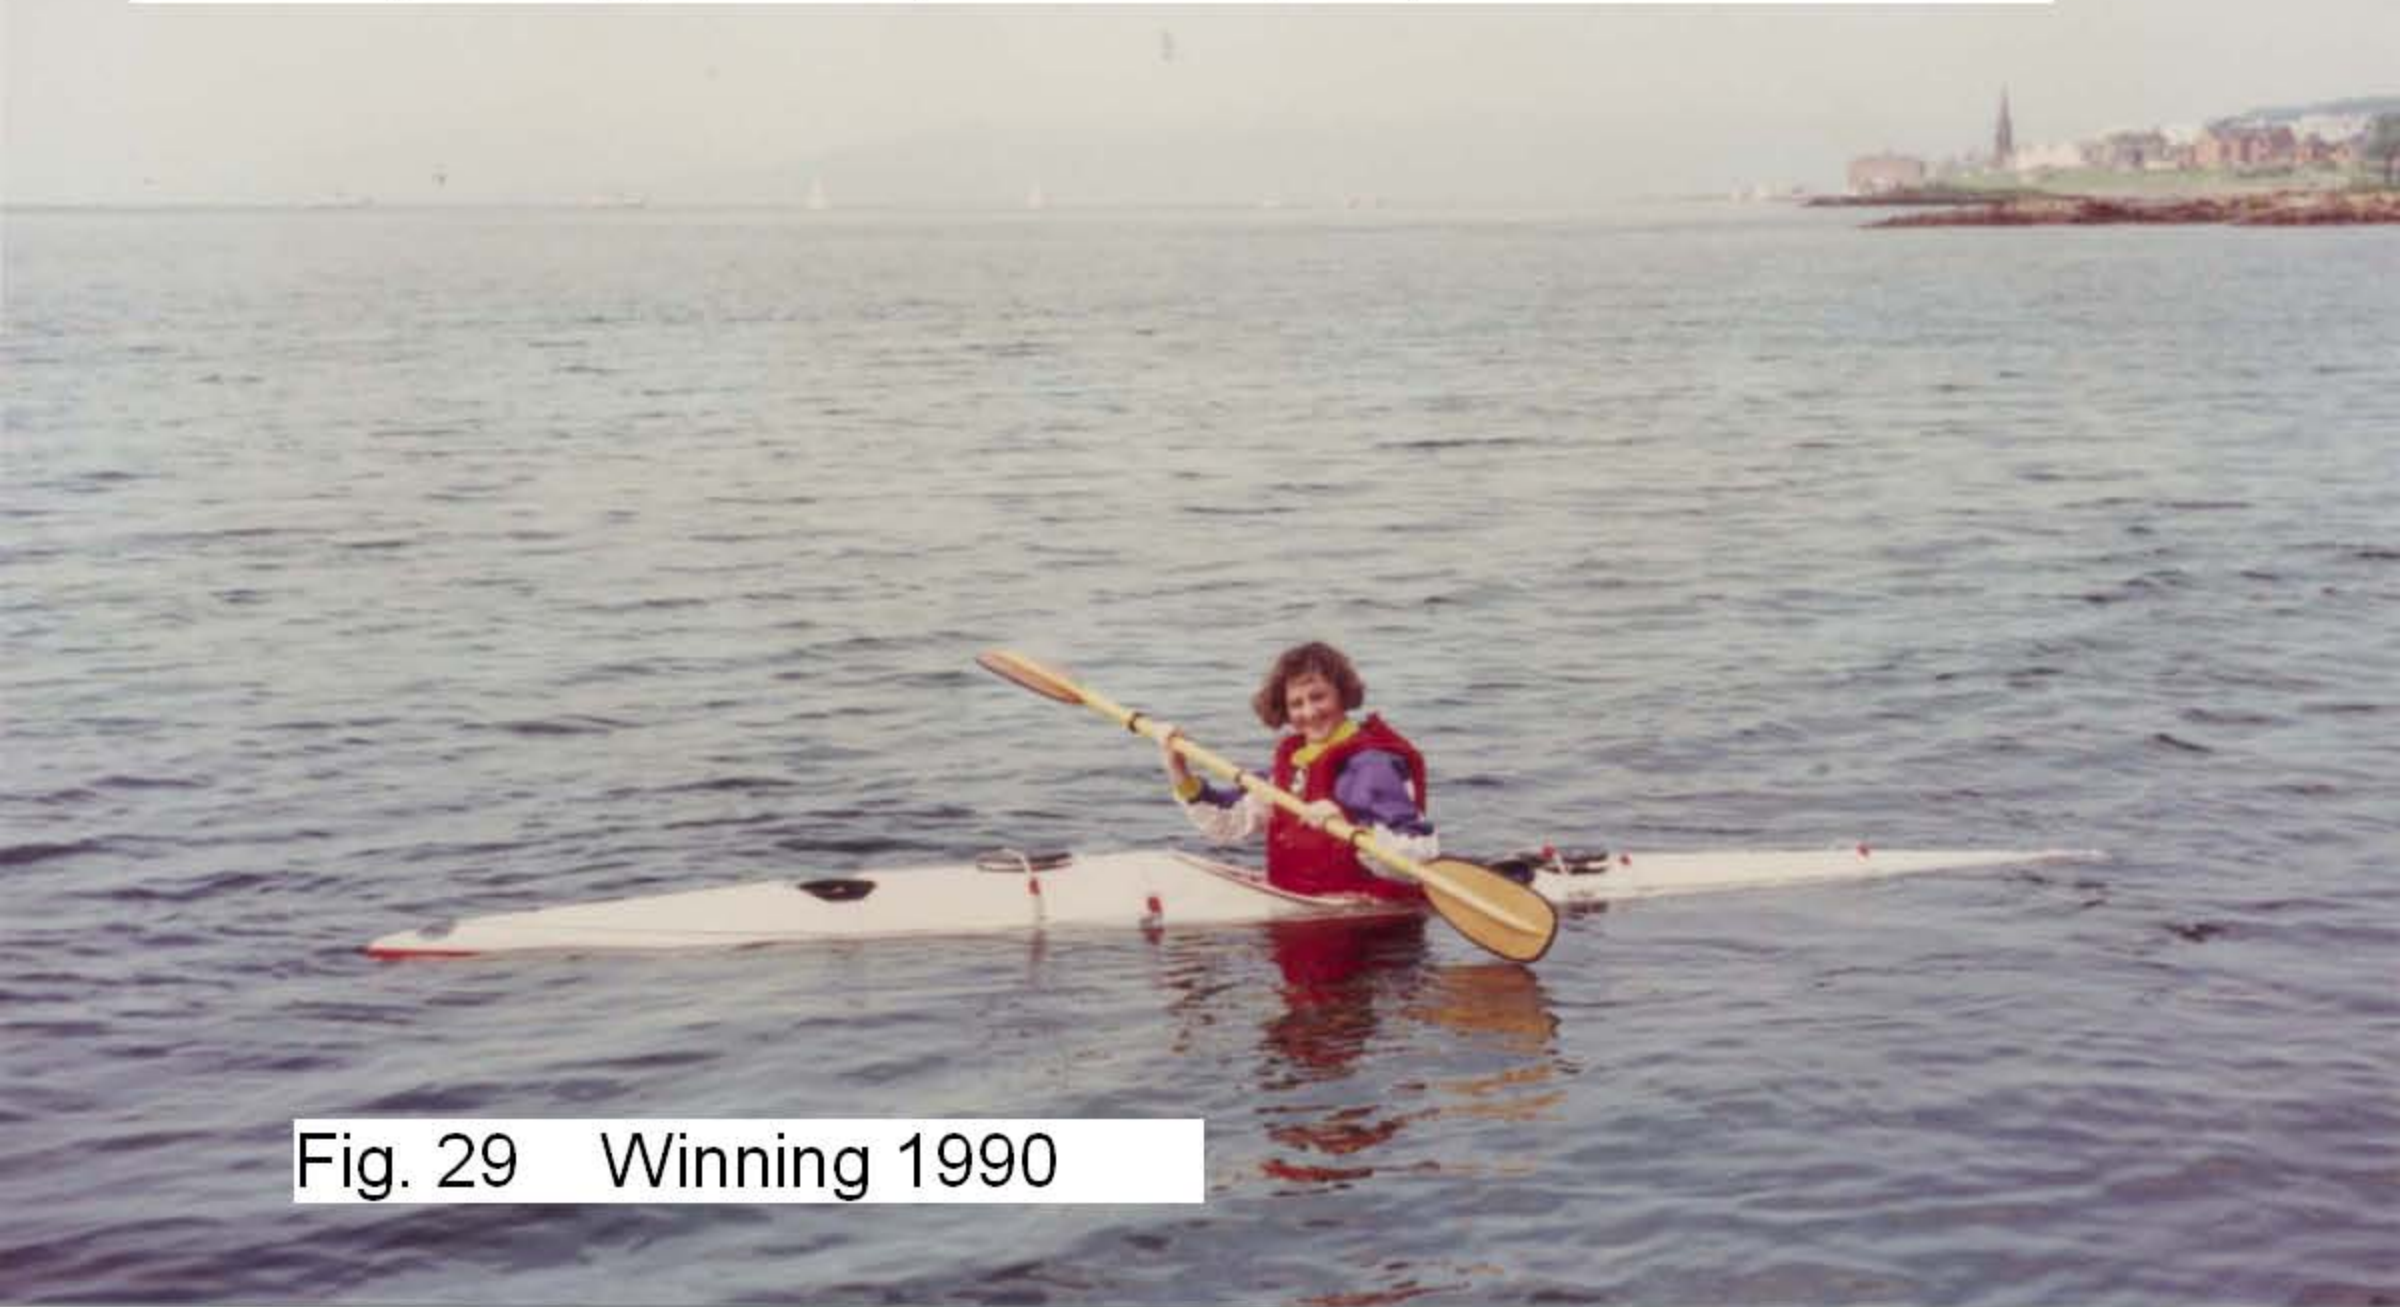
Fig. 29 Winning 1990

- 200 litres +C Fig. 29, water can flow in and out of hull space at will.
- 200 litres +C Fig. 30, Shona paddling the flooded ST hard. The kayak was obviously very heavy and hard to get going but once making way paddled OK. Kayak hard to turn but not affected by wind very much.

Sea Tiger about 200 litres in hull 9.vi.90
+ pod cockpit flooded, water flowing in and out of hatches
kayak supported by solid buoyancy fore and aft
