Sea Tiger Report

Report on comparative tests of “Sea Tiger” sea kayak and other sea kayaks on behalf of the British Canoe Union

**Presented by Duncan R. Winning O.B.E.
22 Brisbane Glen Road,
Largs,
Ayrshire,
Scotland,
KA30 8QX.**

Twelfth June 1990

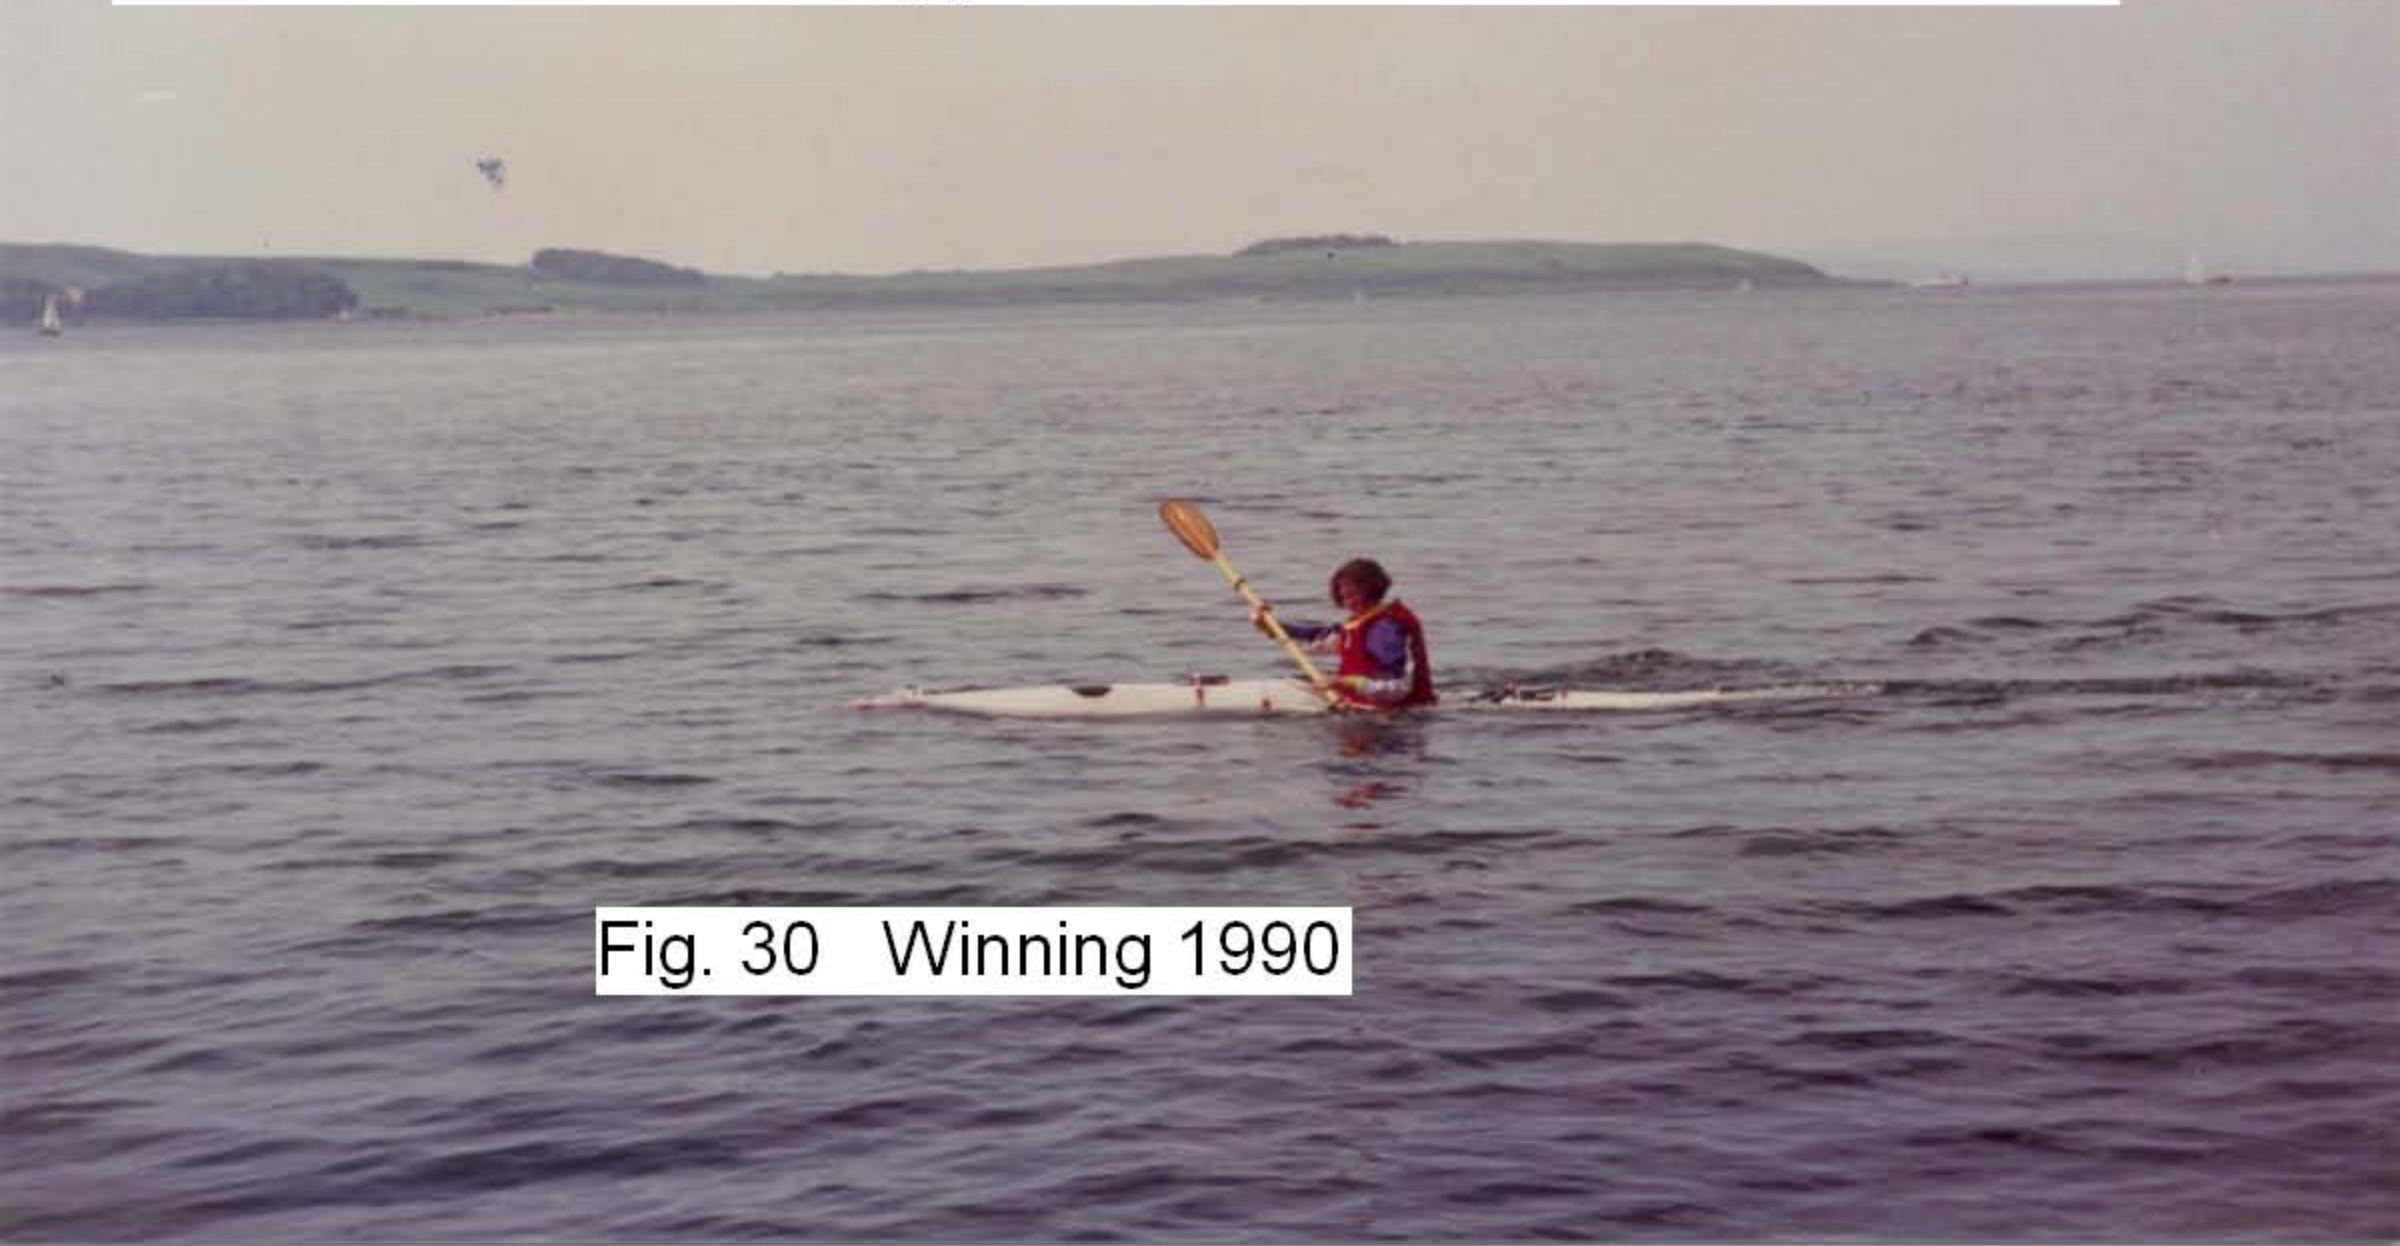
Fig. 30 Winning 1990

- 200 litres +C Fig. 29, water can flow in and out of hull space at will.
- 200 litres +C Fig. 30, Shona paddling the flooded ST hard. The kayak was obviously very heavy and hard to get going but once making way paddled OK. Kayak hard to turn but not affected by wind very much.

Sea Tiger about 200 litres in hull 9.vi.90
+ pod cockpit flooded, water flowing in and out of hatches
kayak supported by buoyancy blocks fore and aft,
being paddled hard

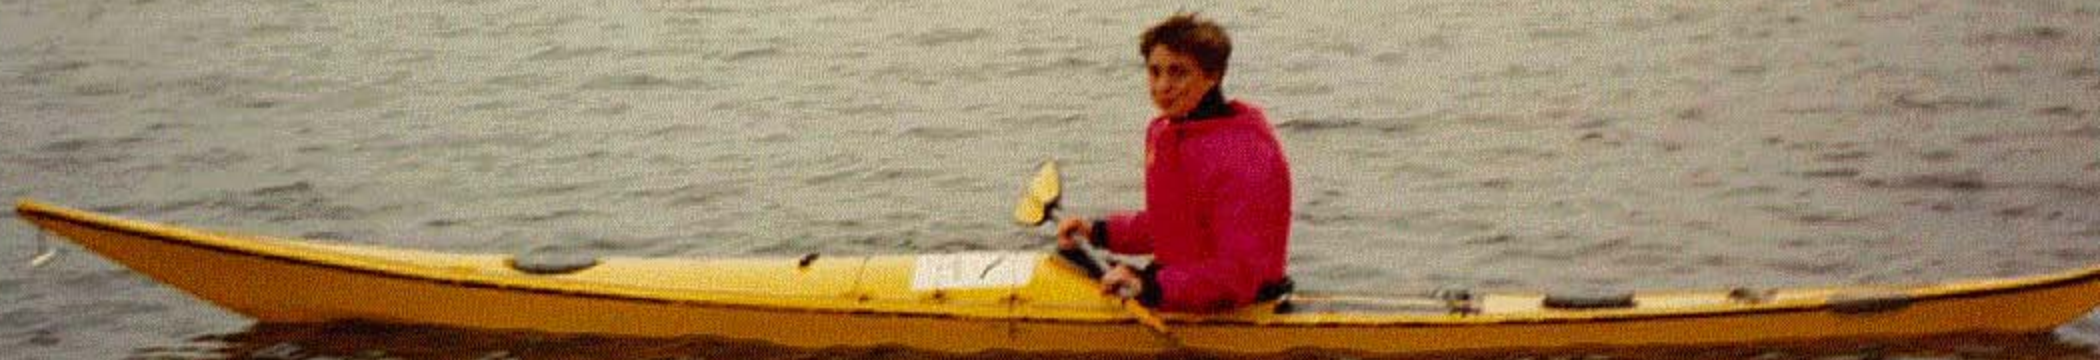
Fig. 31 Winning 1990

- 0 litres [Fig. 31](#), no apparent effect from cross wind. Note: Photo with paddler (Helen Sutherland) from "Sea Tiger test 2 used here to show trim only.

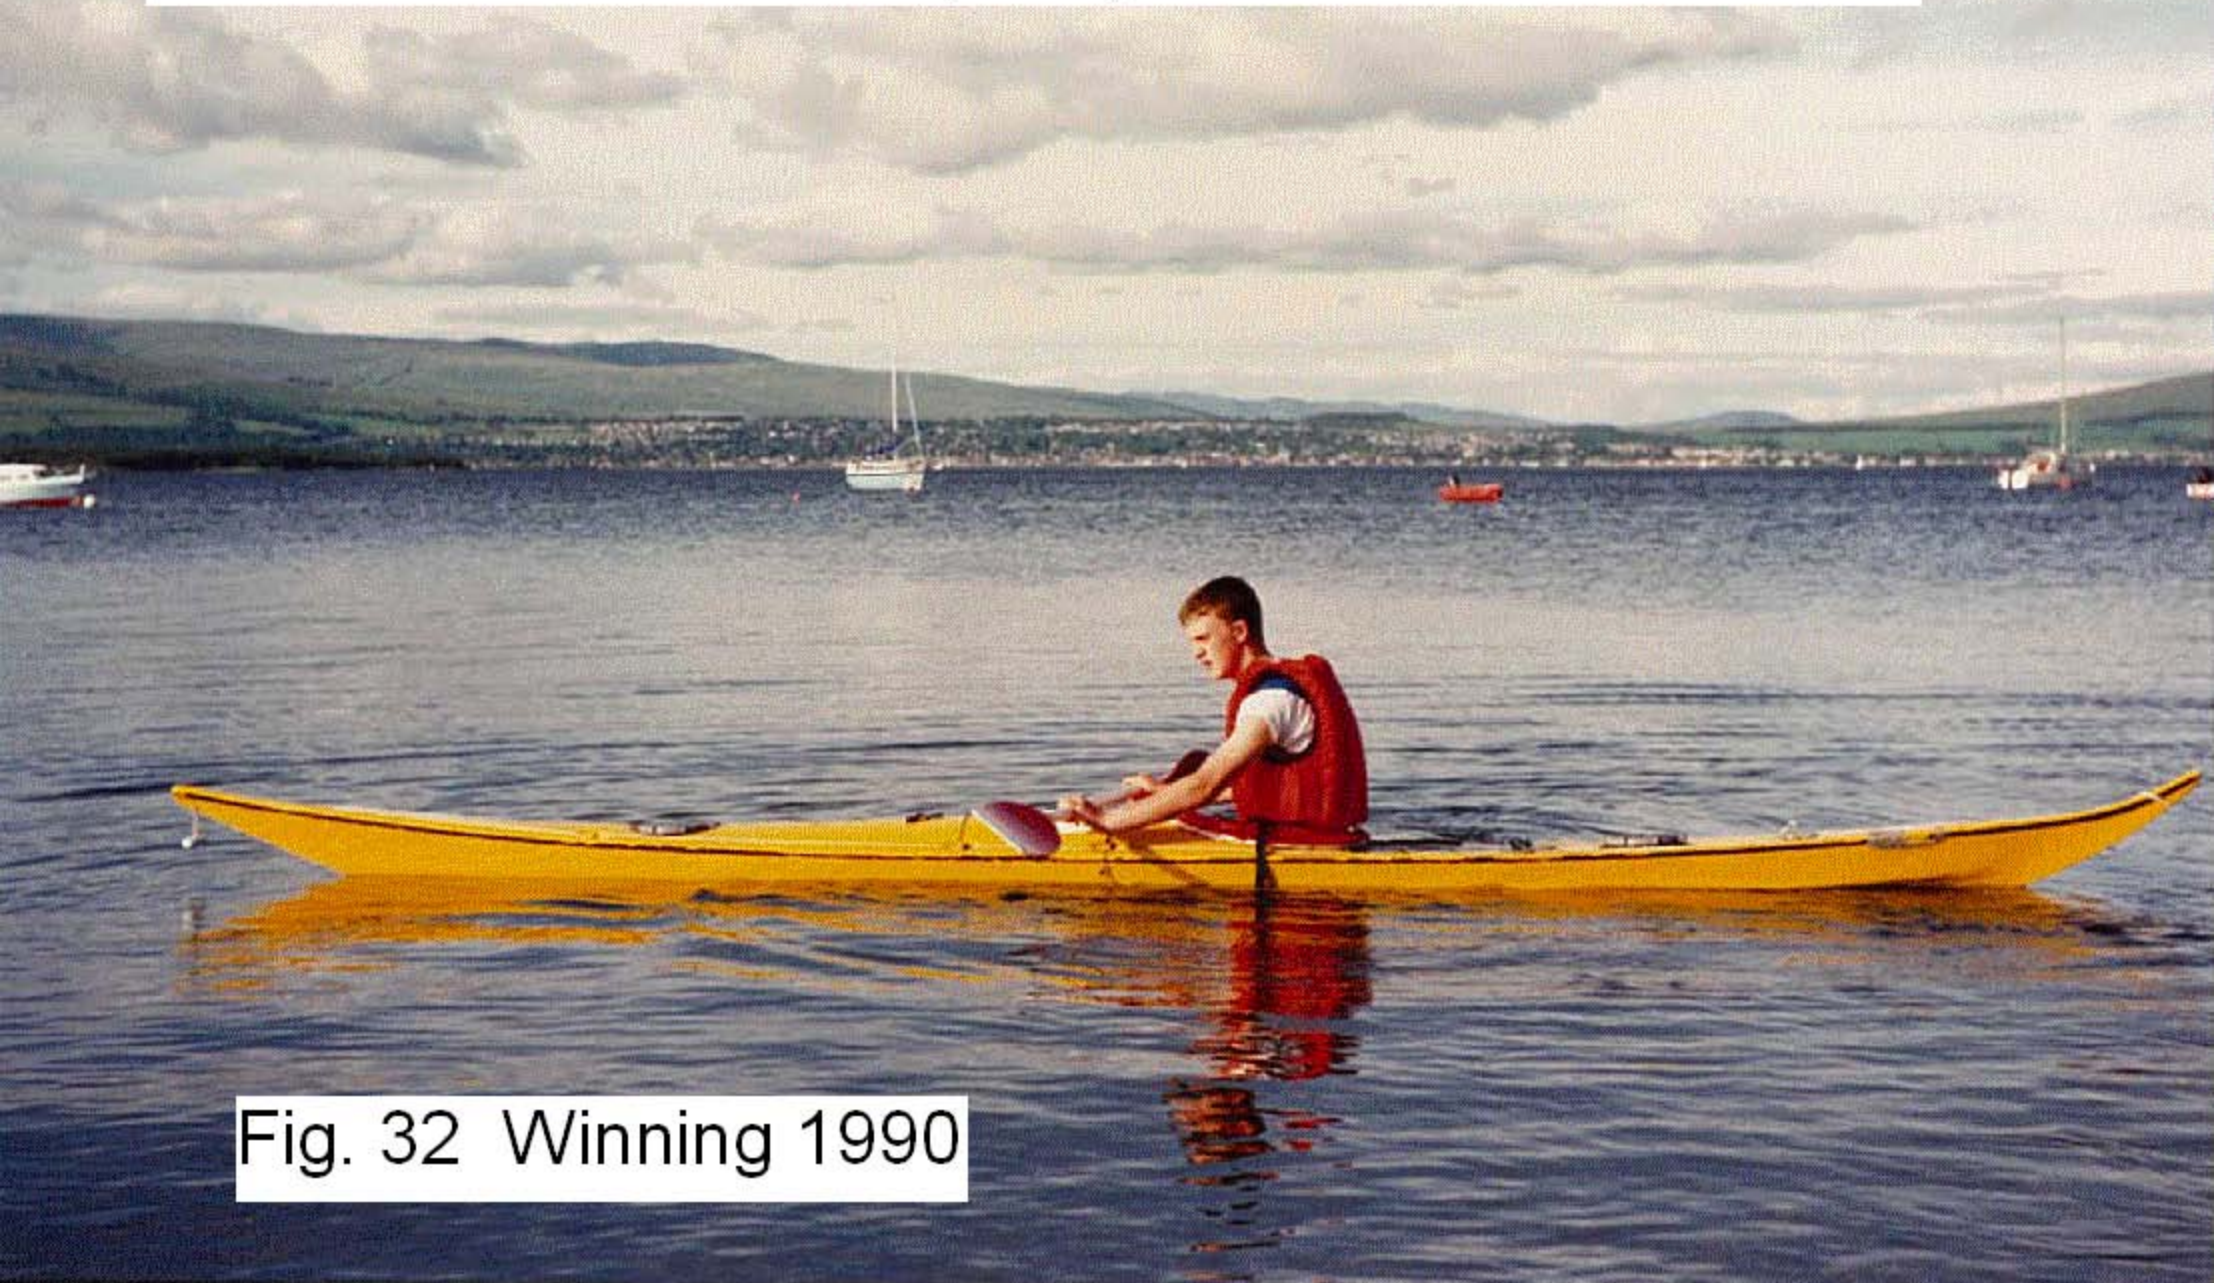
Fig. 32 Winning 1990

- 20 litres [Fig. 32](#), constant course correction on all 3 legs of circuit. Not unstable.
- 40 litres [Fig. 33](#), as stage 2. but more correction needed.

Anas Acuta 20 litres in bow compartment 30.v.90 1.12
cockpit dry

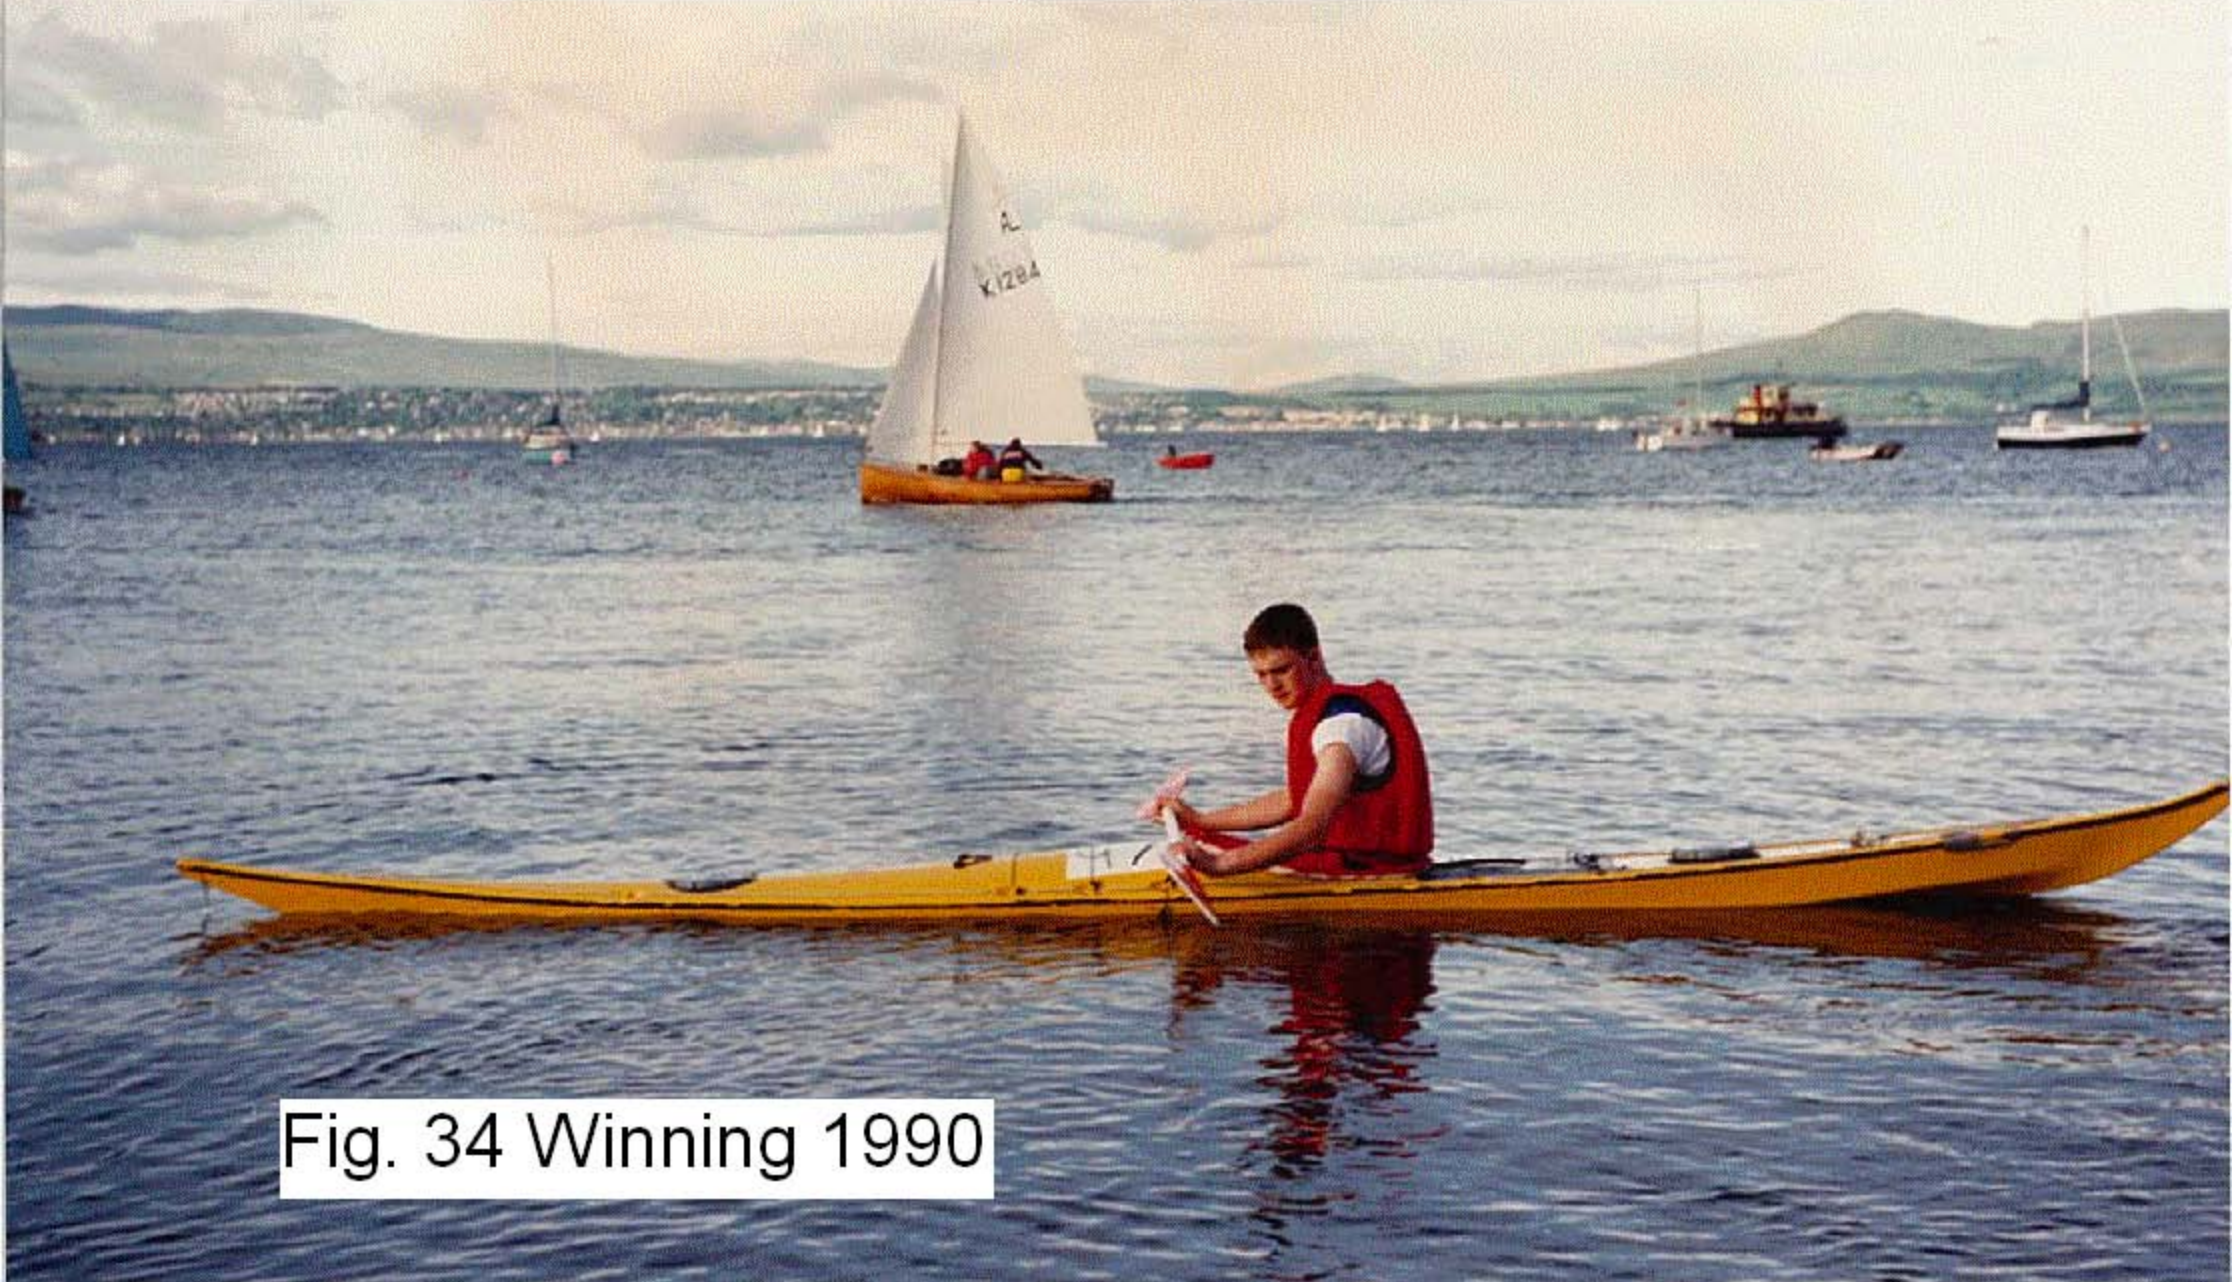
Fig. 34 Winning 1990

- 50 litres [Fig. 34](#), fore hold full. Almost un-steerable.
- 50 litres +C [Fig. 35](#), cockpit flooded (clothes bag in fore compartment). Became more steerable but very tippy.

Anas Acuta 50 litres in bow compartment
cockpit dry 30.5.90

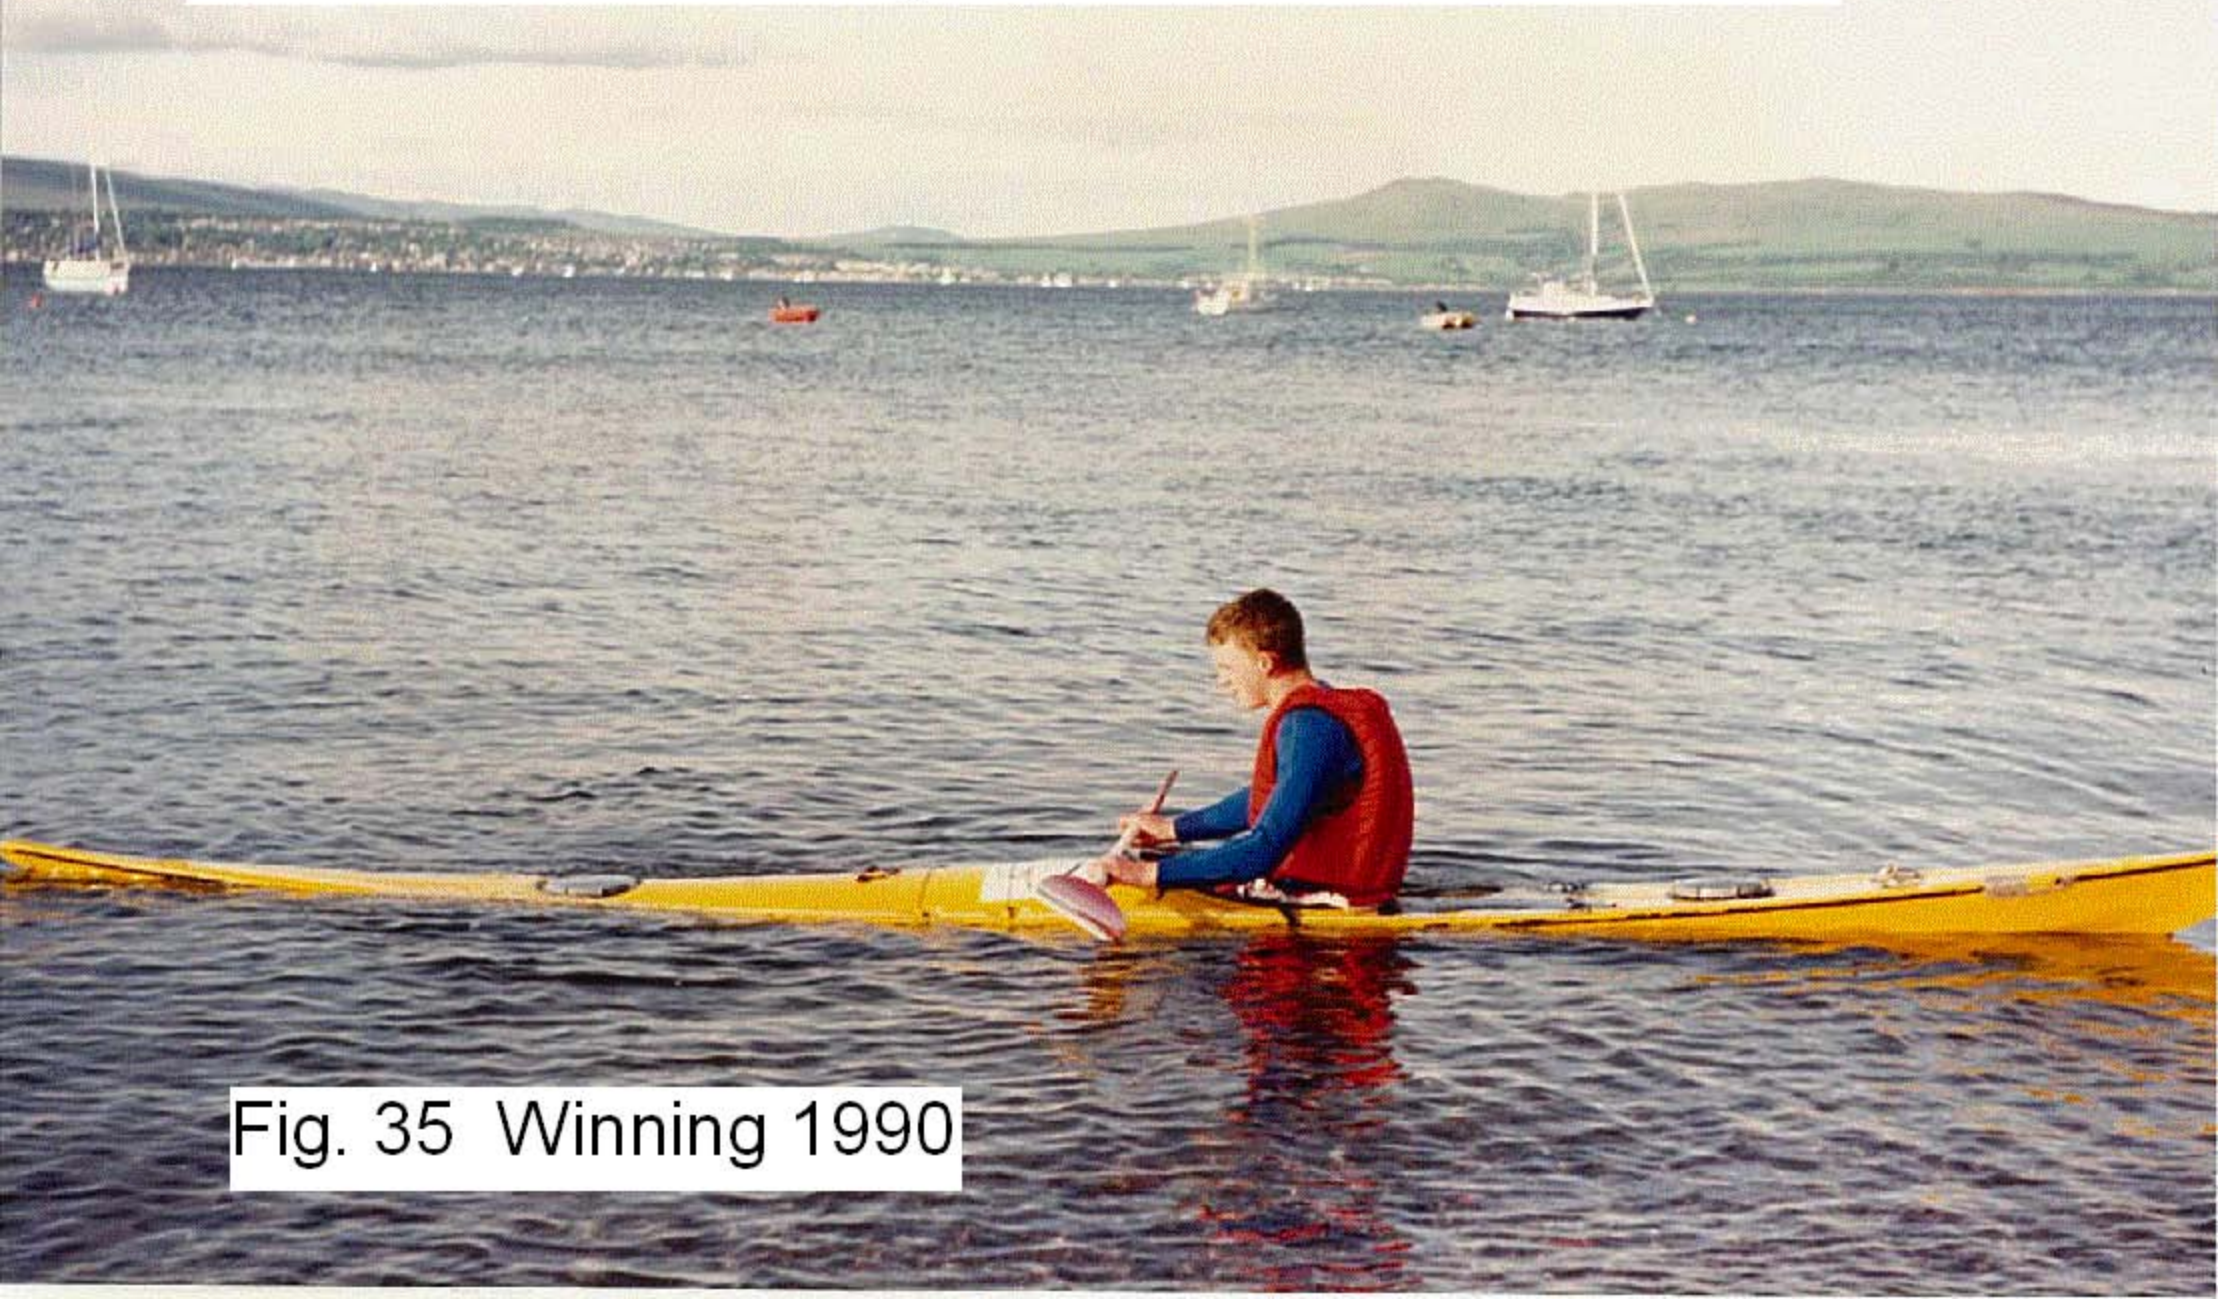
Fig. 35 Winning 1990

Anas Acuta 50 litres in bow compartment 30.v.90
cockpit flooded

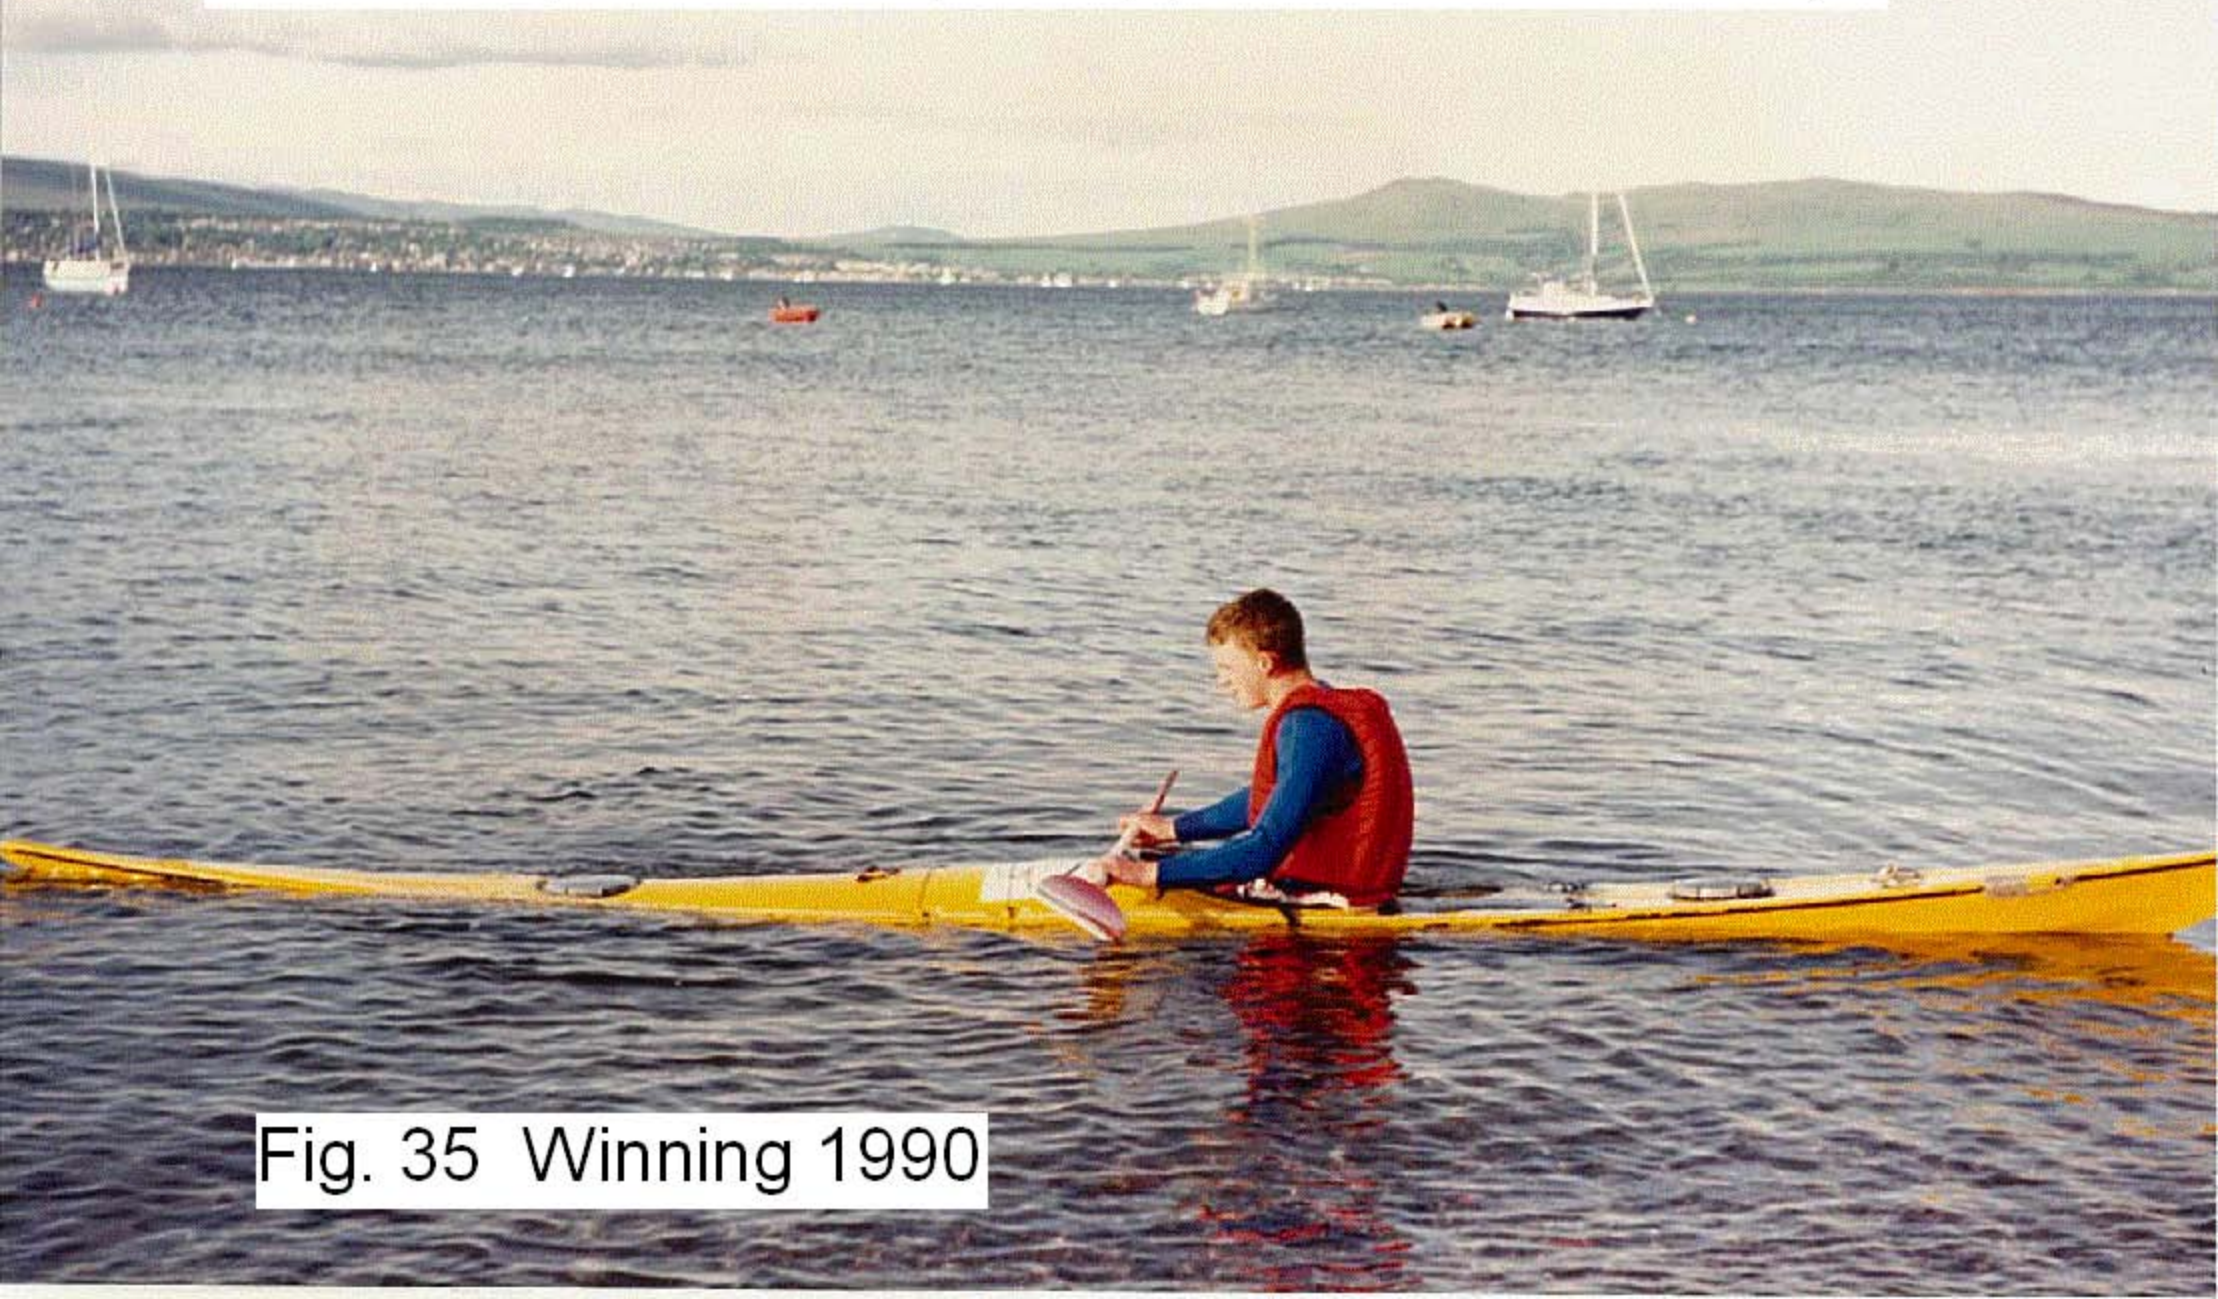
Fig. 35 Winning 1990

- >65 litres +C [Fig. 36](#), cockpit flooded. Clothes bag removed from fore hold, 15 litres of water added with difficulty. The cockpit was then flooded again. Bow on the bottom. It is reasonable to assume that in deep water the kayak would have adopted a vertical position.

Anas Acuta 50 litres in bow compartment 30.v.90
cockpit flooded (air trapped under foredeck)

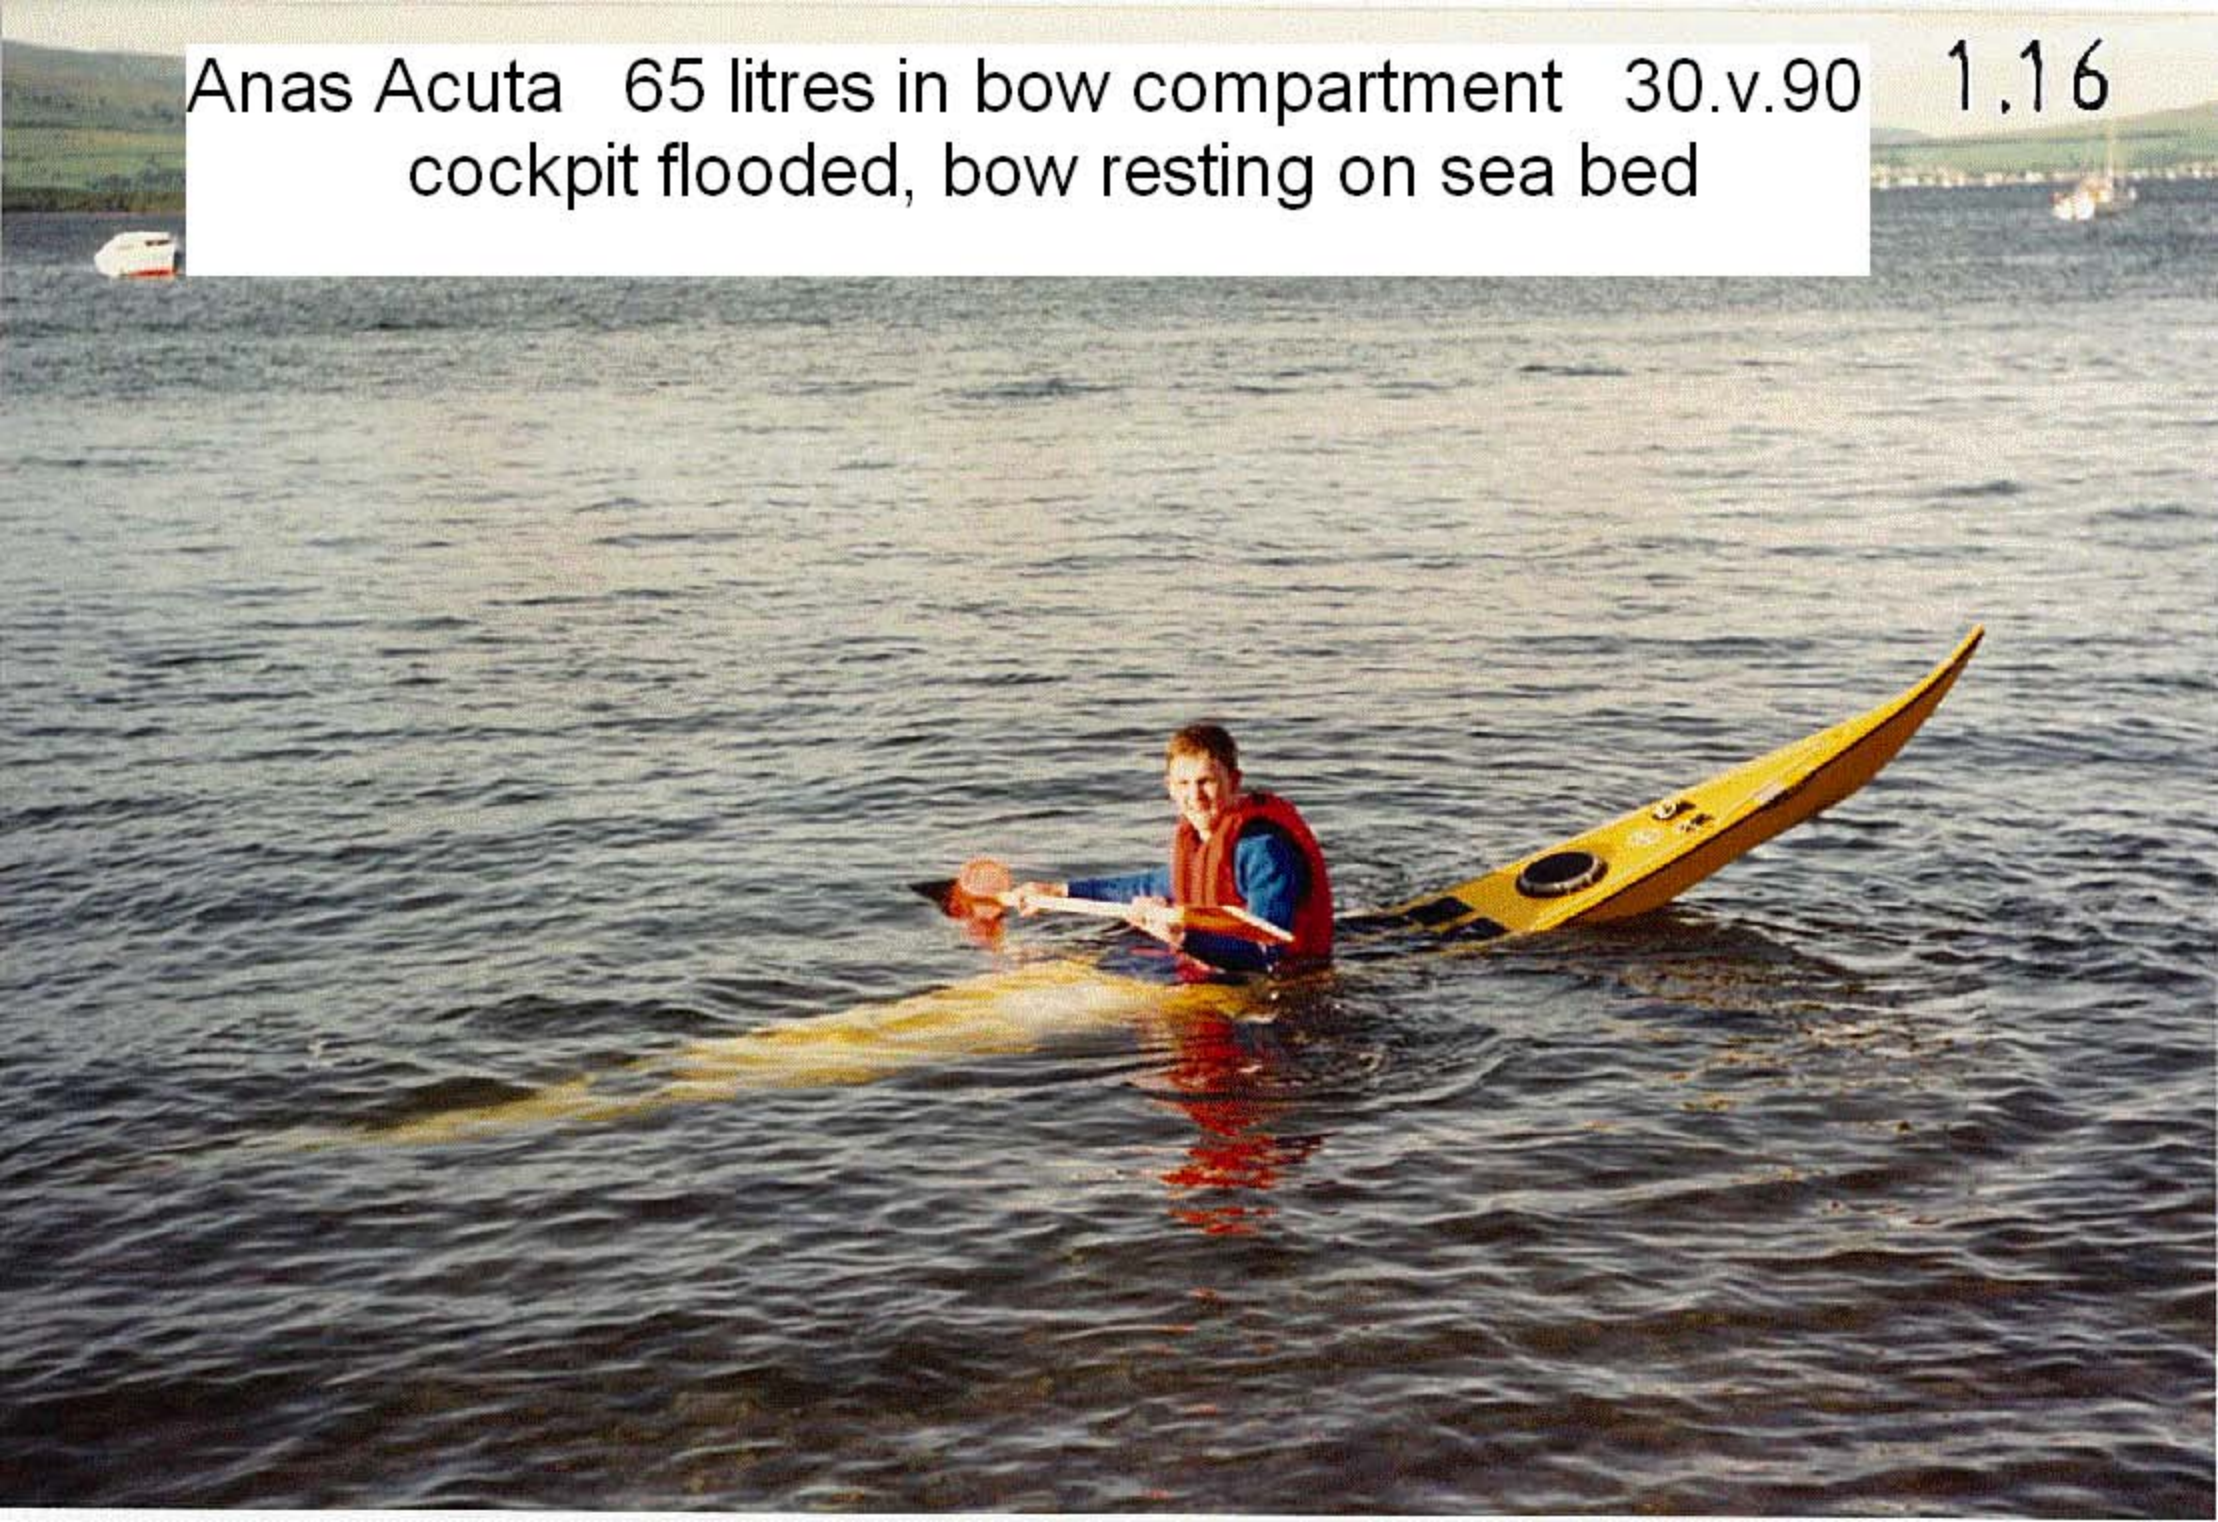
- >65 litres [Fig. 37](#), cockpit empty. Hatch cover removed (clothes bag removed). By rocking the boat and pushing it down a small extra amount of water was introduced. Not measurable. The boat was fairly stable but was uncontrollable i.e. not steerable. Boat drained.

Anas Acuta 65 litres in bow compartment 30.v.90
cockpit flooded, bow resting on sea bed

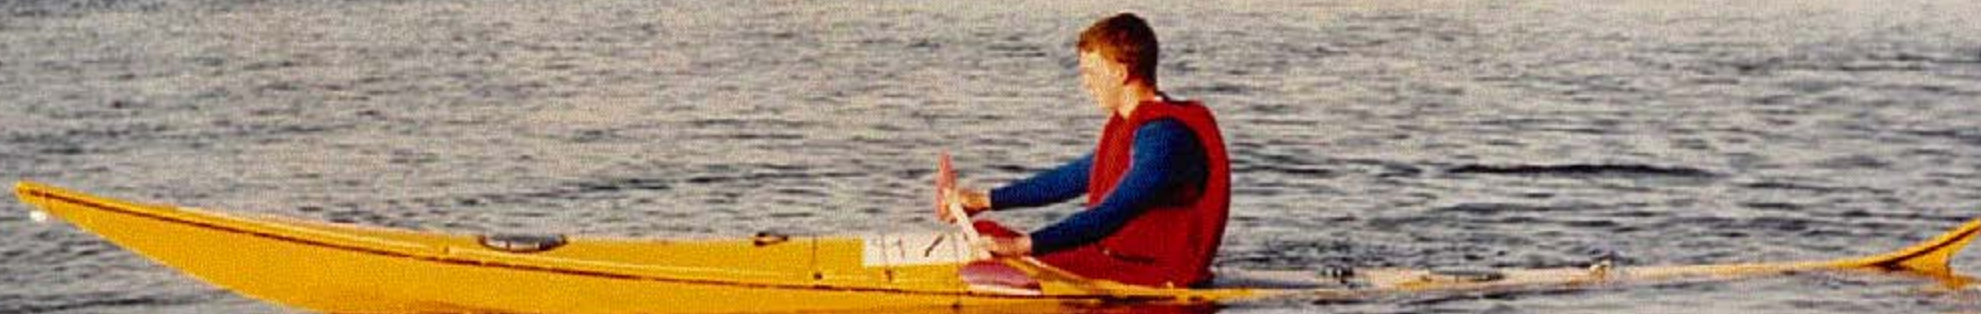
Fig. 43 Winning 1990

50 litres Fig. 43, course corrected on two legs of circuit, OK dead into wind.

Felt heavy but stable.

Anas Acuta 50 litres in stern compartment 30.v.90

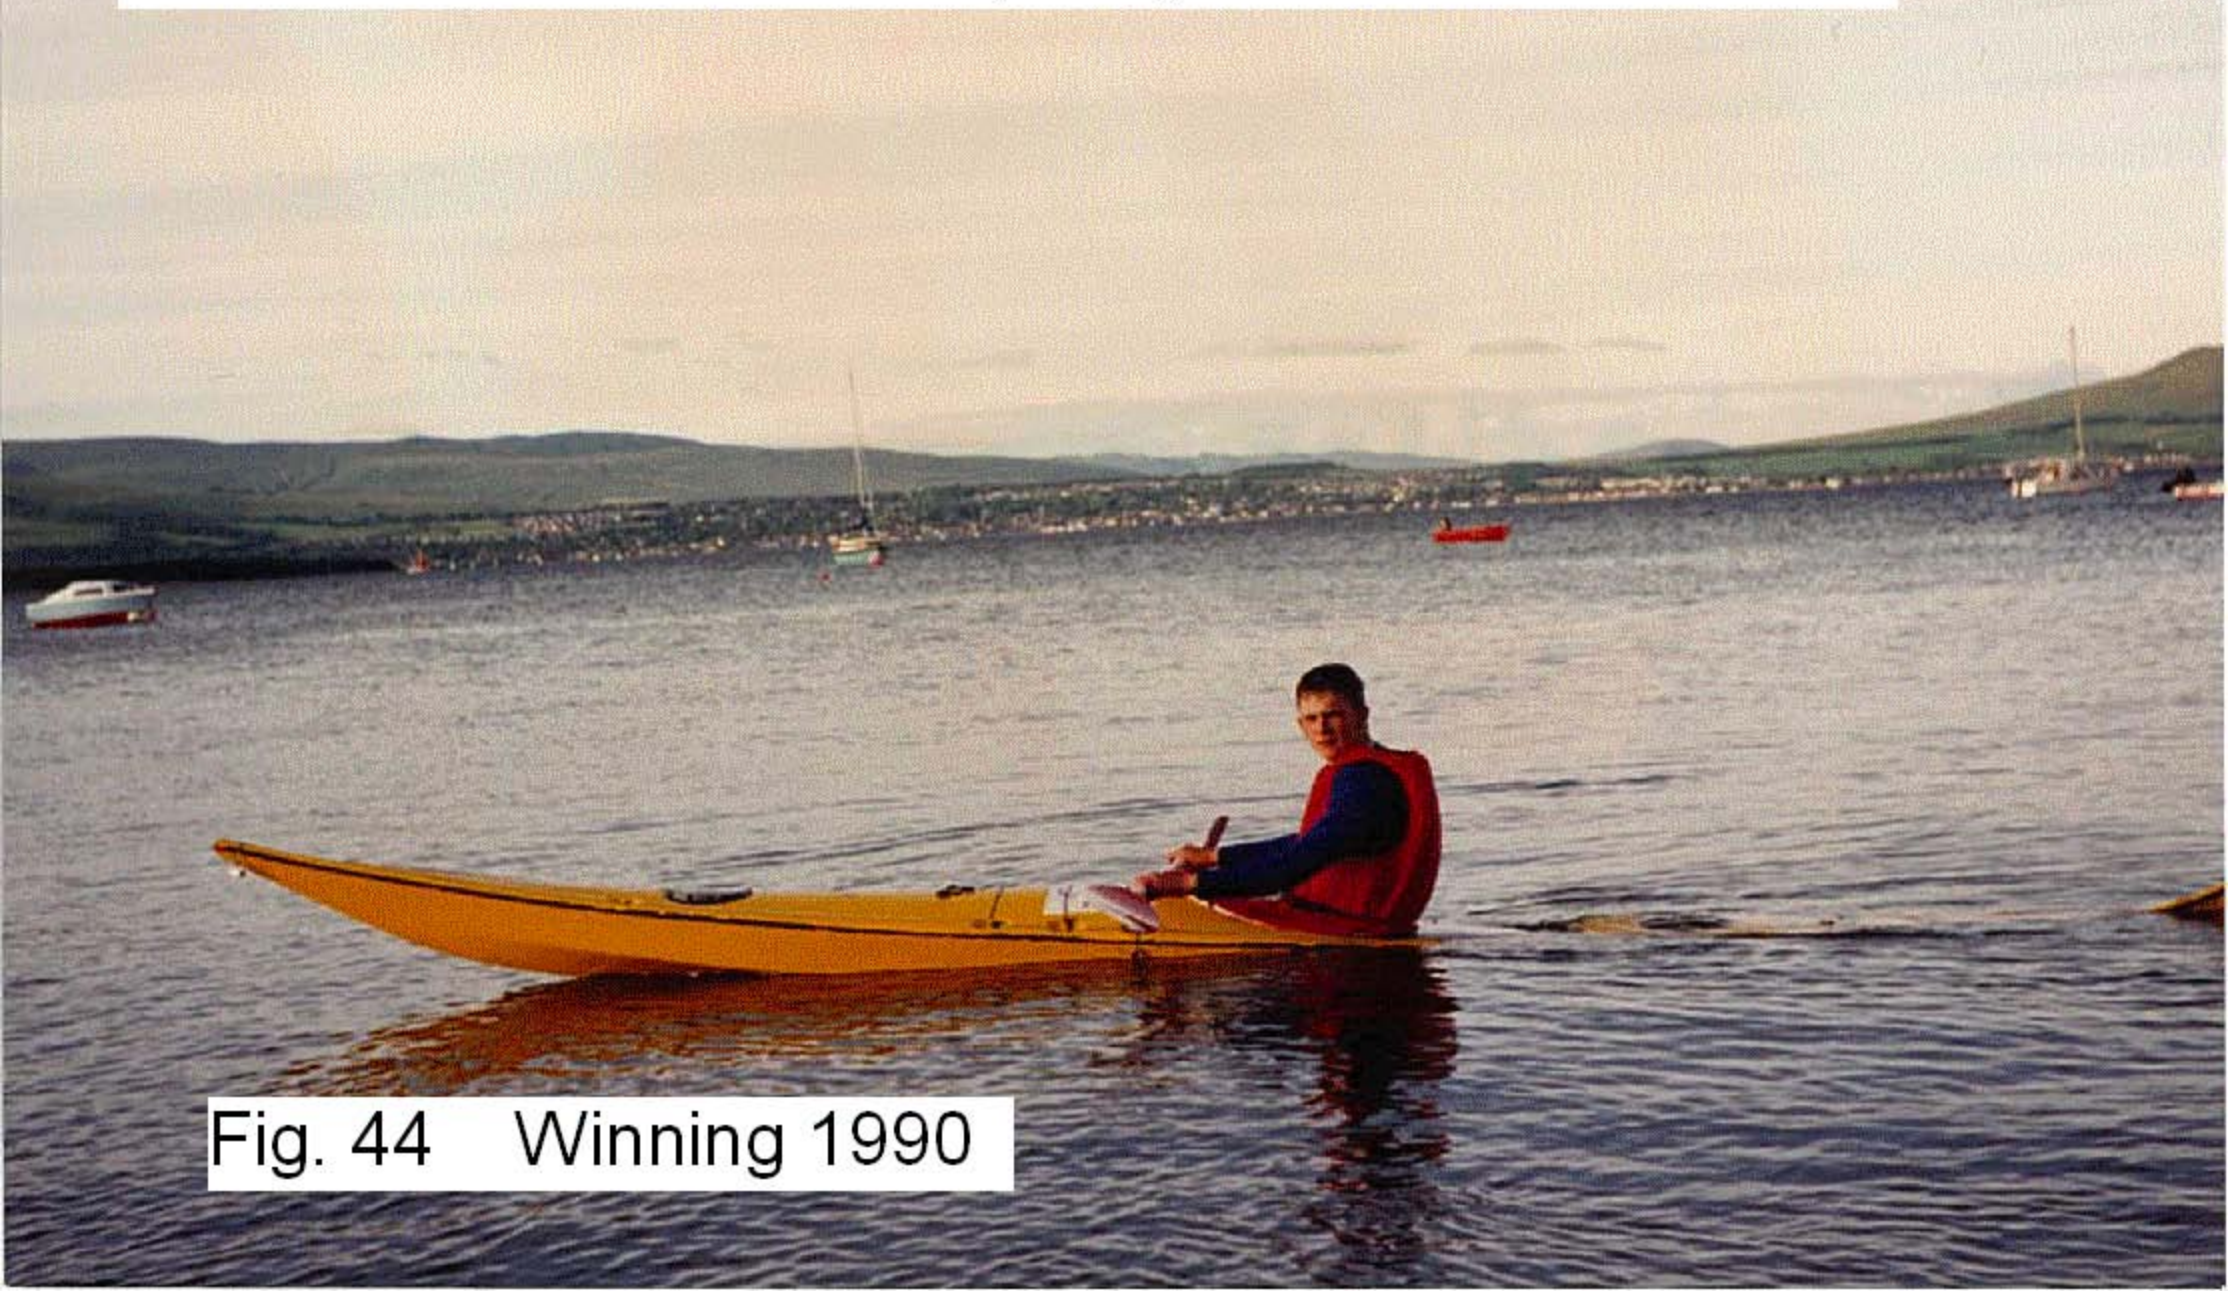
Fig. 44 Winning 1990

>50 litres Fig. 44, aft hold took very little more water not measurable with equipment. Behaved as at 50 litres. Very difficult to turn.

Anas Acuta >50 litres in stern compartment 30.v.90 1.24
cockpit dry
