Sea Tiger Report

Report on comparative tests of “Sea Tiger” sea kayak and other sea kayaks on behalf of the British Canoe Union

**Presented by Duncan R. Winning O.B.E.
22 Brisbane Glen Road,
Largs,
Ayrshire,
Scotland,
KA30 8QX.**

Twelfth June 1990

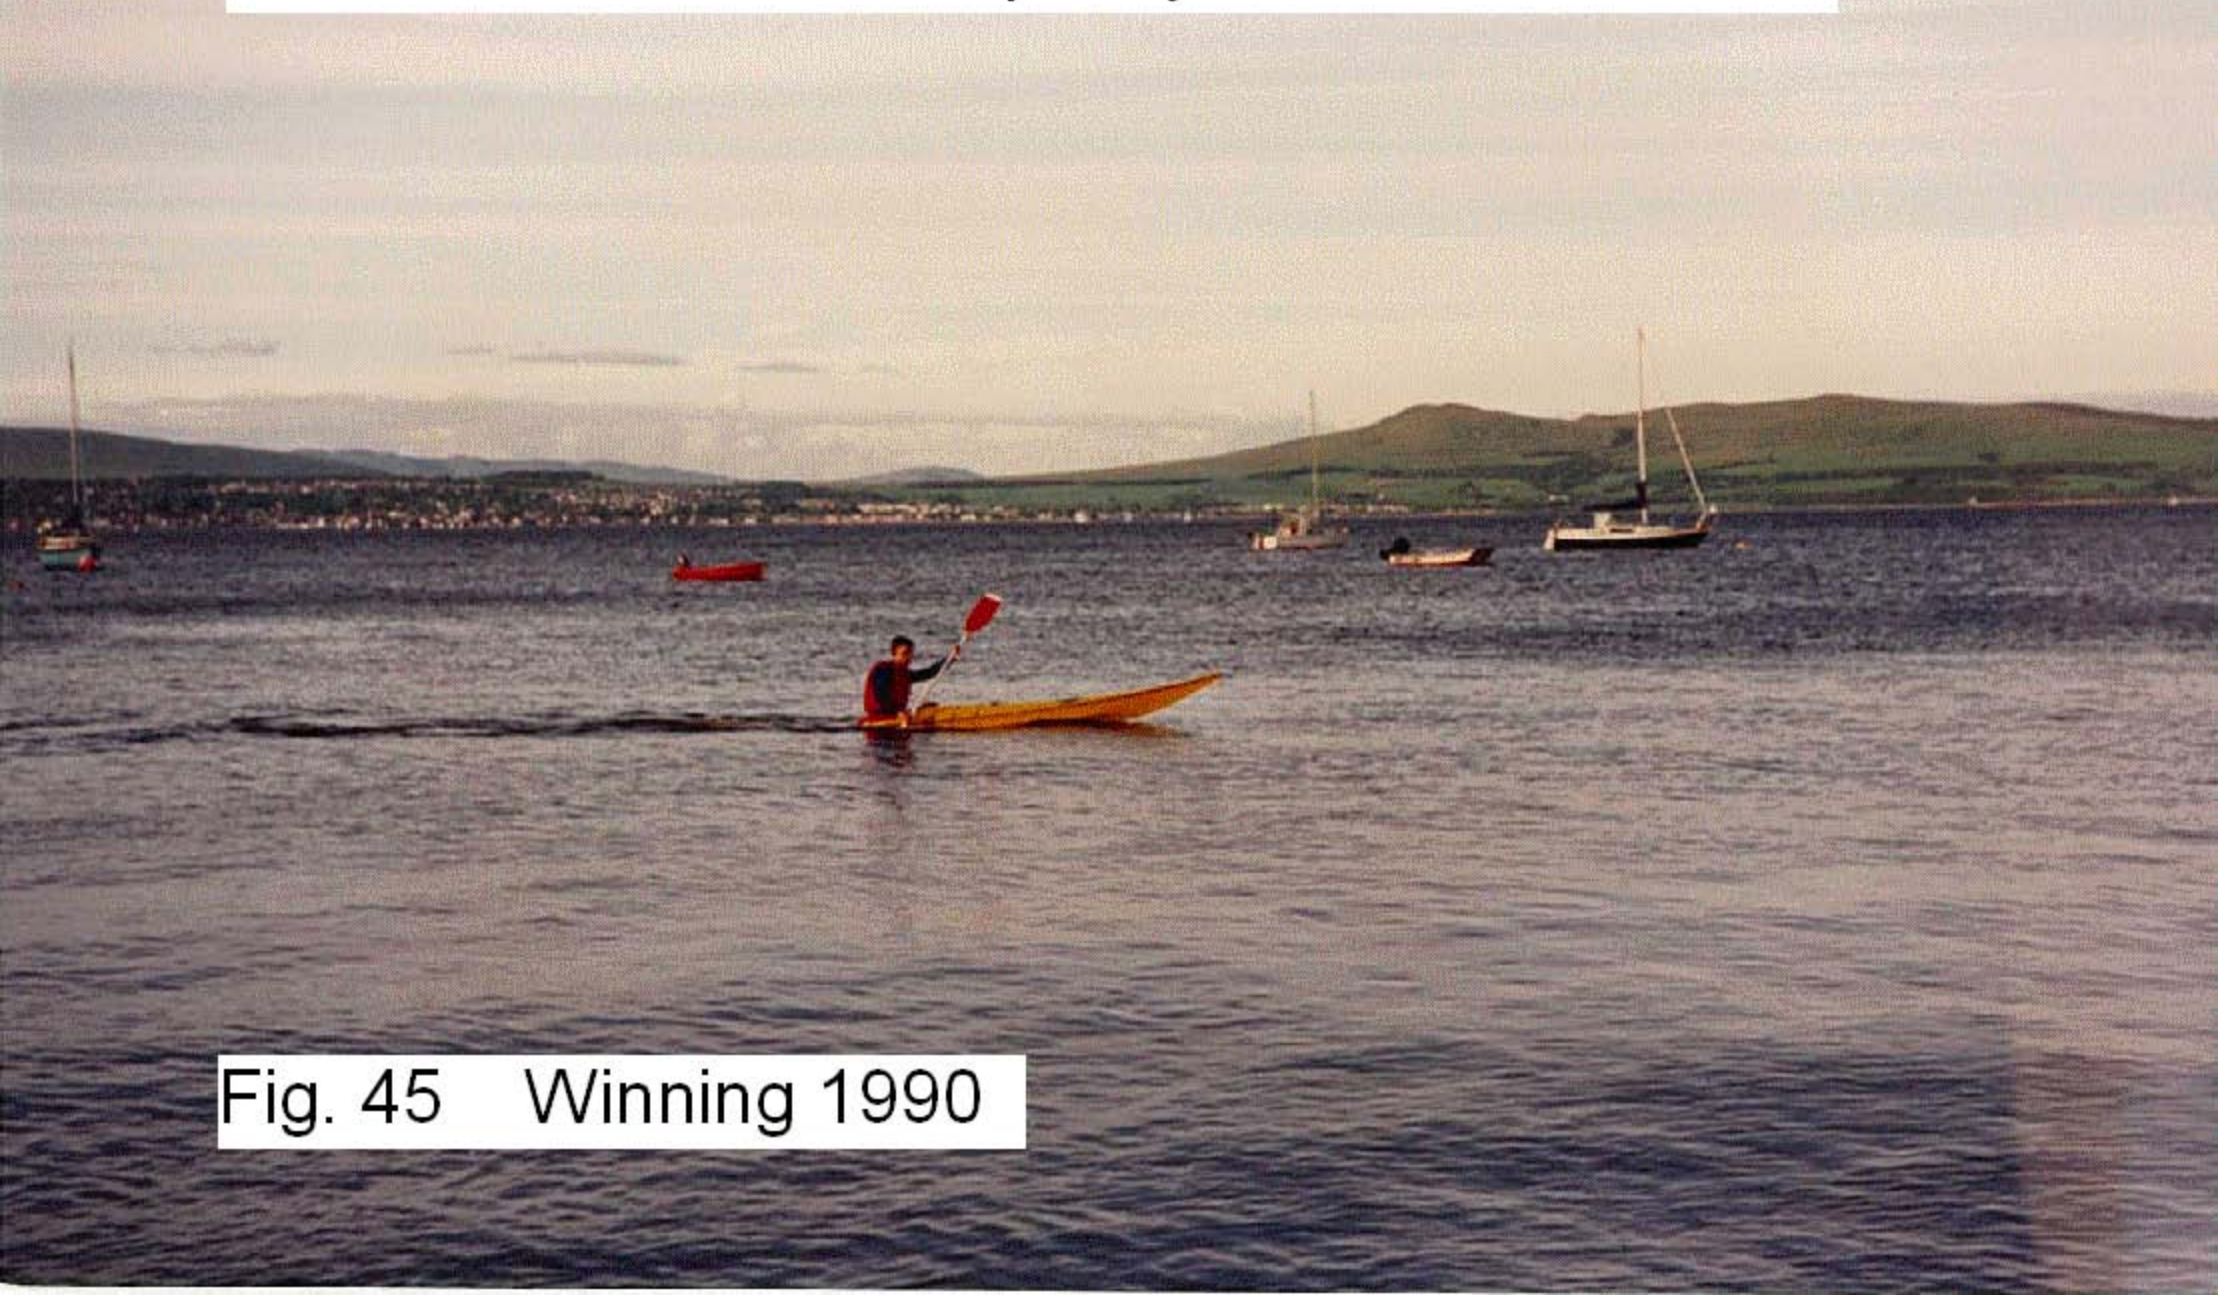
Fig. 45 Winning 1990

>50 litres +C Fig. 45, cockpit flooded. Stern on bottom. Potential Cleopatra's Needle.

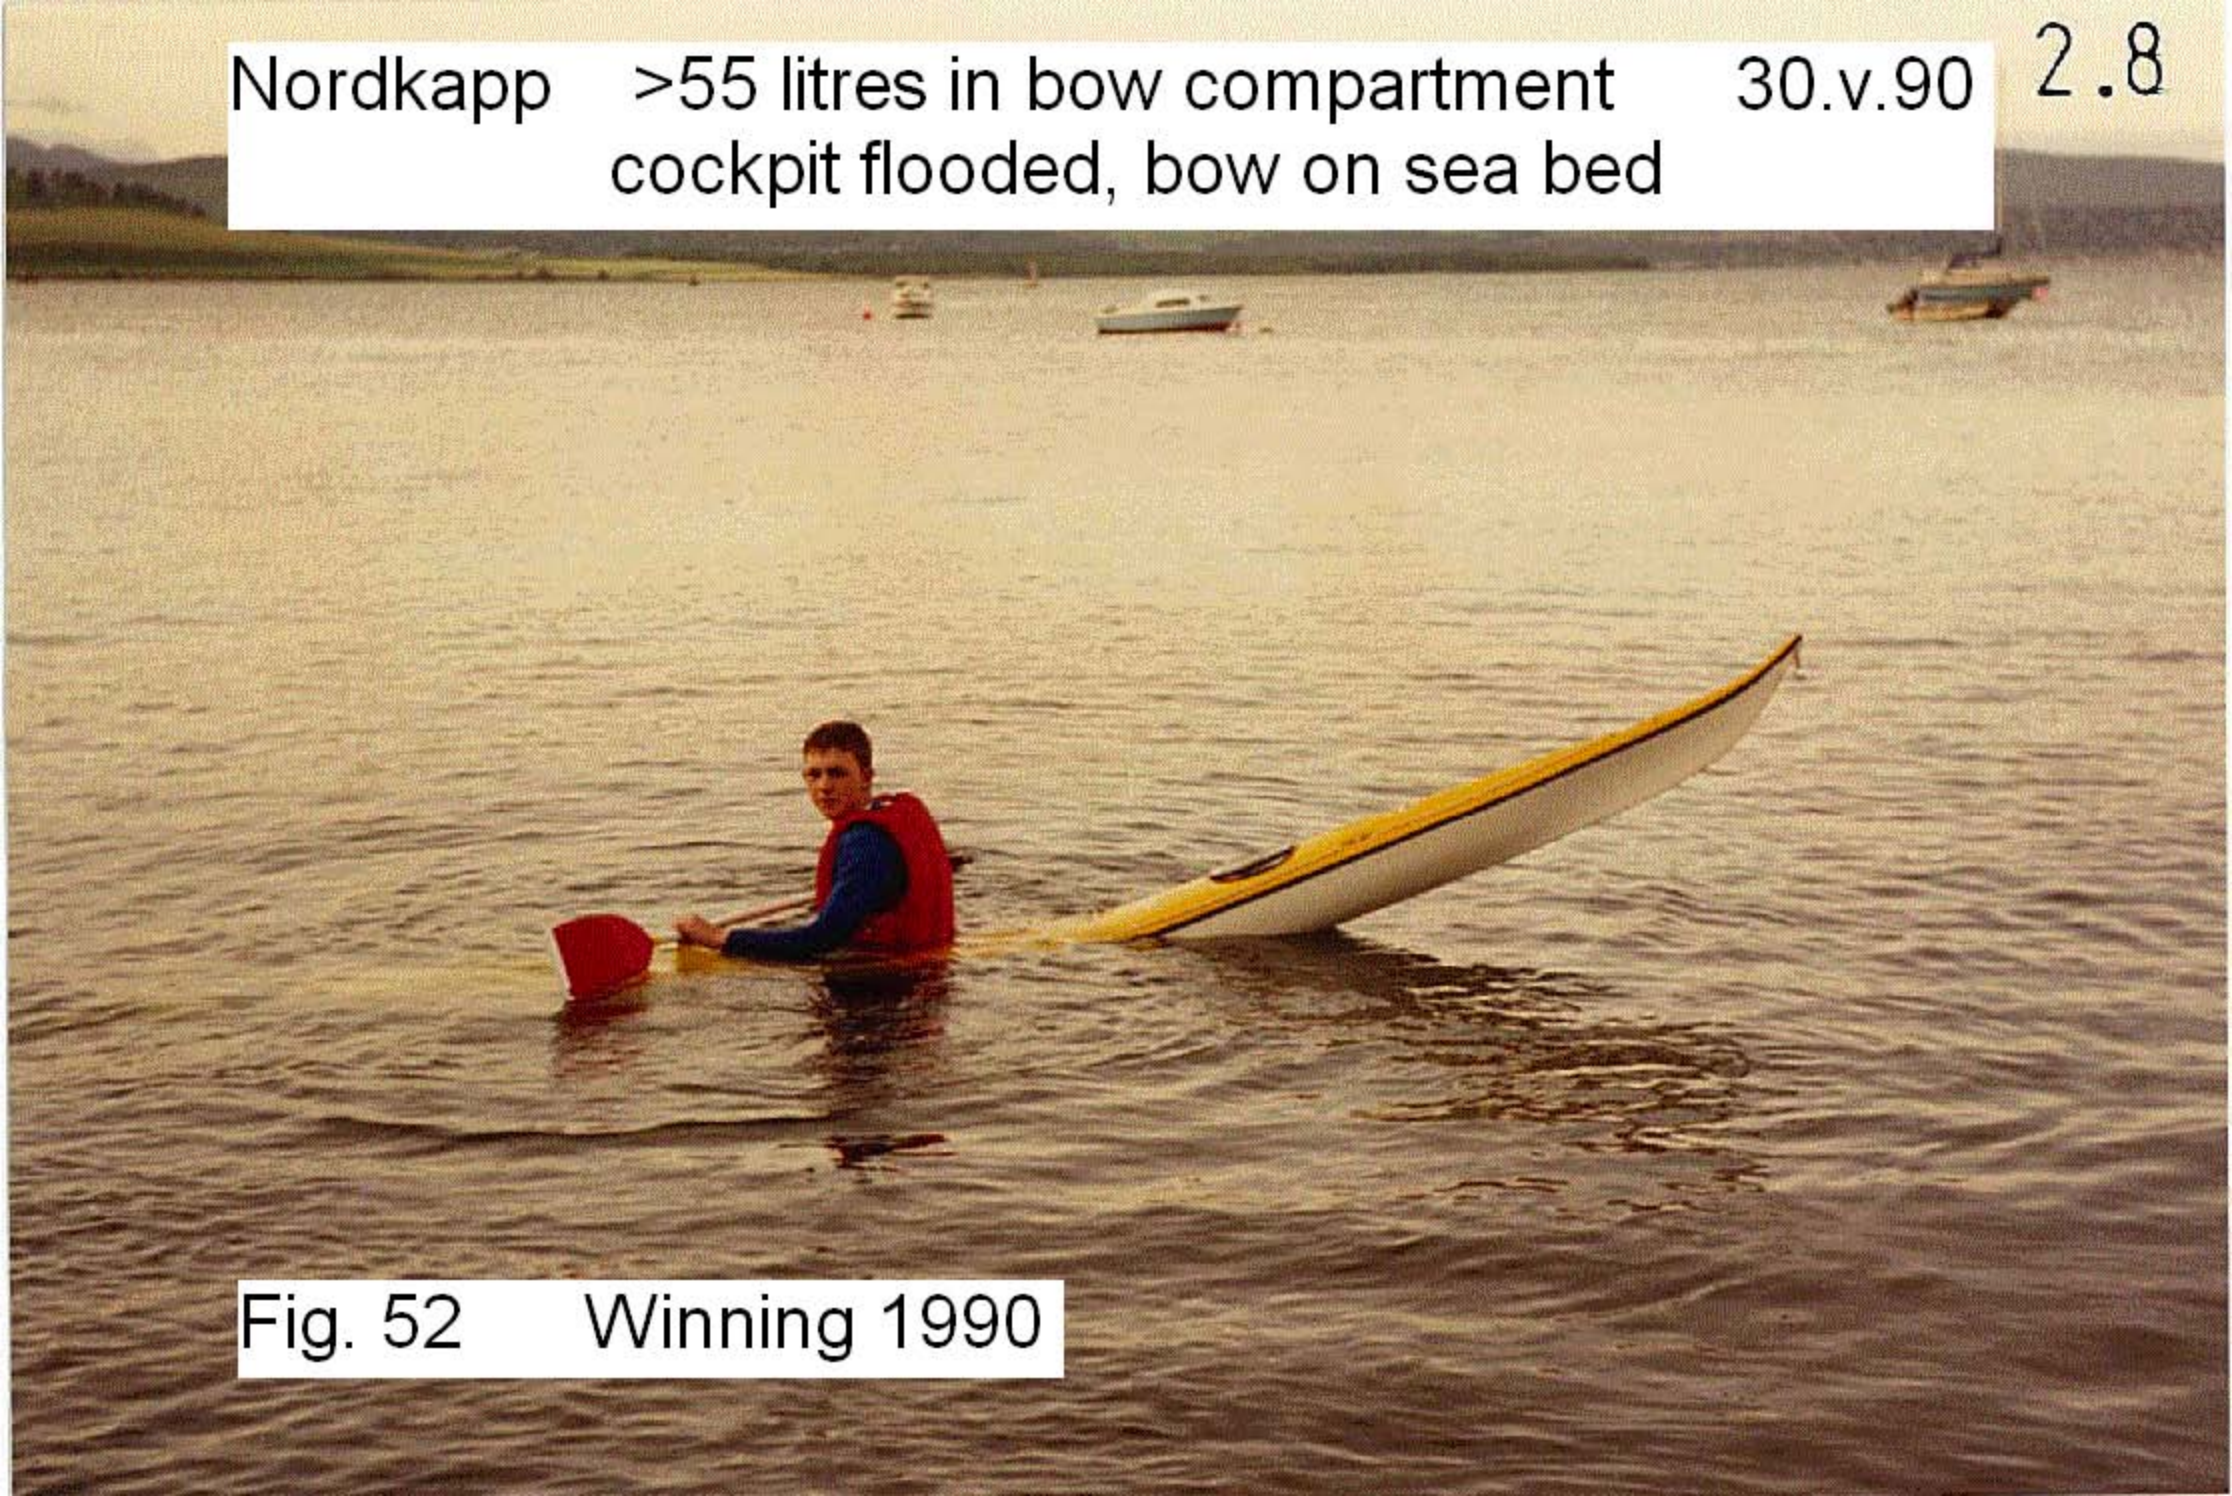
Fig. 52

>55 litres +C Fig. 52, cockpit flooded. Bow on bottom. In deep water assumed kayak would go vertical. Boat drained, bag replaced in fore hold.

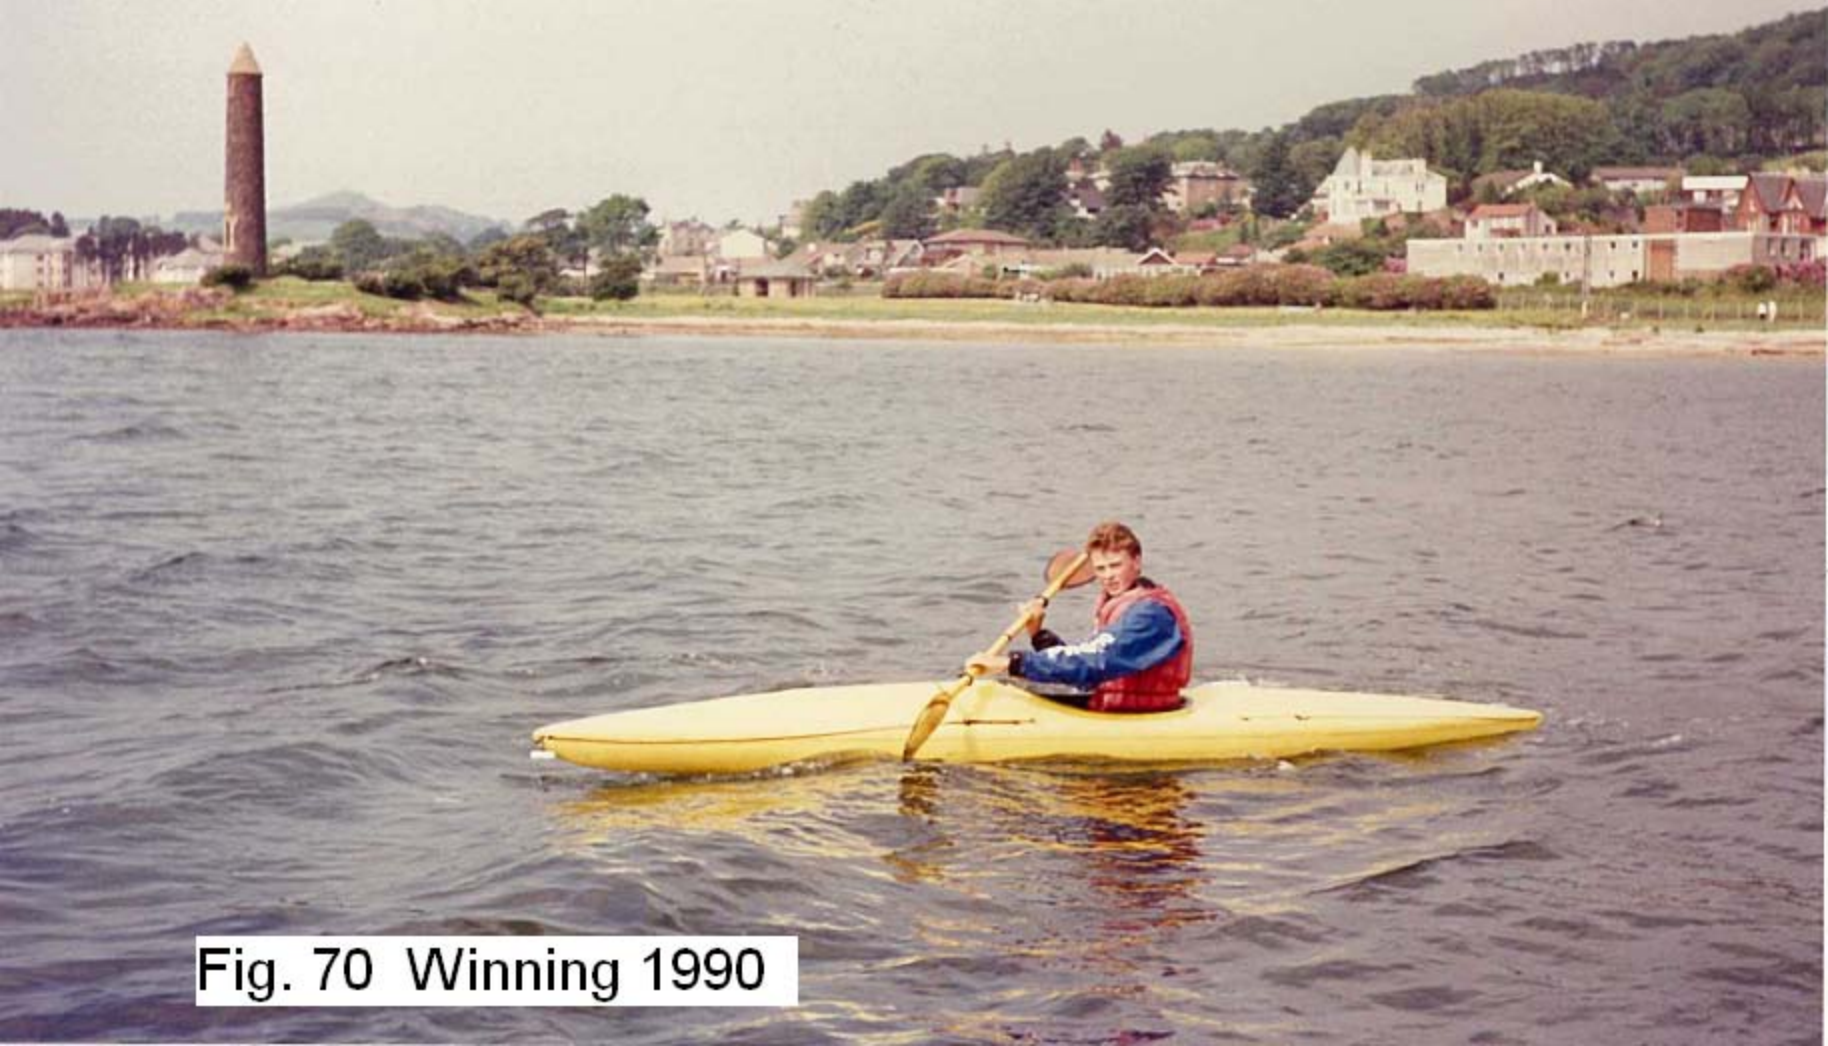
Fig. 70 Winning 1990

- 0 litres Fig. 70, very manoeuvrable and easy to paddle.
- 20 litres Fig. 71, slightly heavier to paddle.
- 40 litres Fig. 72, beginning to feel tippy.
- 60 litres Fig. 73, same as stage 3 only more so.
- 80 litres Fig. 74, ditto.
- 100 litres Fig. 75, paddler feels very unstable.
- 120 litres Fig. 76, as stage 6 (100 litres) but more so becoming much harder to turn but keeping course in conditions.
- 140 litres Fig. 77, becoming stern heavy.
- 160 litres Fig. 78, paddler getting very nervous.
- 180 litres Fig. 79, getting more stable again.
- 200 litres Fig. 80, kayak has slow roll which paddler can predict.
- 200 litres +C Fig. 81, kayak afloat, bow submerged. This paddler would have capsized soon. Could not go anywhere in this condition.
