EXPERIMENTAL PROGRESSIVE FLOODING OF TWO SEA KAYAKS

1. Fore and Aft Bulkheads (Nordkapp)

2. Confluent Hull with Safety Cockpit (Sea Tiger)

2nd September 1989

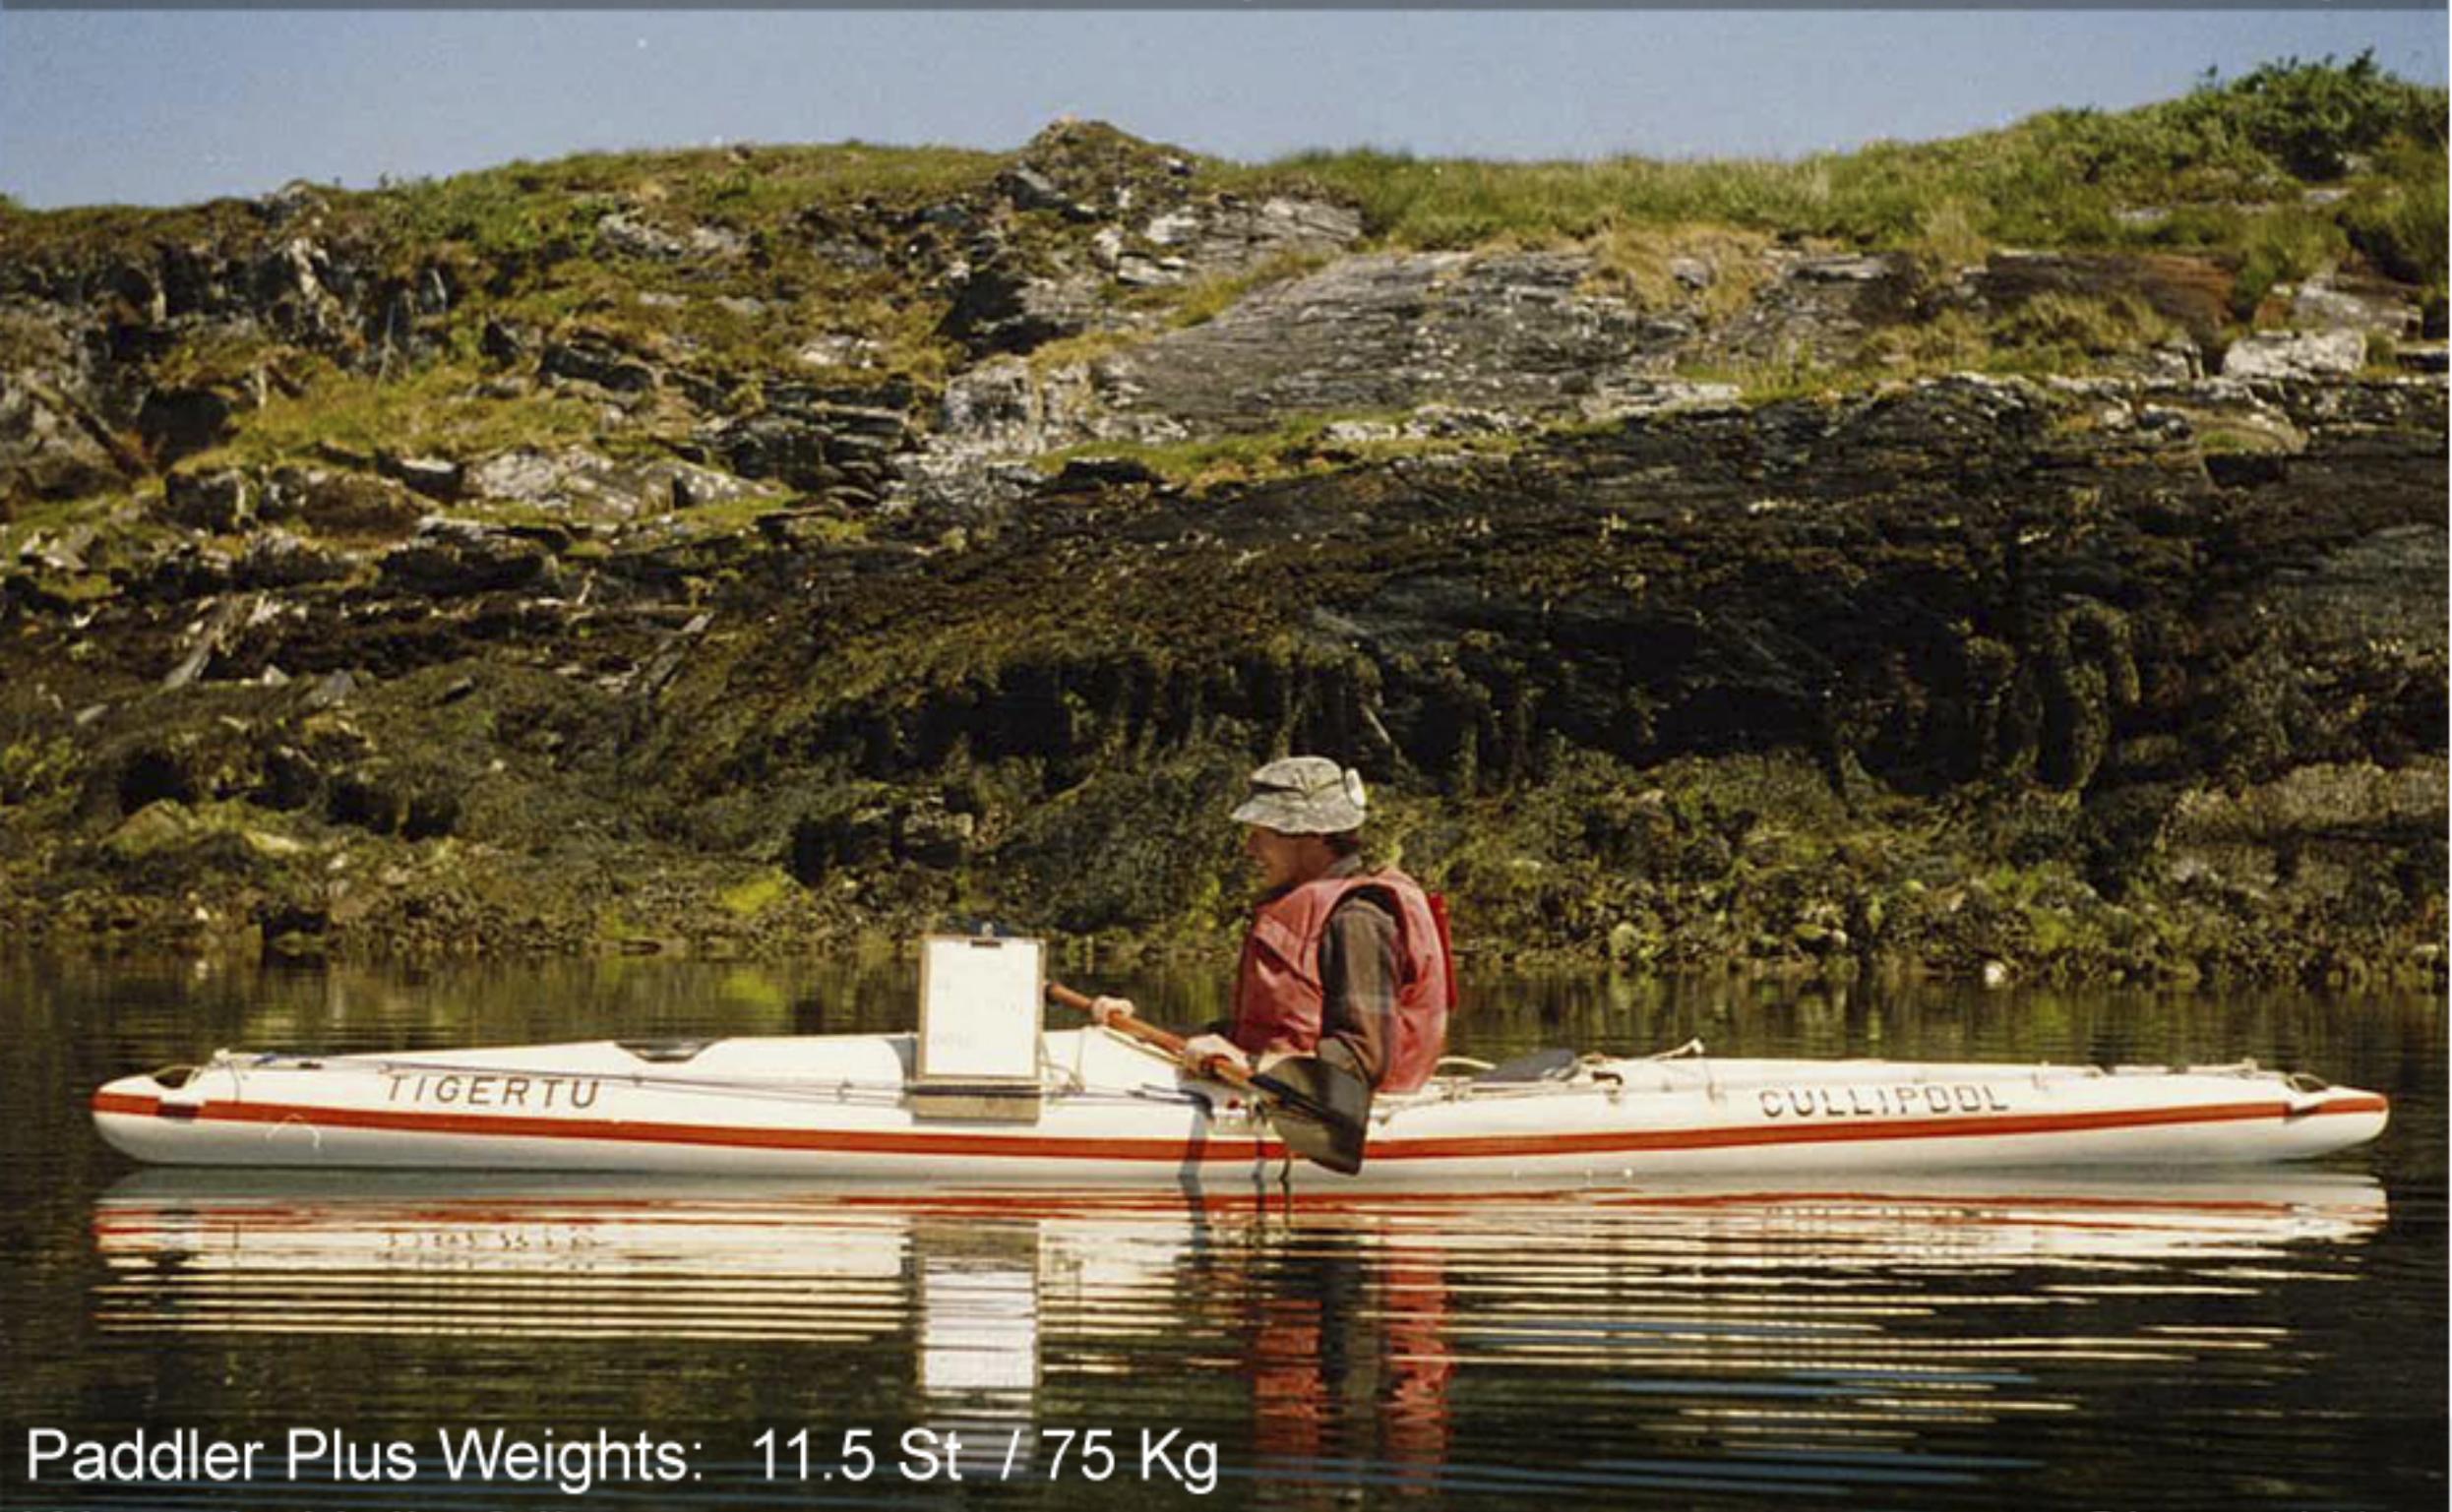
Paddler Plus Weights: 11.5 St / 75 Kg
Water in Hull: 0 litres

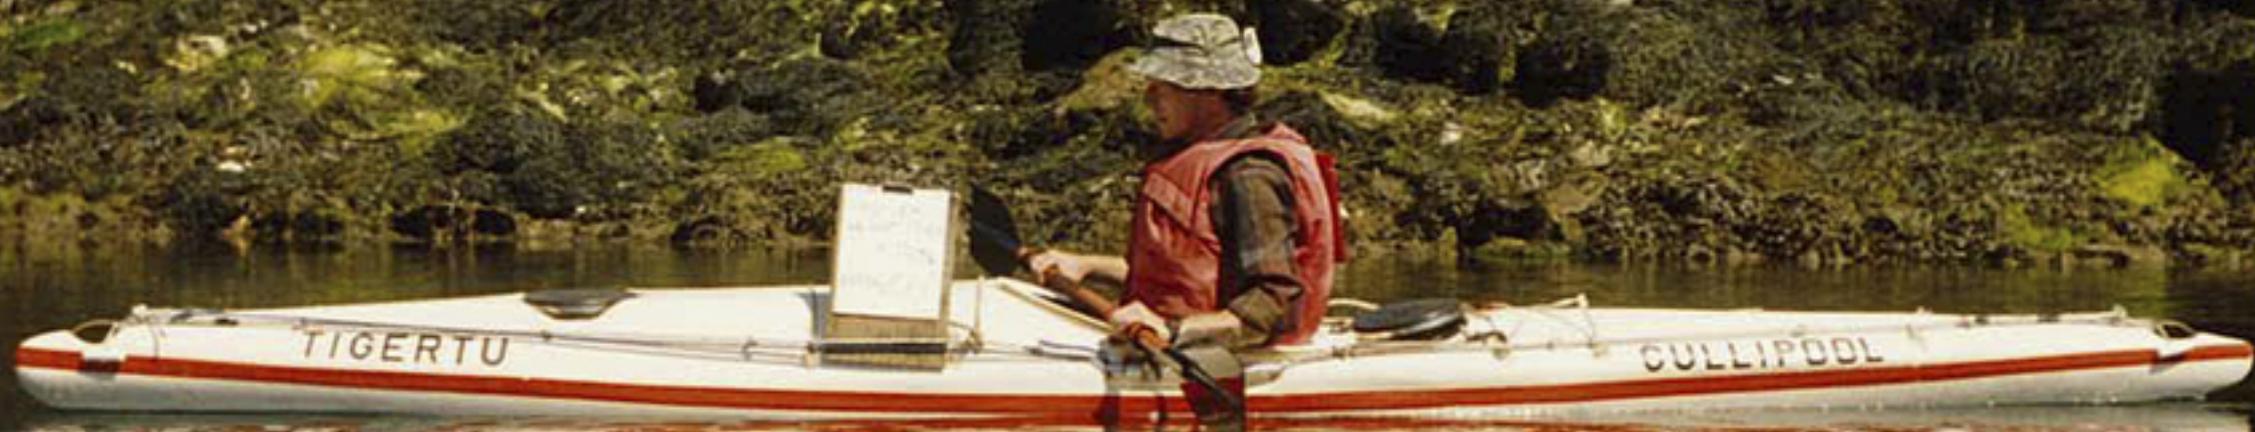
Sheet 2/11

Paddler Plus Weights: 11.5 St / 75 Kg

Water in Hull: 20 litres

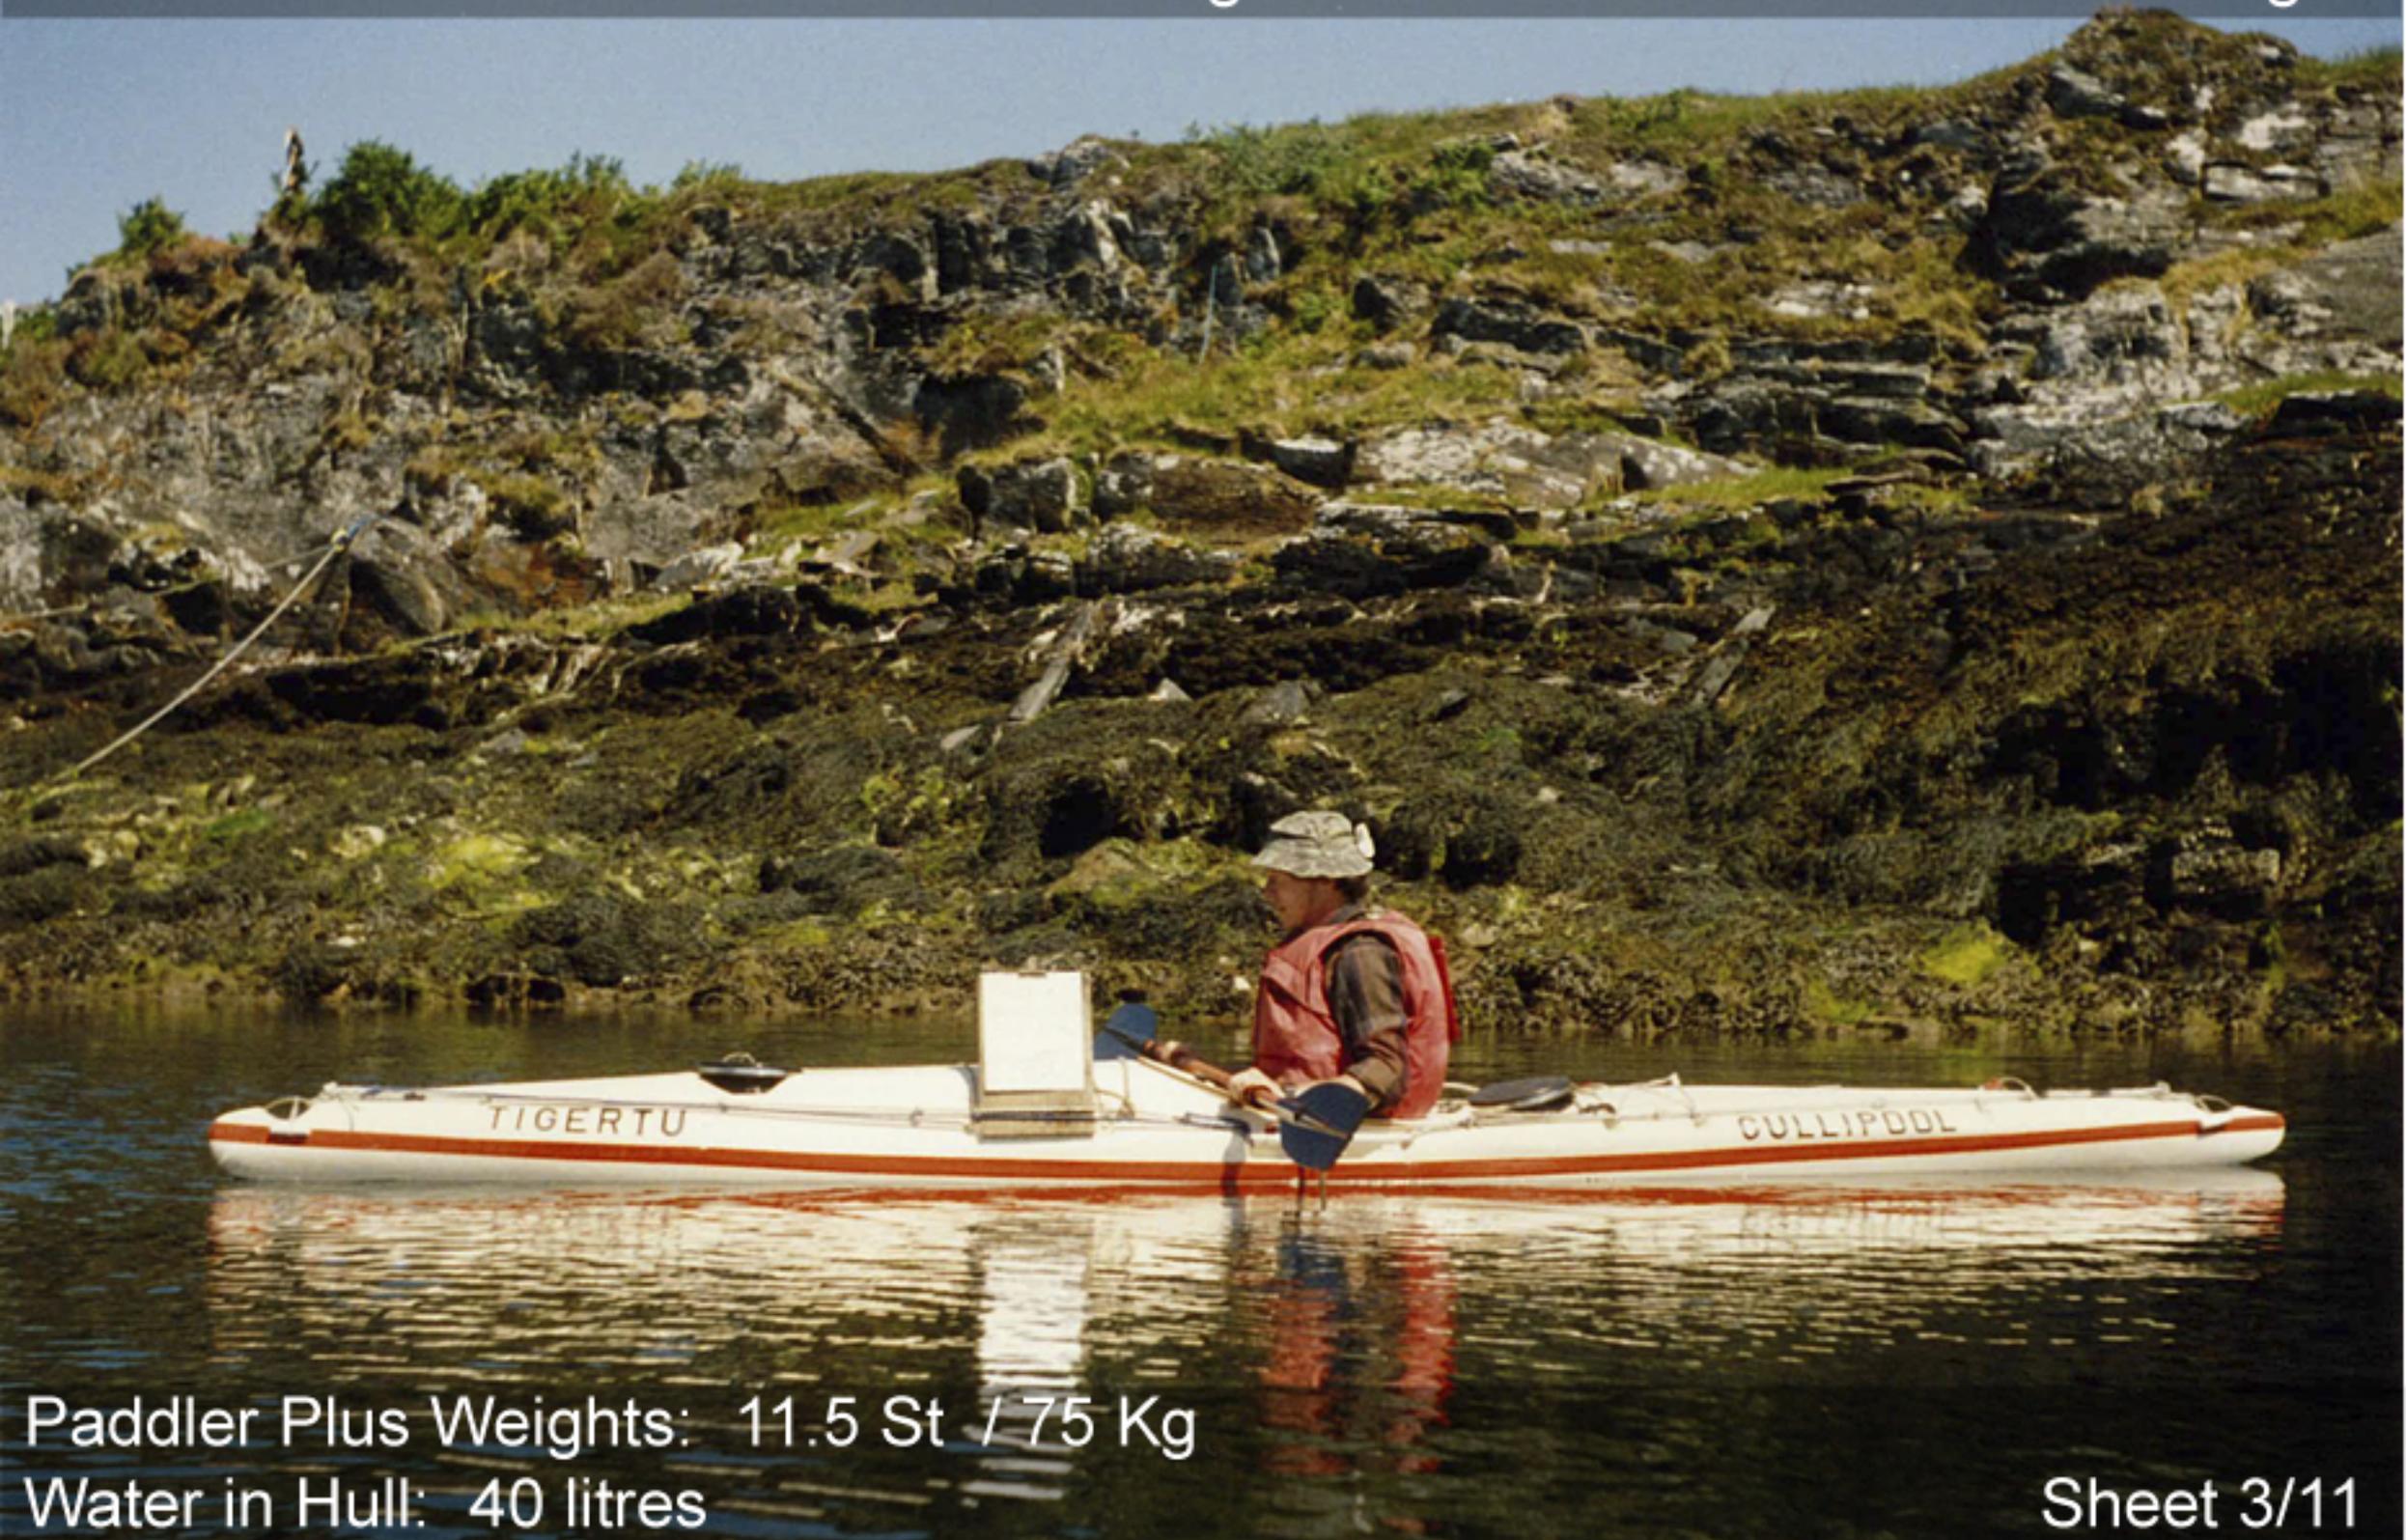
Sheet 3/11

Paddler Plus Weights: 11.5 St / 75 Kg
Water in Hull: 40 litres

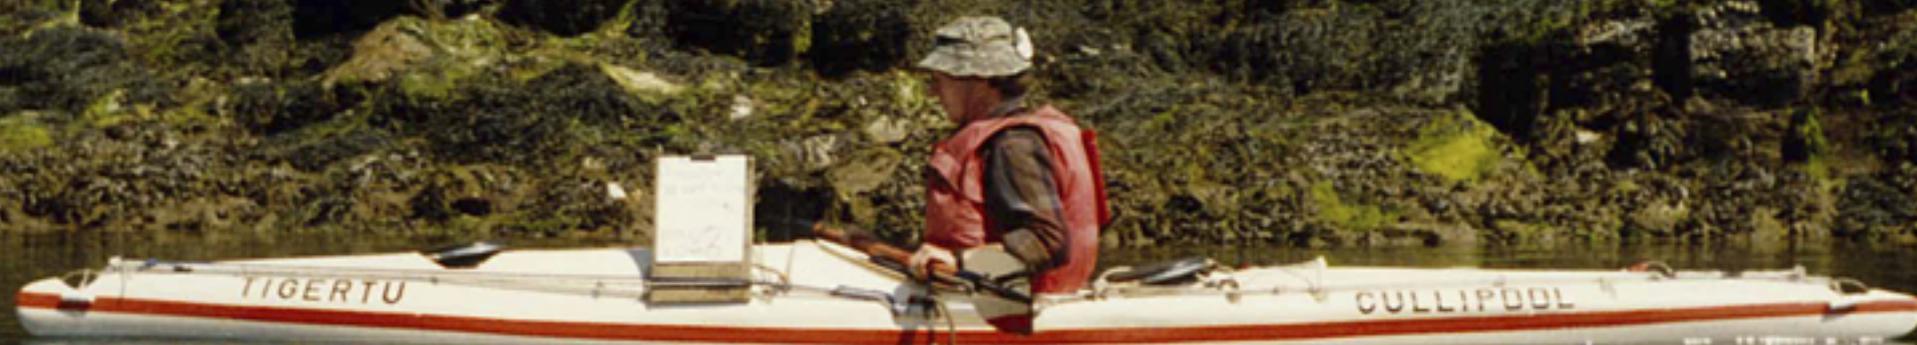
Sheet 4/11

Paddler Plus Weights: 11.5 St / 75 Kg

Water in Hull: 60 litres

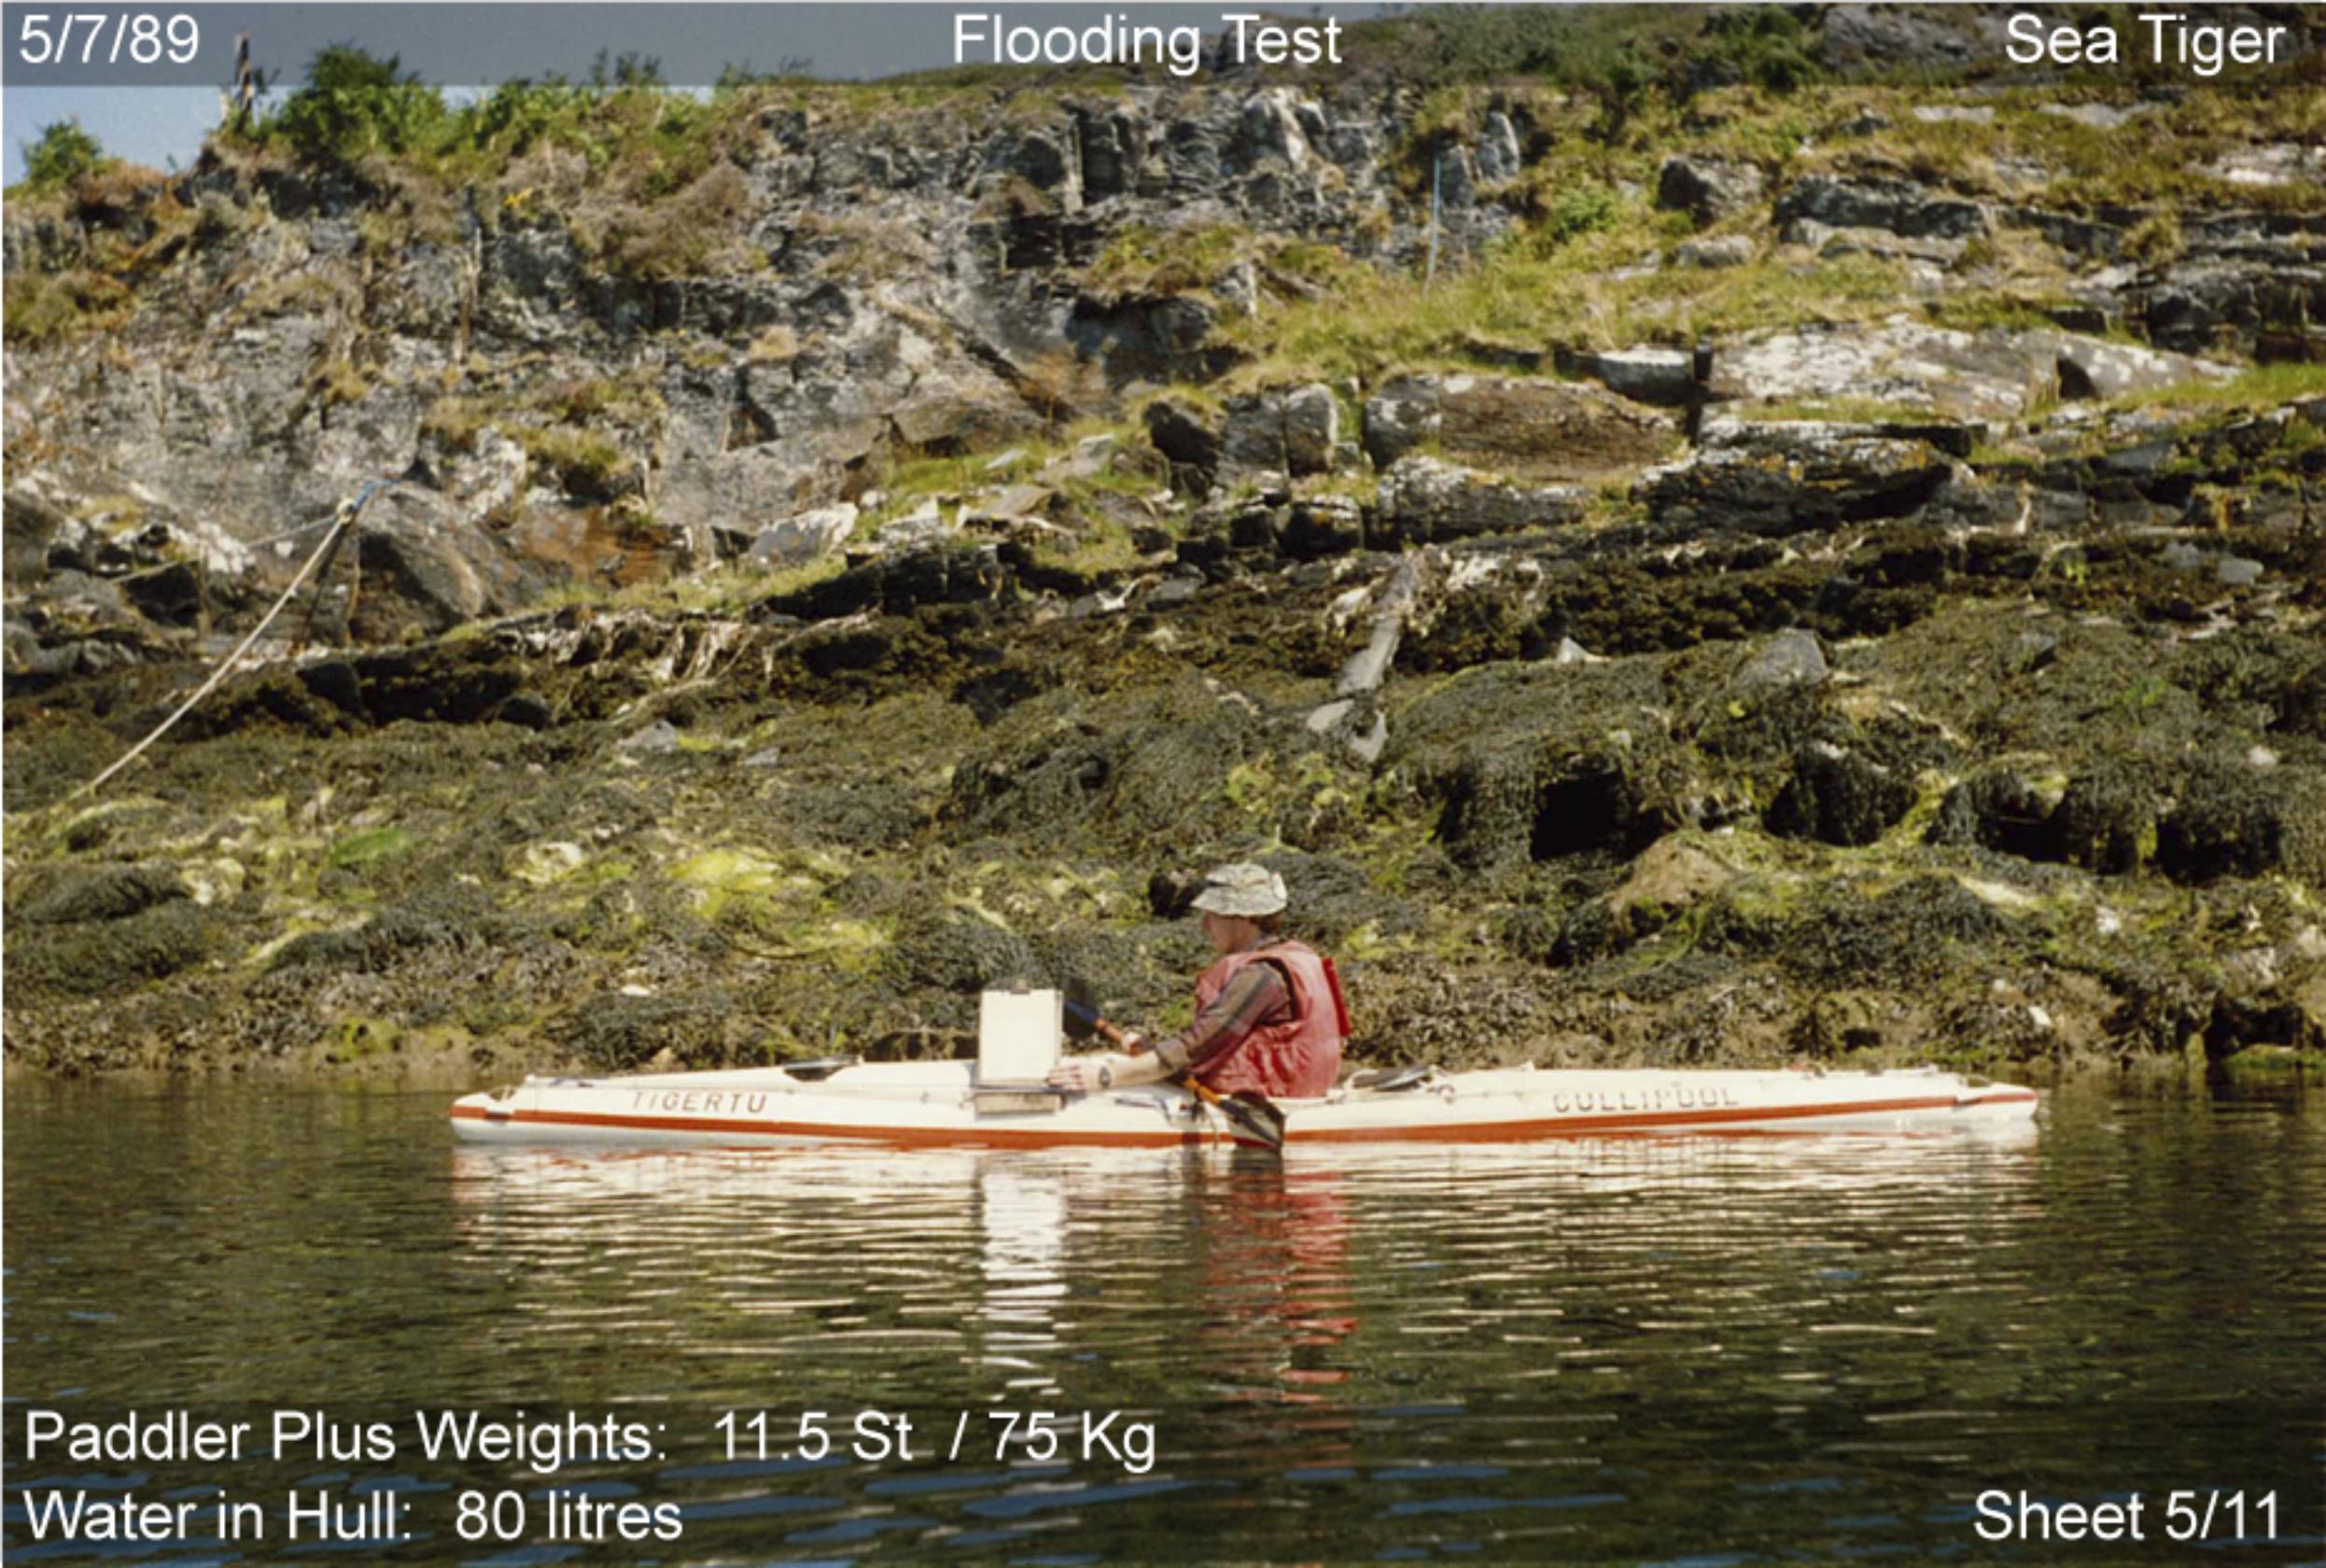
Sheet 5/11

Paddler Plus Weights: 11.5 St / 75 Kg
Water in Hull: 80 litres

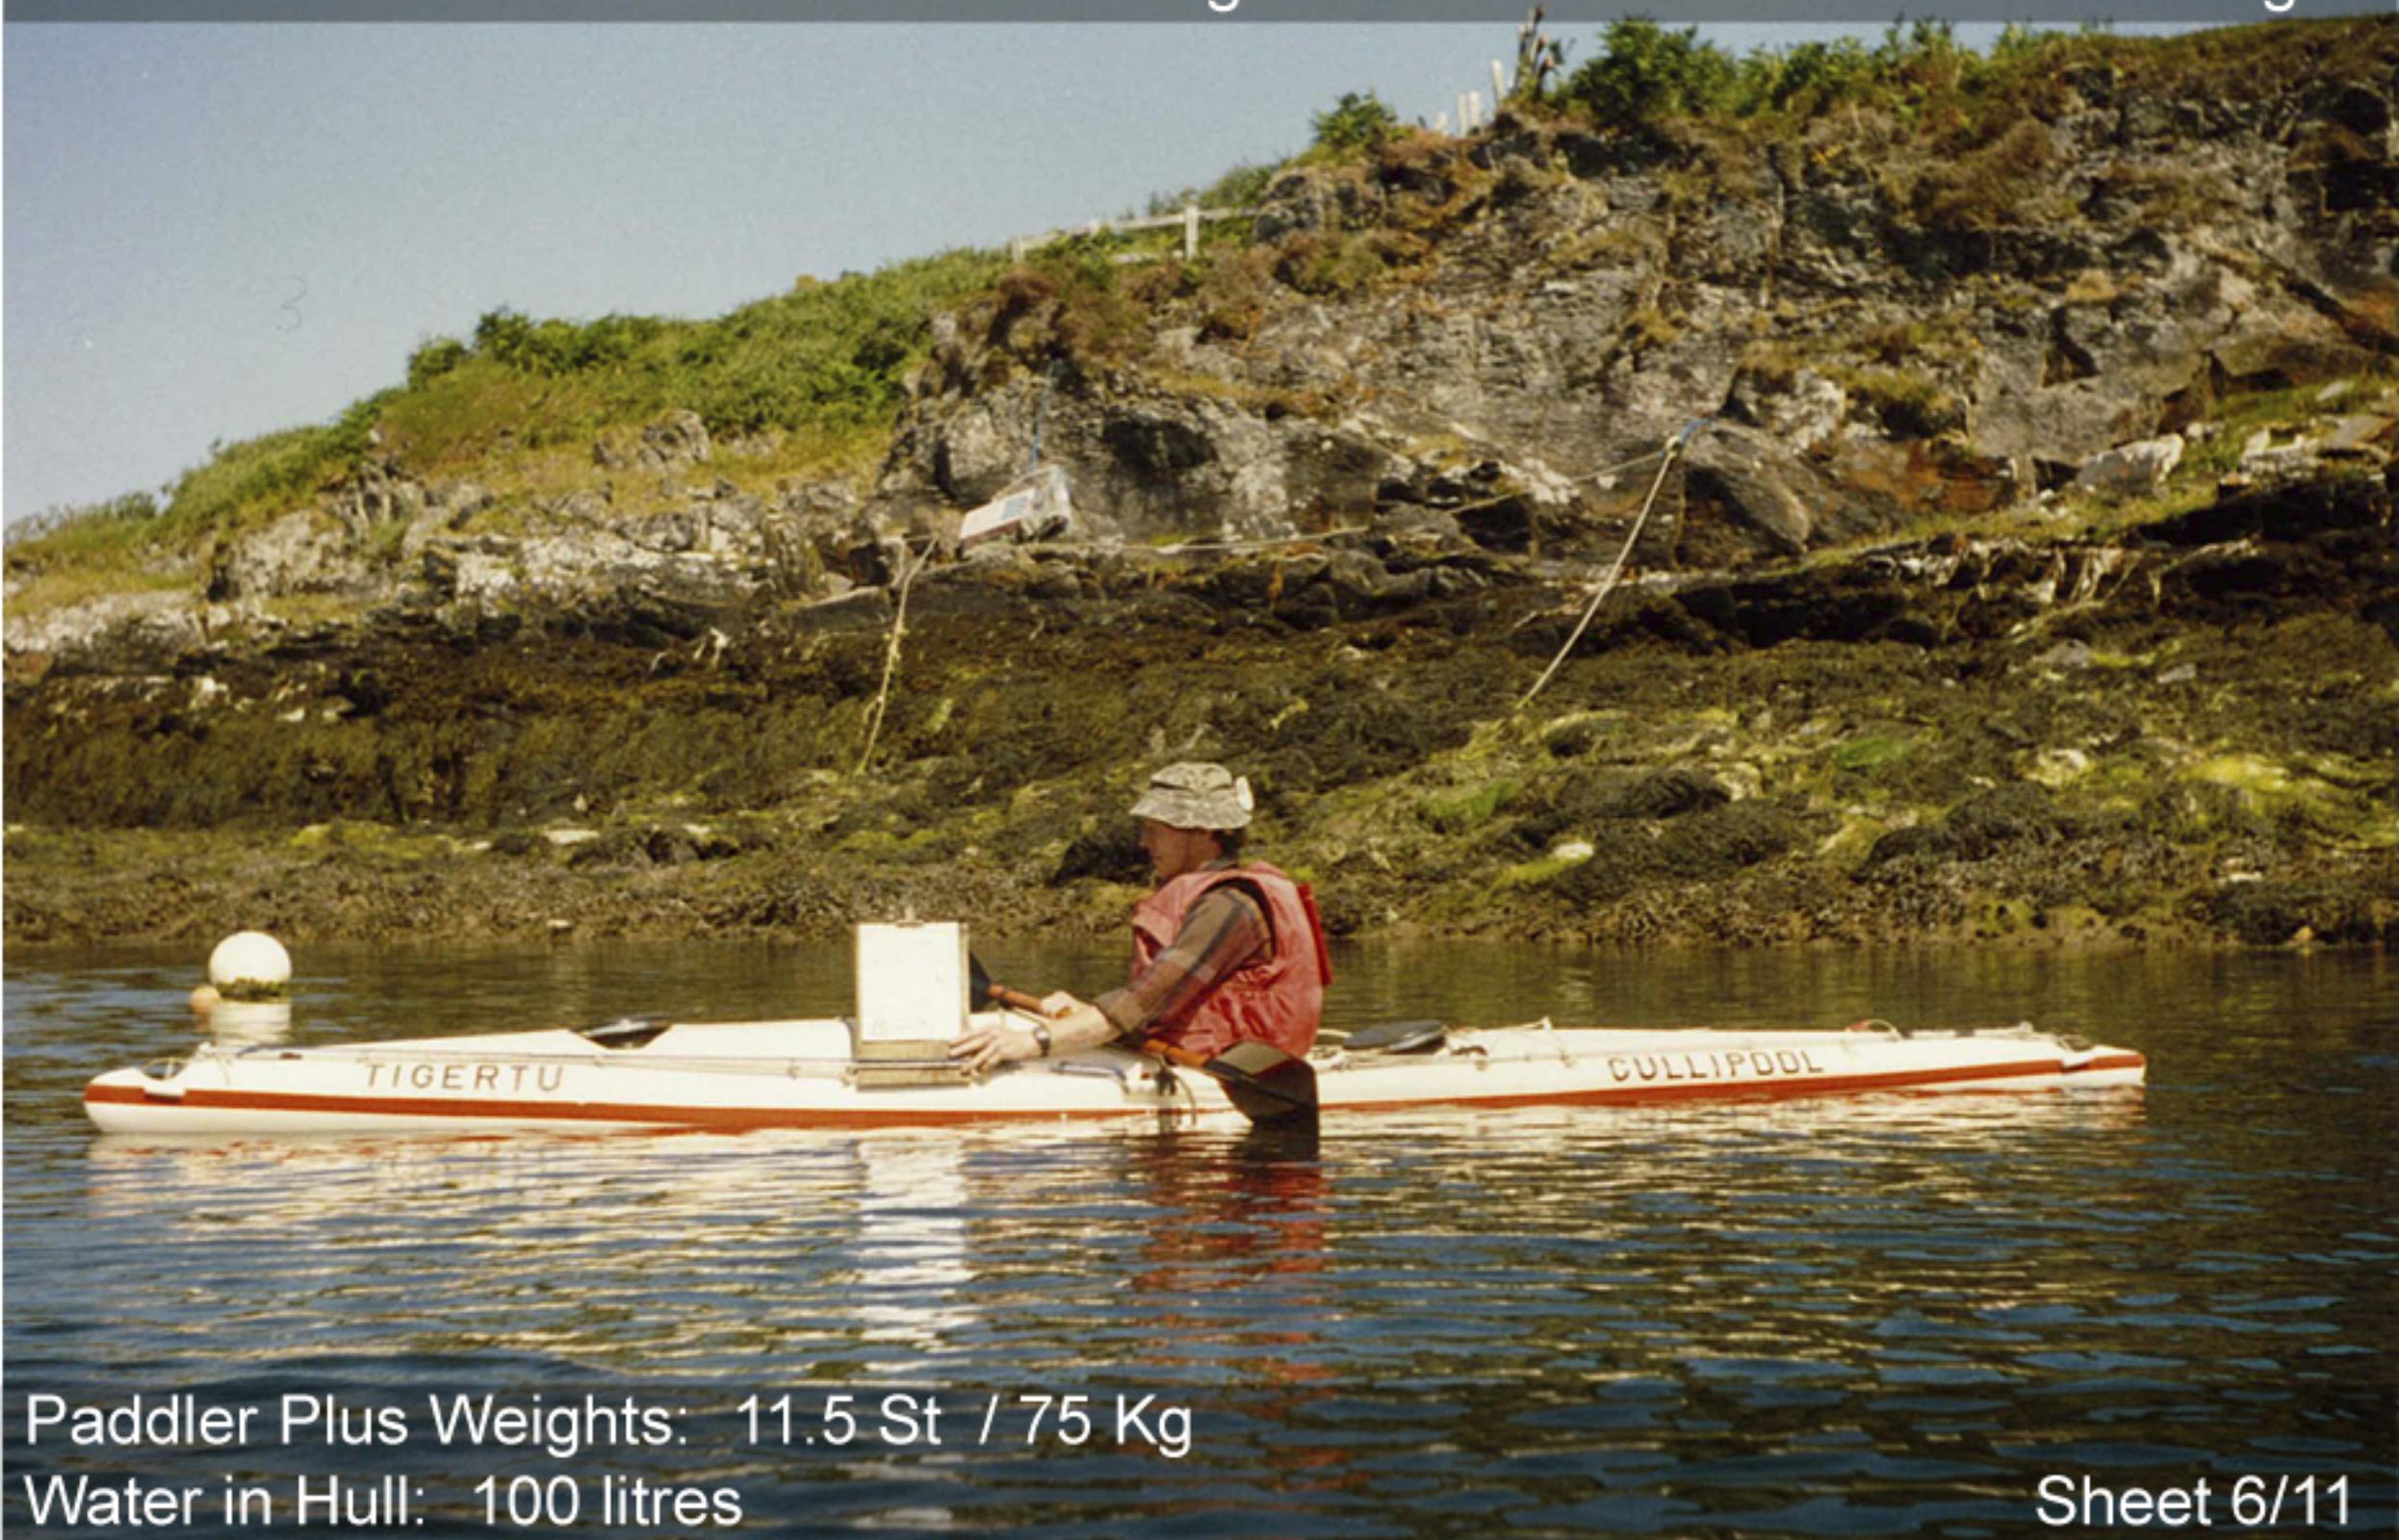
Sheet 6/11

Paddler Plus Weights: 11.5 St / 75 Kg

Water in Hull: 100 litres

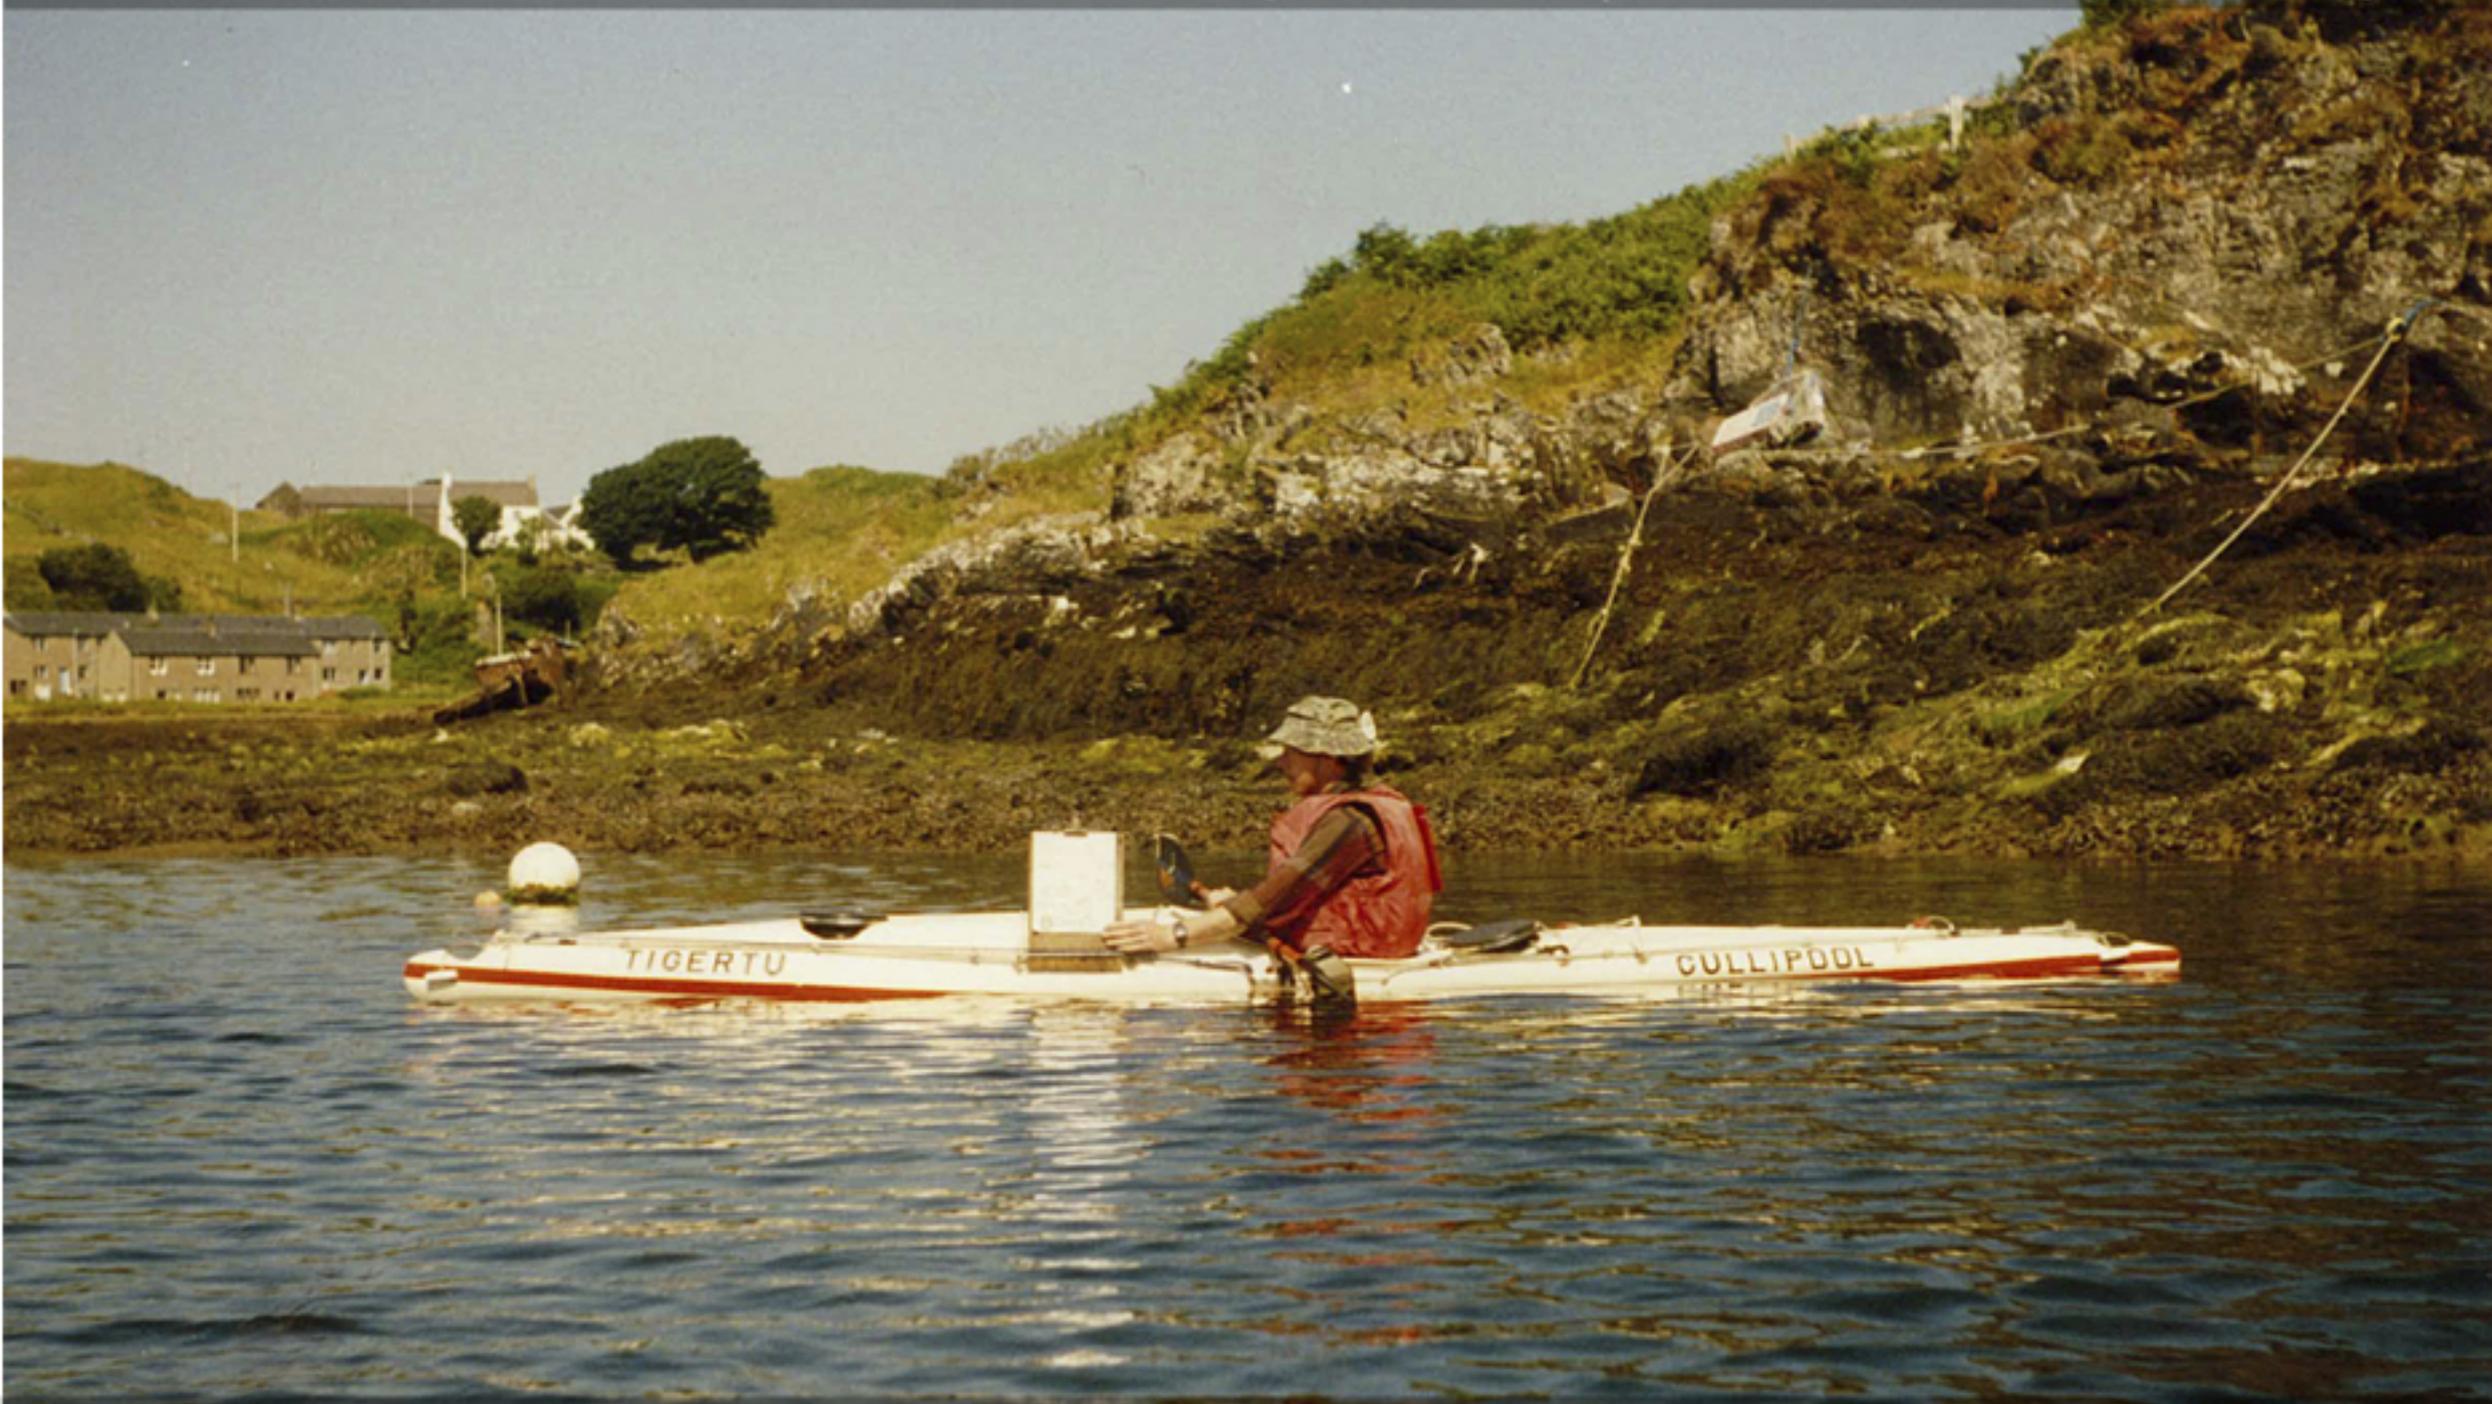
Sheet 7/11

Paddler Plus Weights: 11.5 St / 75 Kg
Water in Hull: 120 litres
