EXPERIMENTAL PROGRESSIVE FLOODING OF TWO SEA KAYAKS

1. Fore and Aft Bulkheads (Nordkapp)

2. Confluent Hull with Safety Cockpit (Sea Tiger)

2nd September 1989

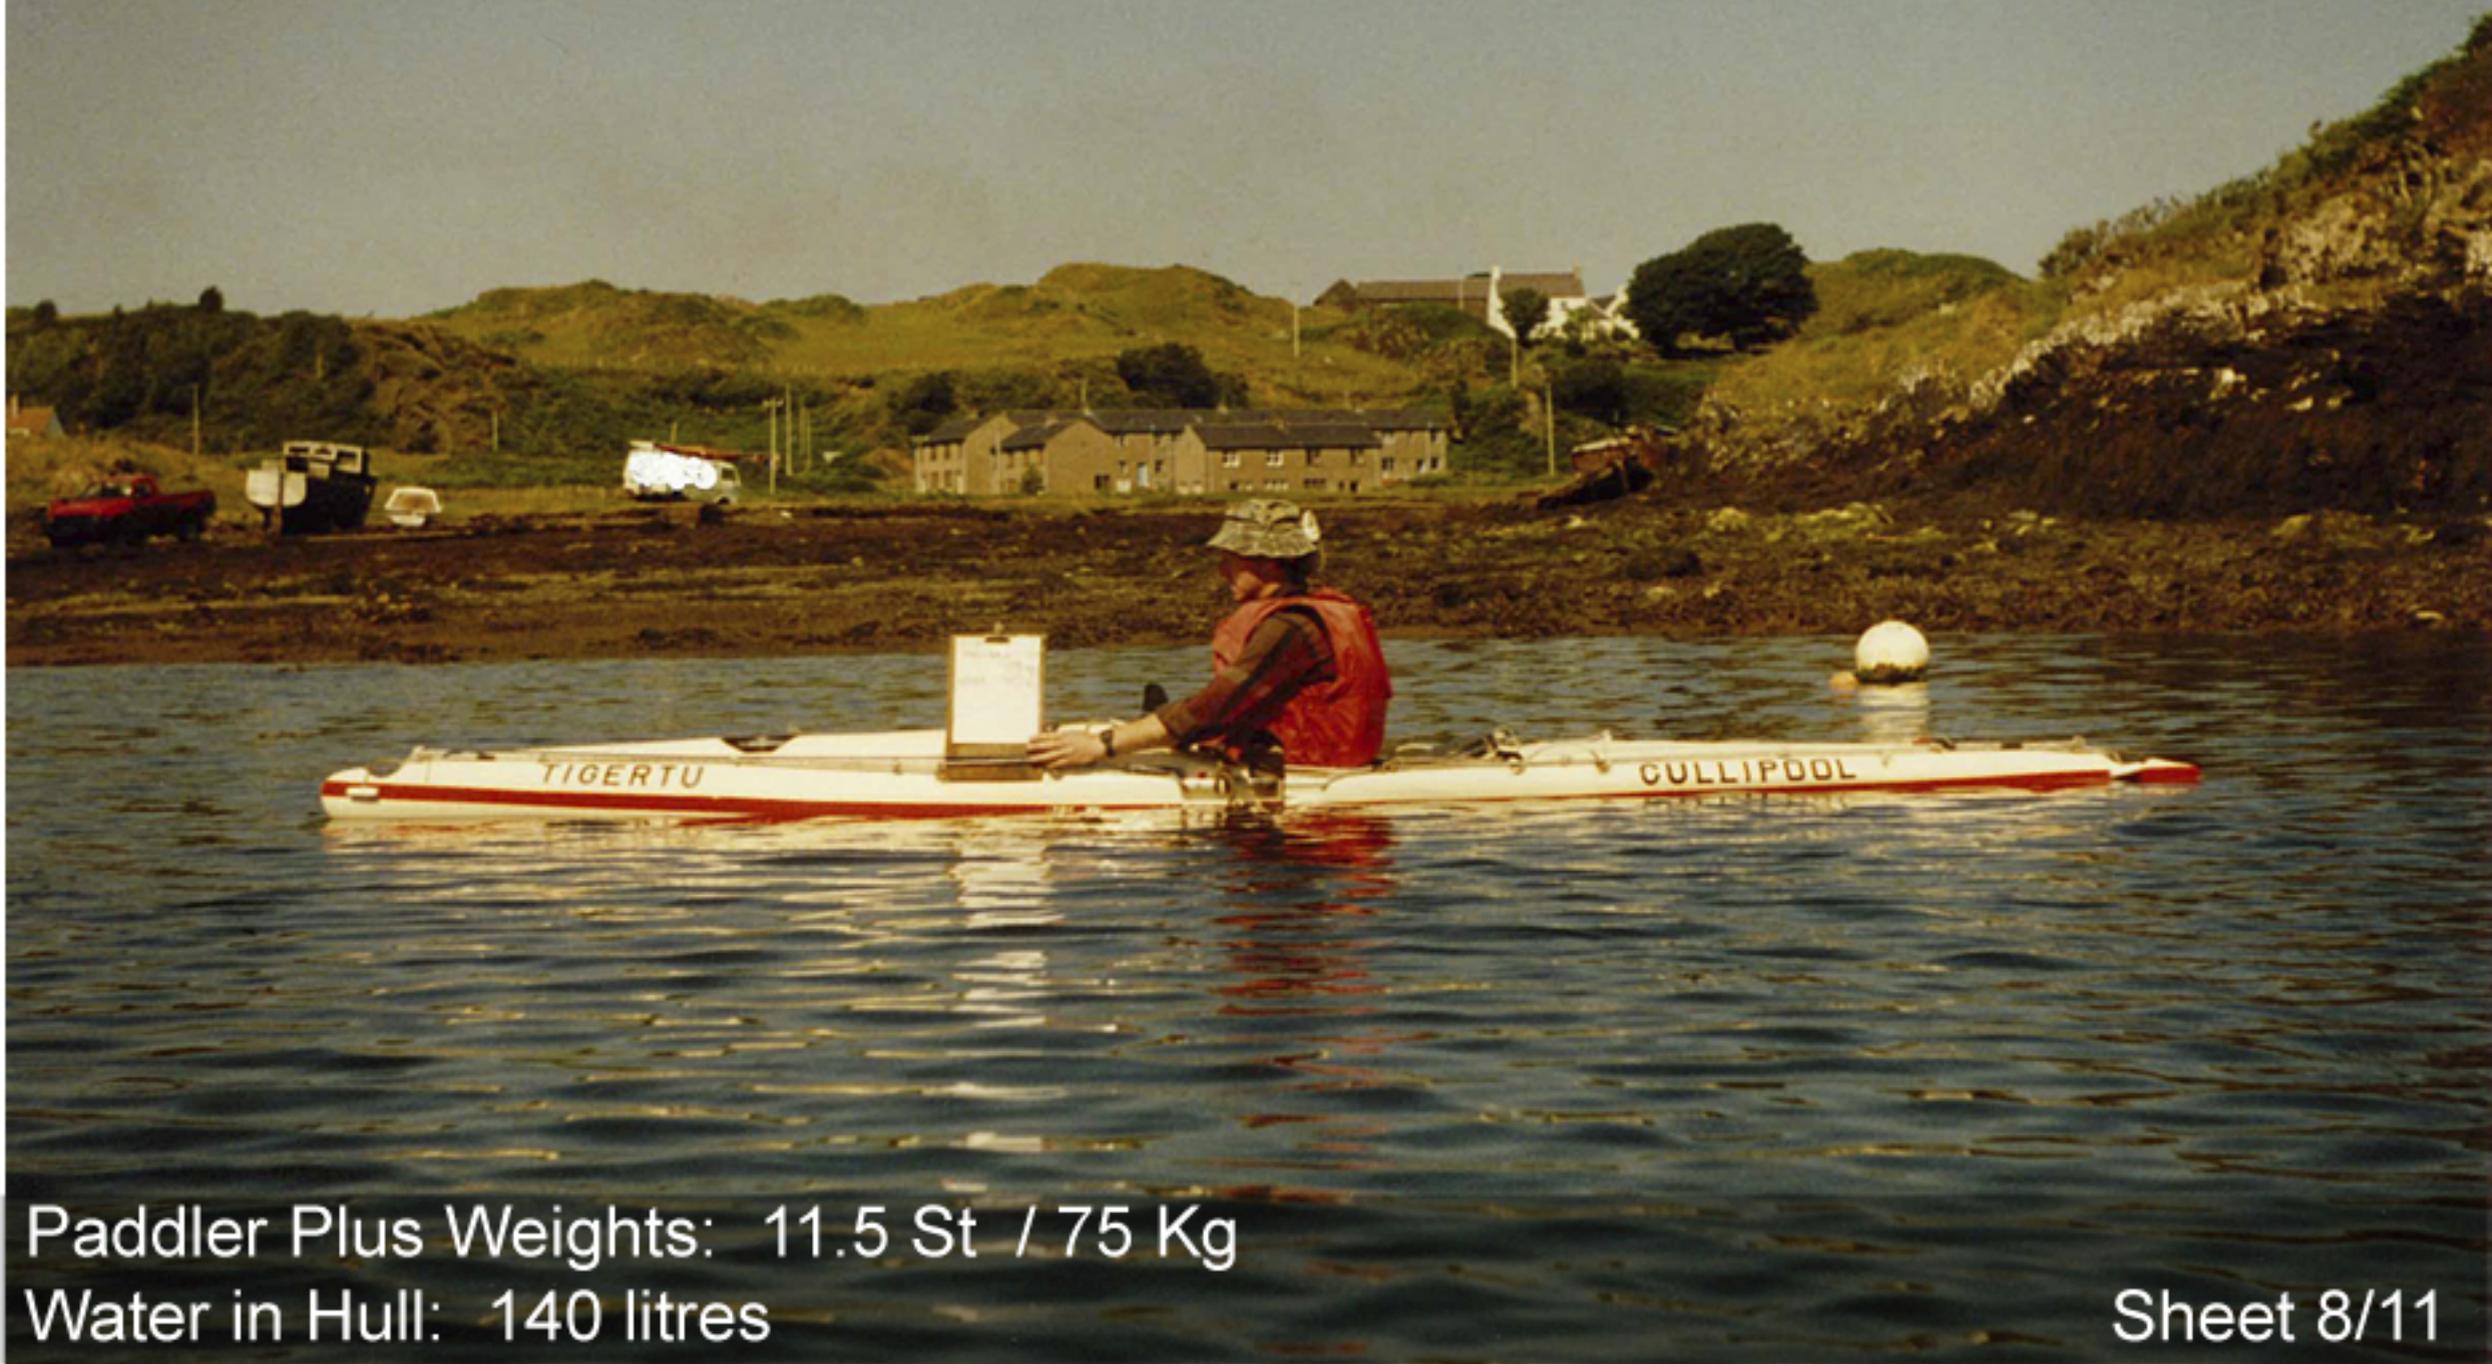
Sheet 8/11

Paddler Plus Weights: 11.5 St / 75 Kg

Water in Hull: 140 litres

By contrast, the confluent hull allowed even distribution of the weight of water fore and aft in the test Sea Tiger, resulting in the kayak maintaining an even trim to a loading of about 140 litres (approximately 140 kg or 309 lb). Provided the movement of this water within the hull is suitably restricted, it seems reasonable to conjecture that, given equal loading or rate, say, of leak, in the case of a bulkhead kayak and one fitted with a Safety Cockpit, the paddler would retain control of direction for longer in the kayak with confluent hull than one subdivided into the conventional three compartments. This comparison will be difficult to measure objectively in open sea conditions.

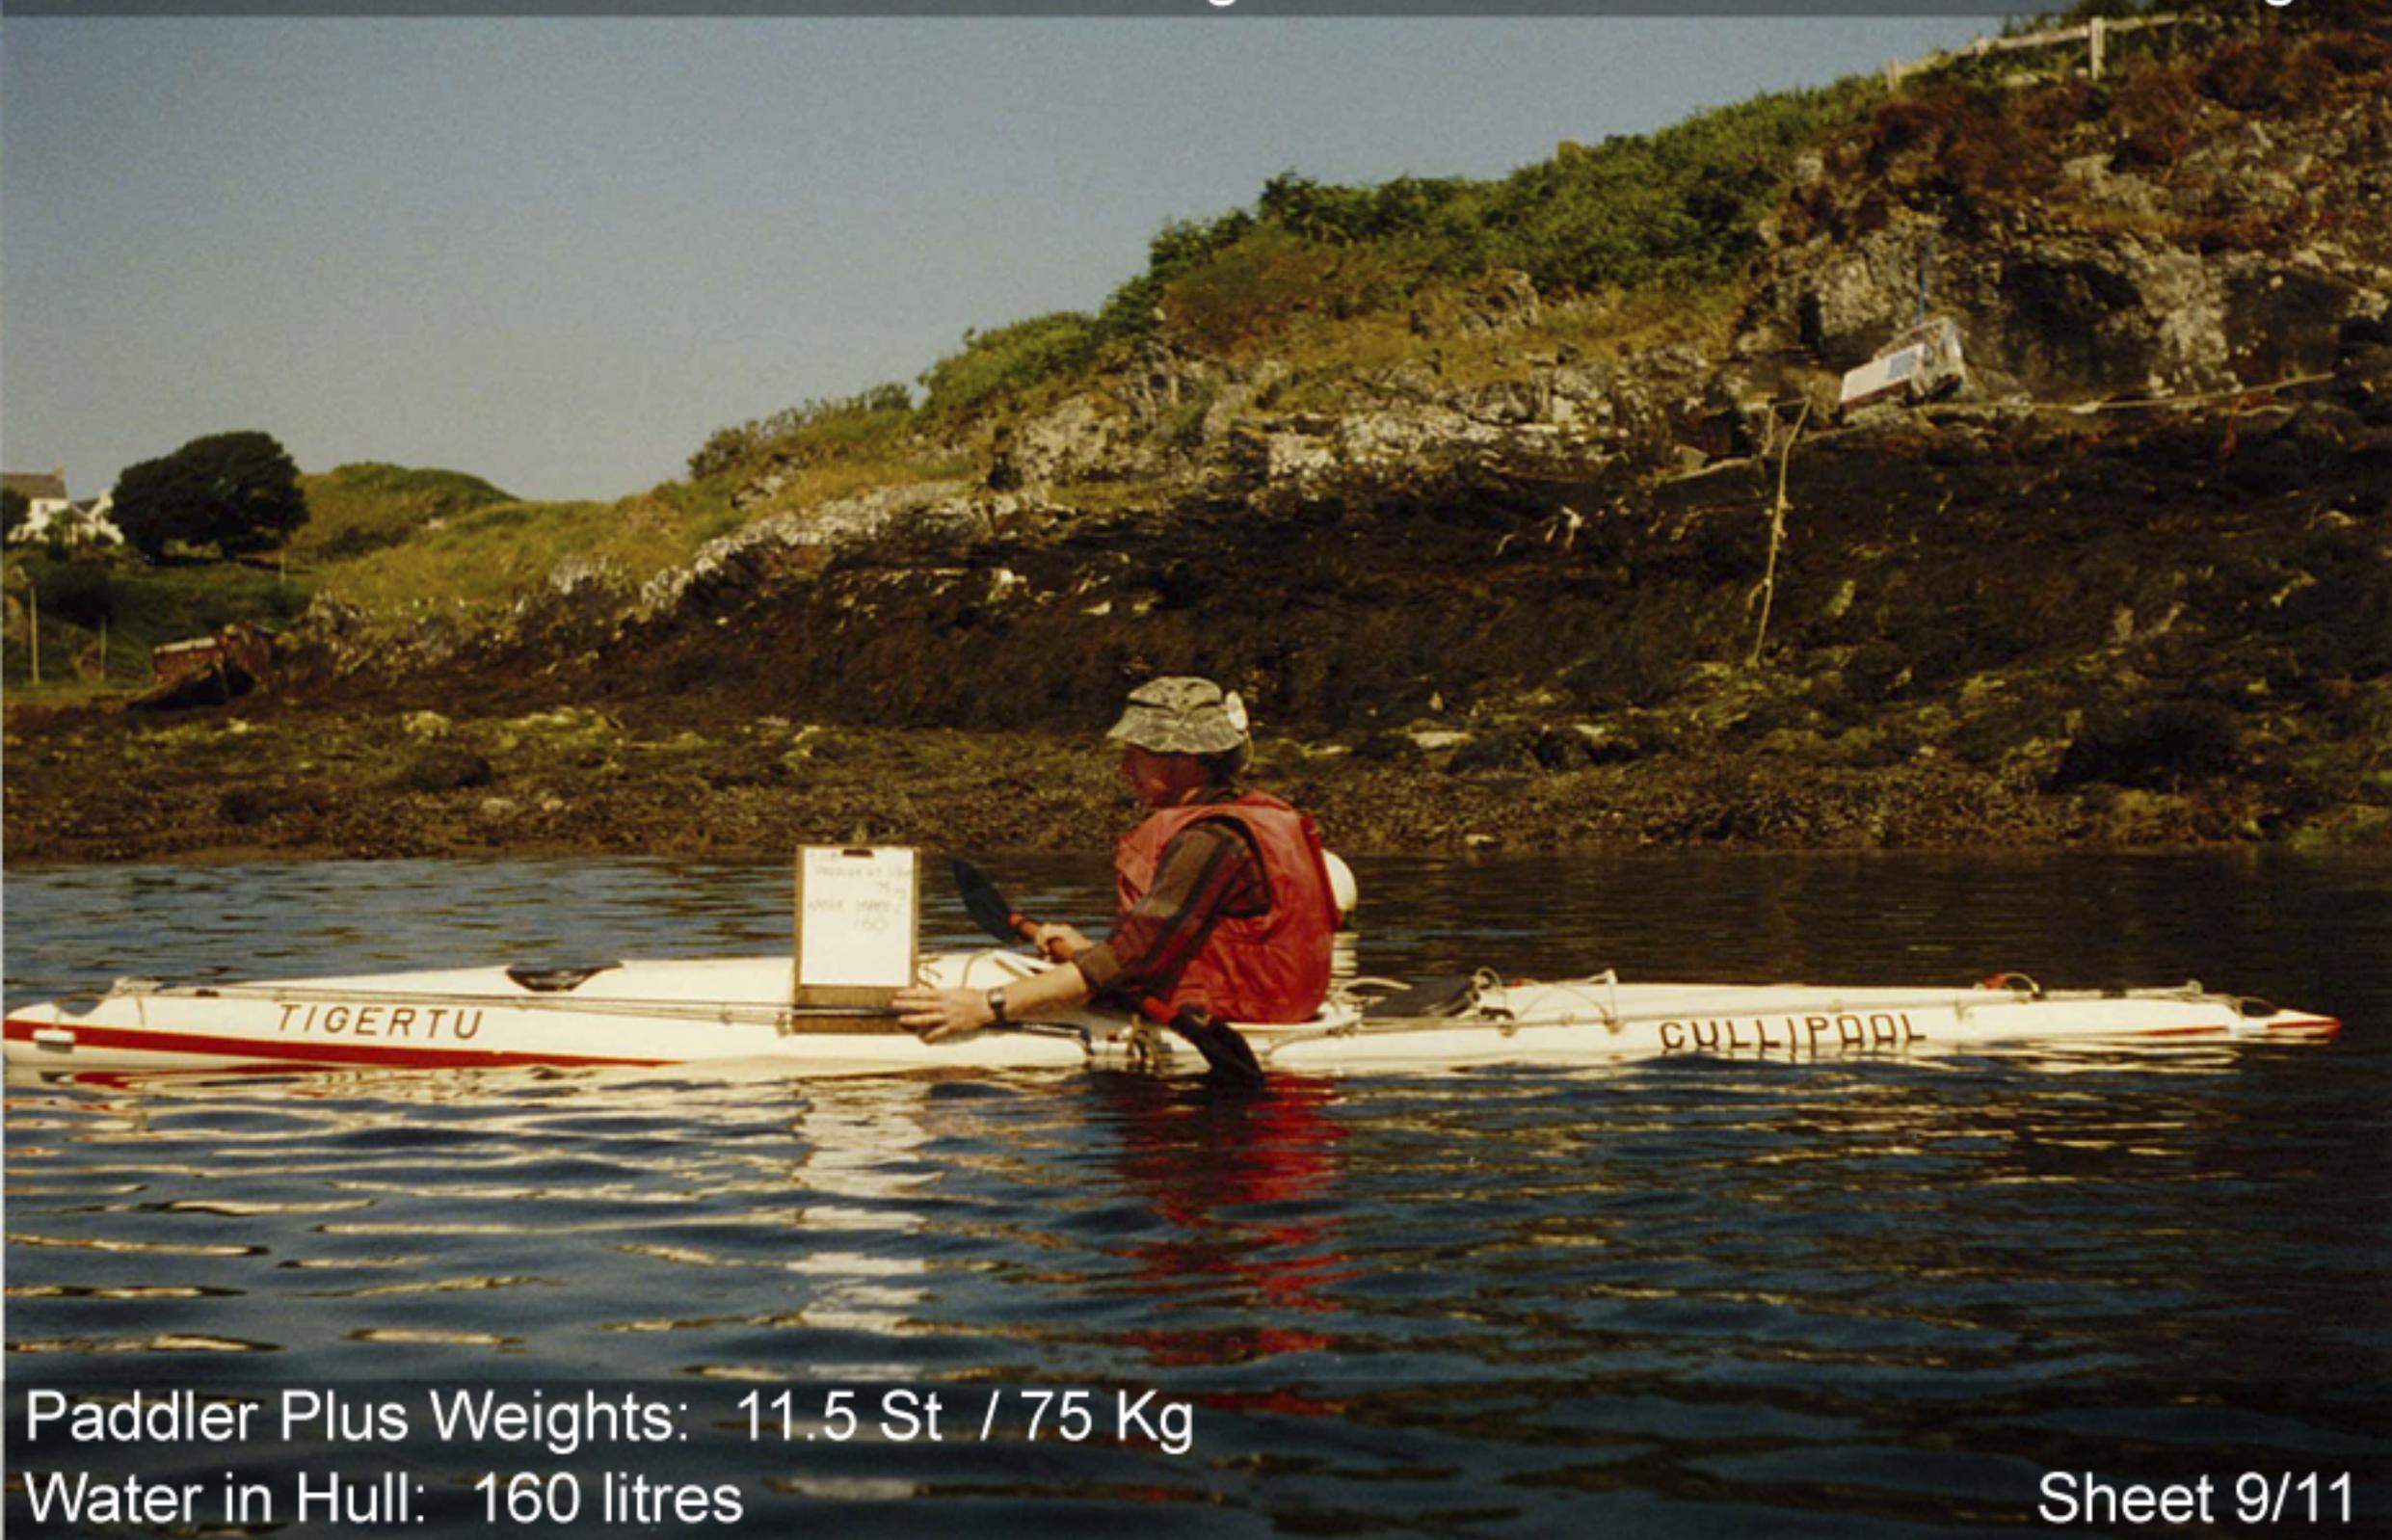
Sheet 9/11

Paddler Plus Weights: 11.5 St / 75 Kg

Water in Hull: 160 litres

The Sea Tiger maintained an even fore and aft trim until a loading of 160 litres (P9). The Nordkapp became noticeably out of trim with small amounts, 20 litres, of water in either end (P15, P26).

The Sea Tiger is capable of containing more water in the stern half, because of the presence of the Safety Cockpit fore. As a result a stern-down trim became noticeable at 160 litres and above (P 9, P 10, P 11). The Sea Tiger Hull with 200 litres added was not fully flooded. The volume of 200 litres is equivalent to a standard cast iron bath filled to the overflow rose.

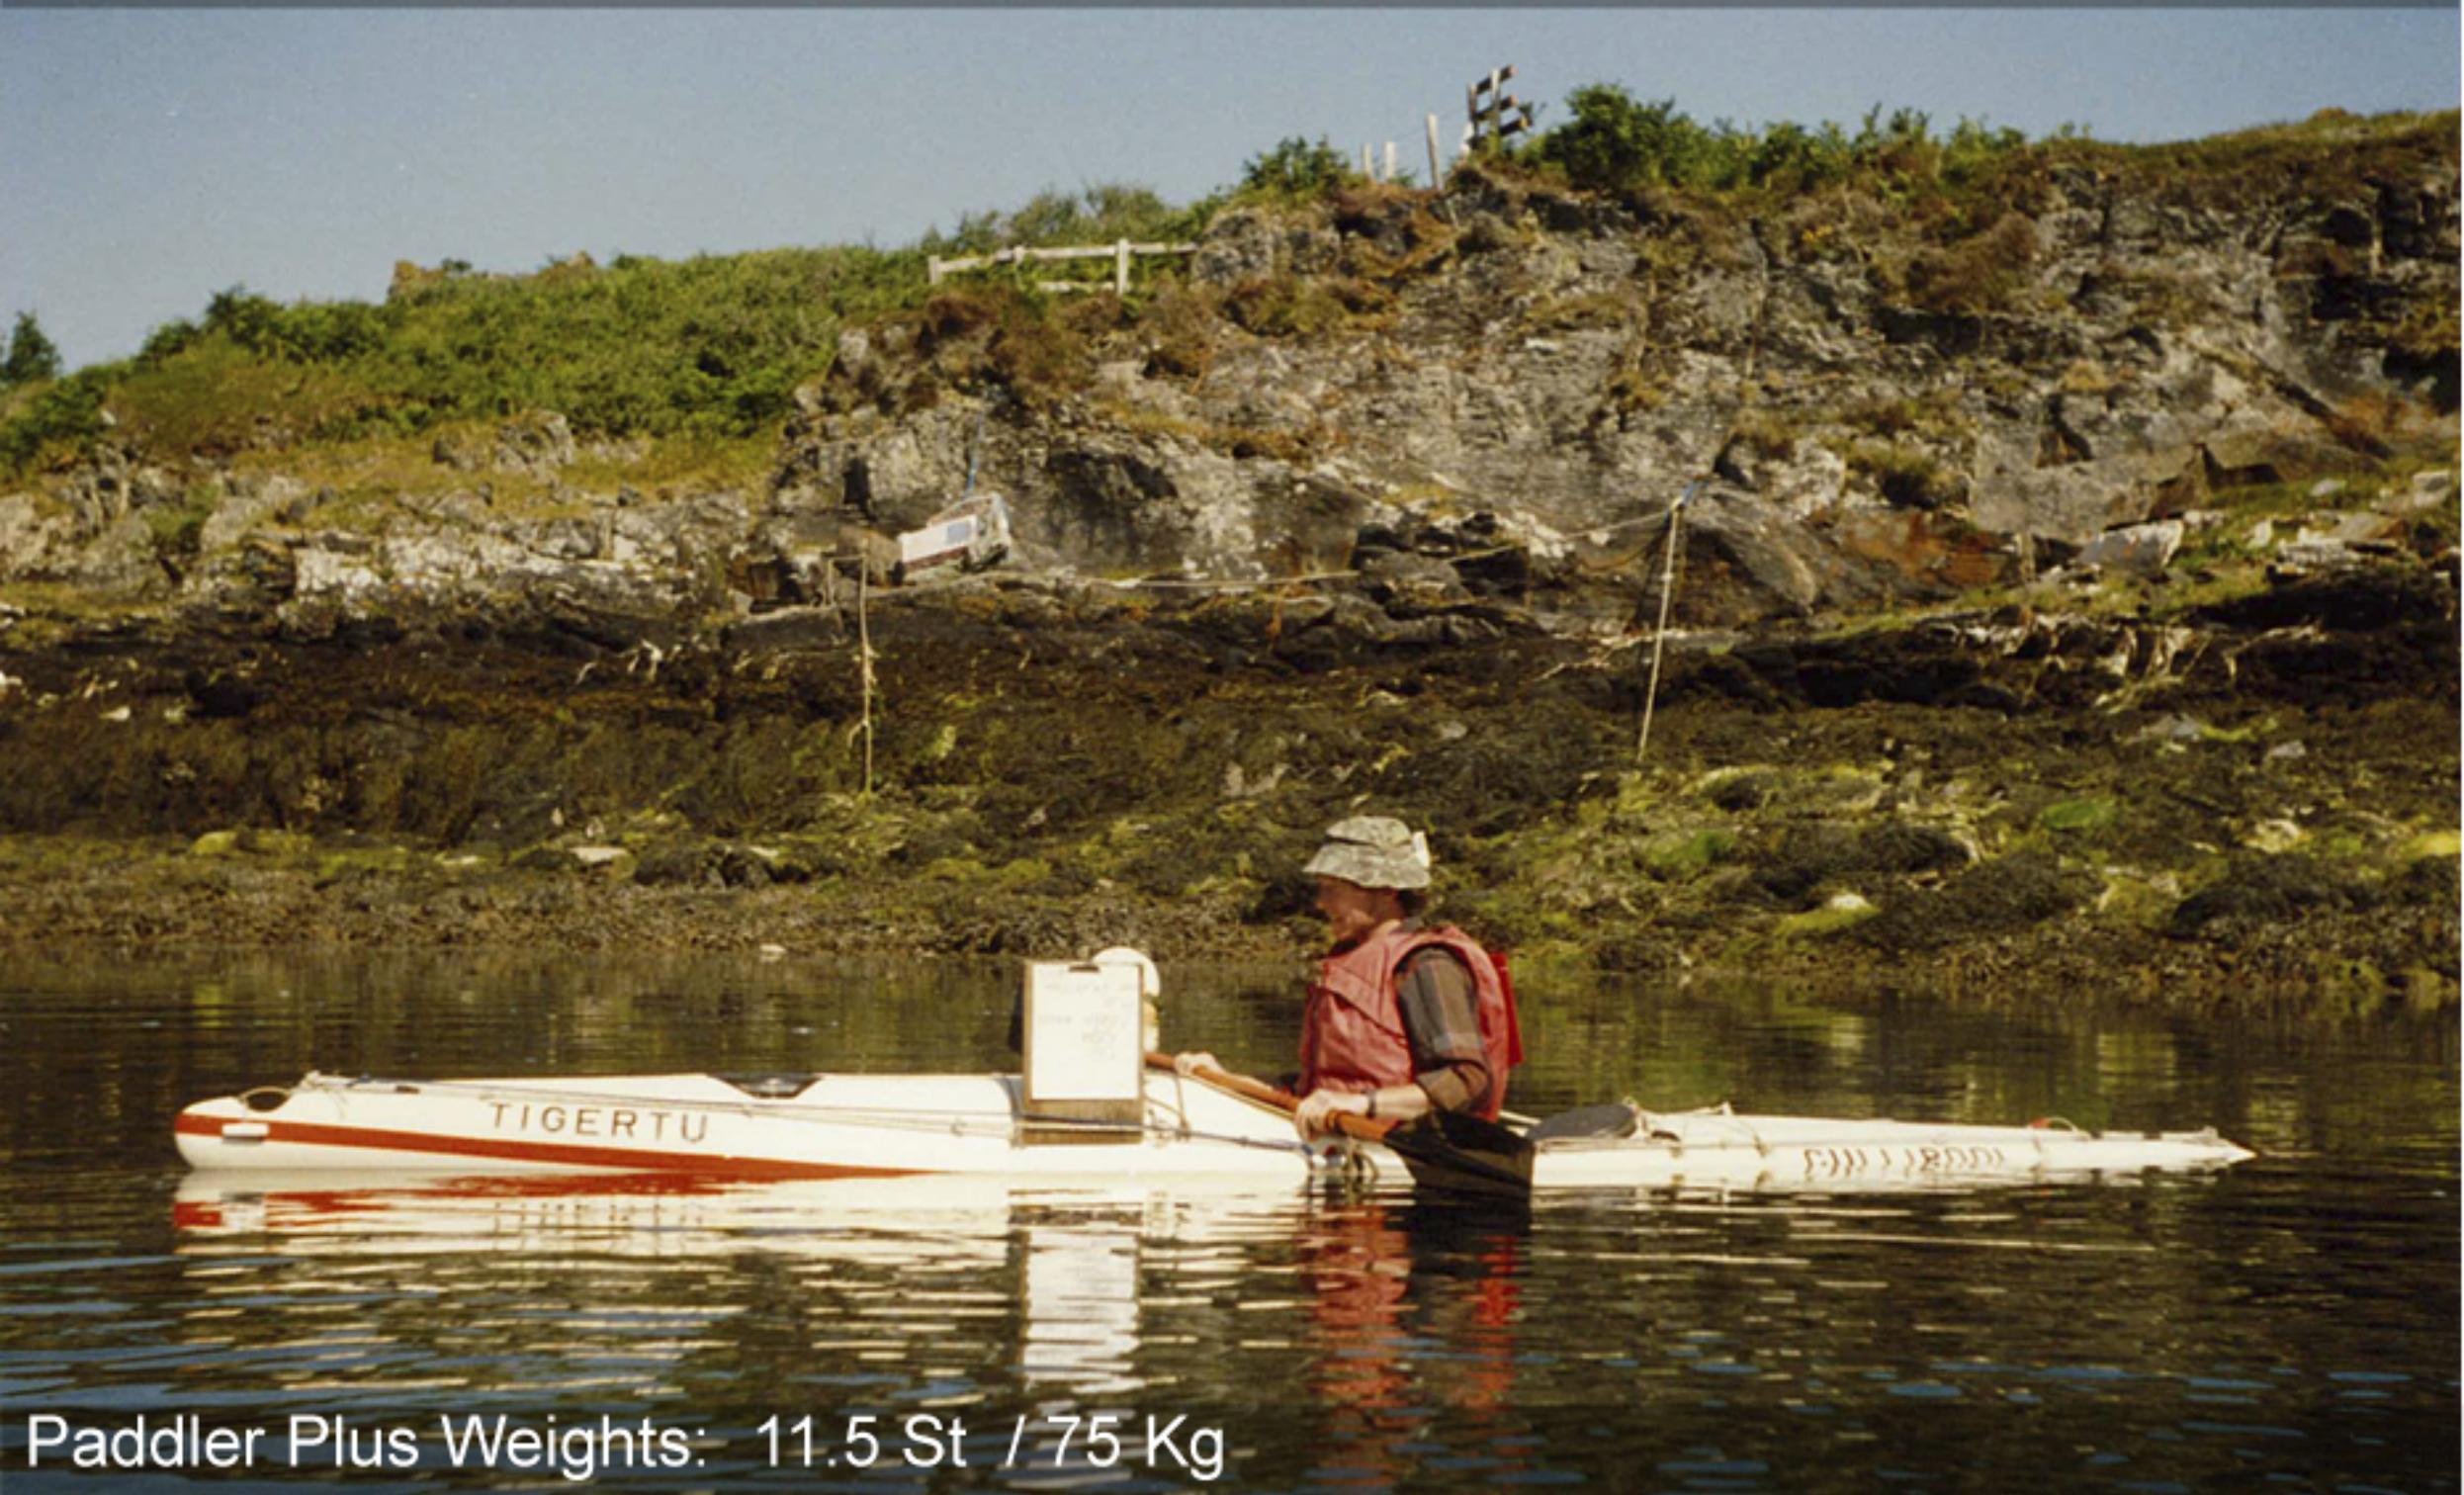
Paddler Plus Weights: 11.5 St / 75 Kg
Water in Hull: 180 litres

The after half of a Sea Tiger can contain a greater weight of water than the forward half (P 10) due to the presence of the Safety Cockpit. The fixed buoyancy aft should be increased to compensate for this imbalance.

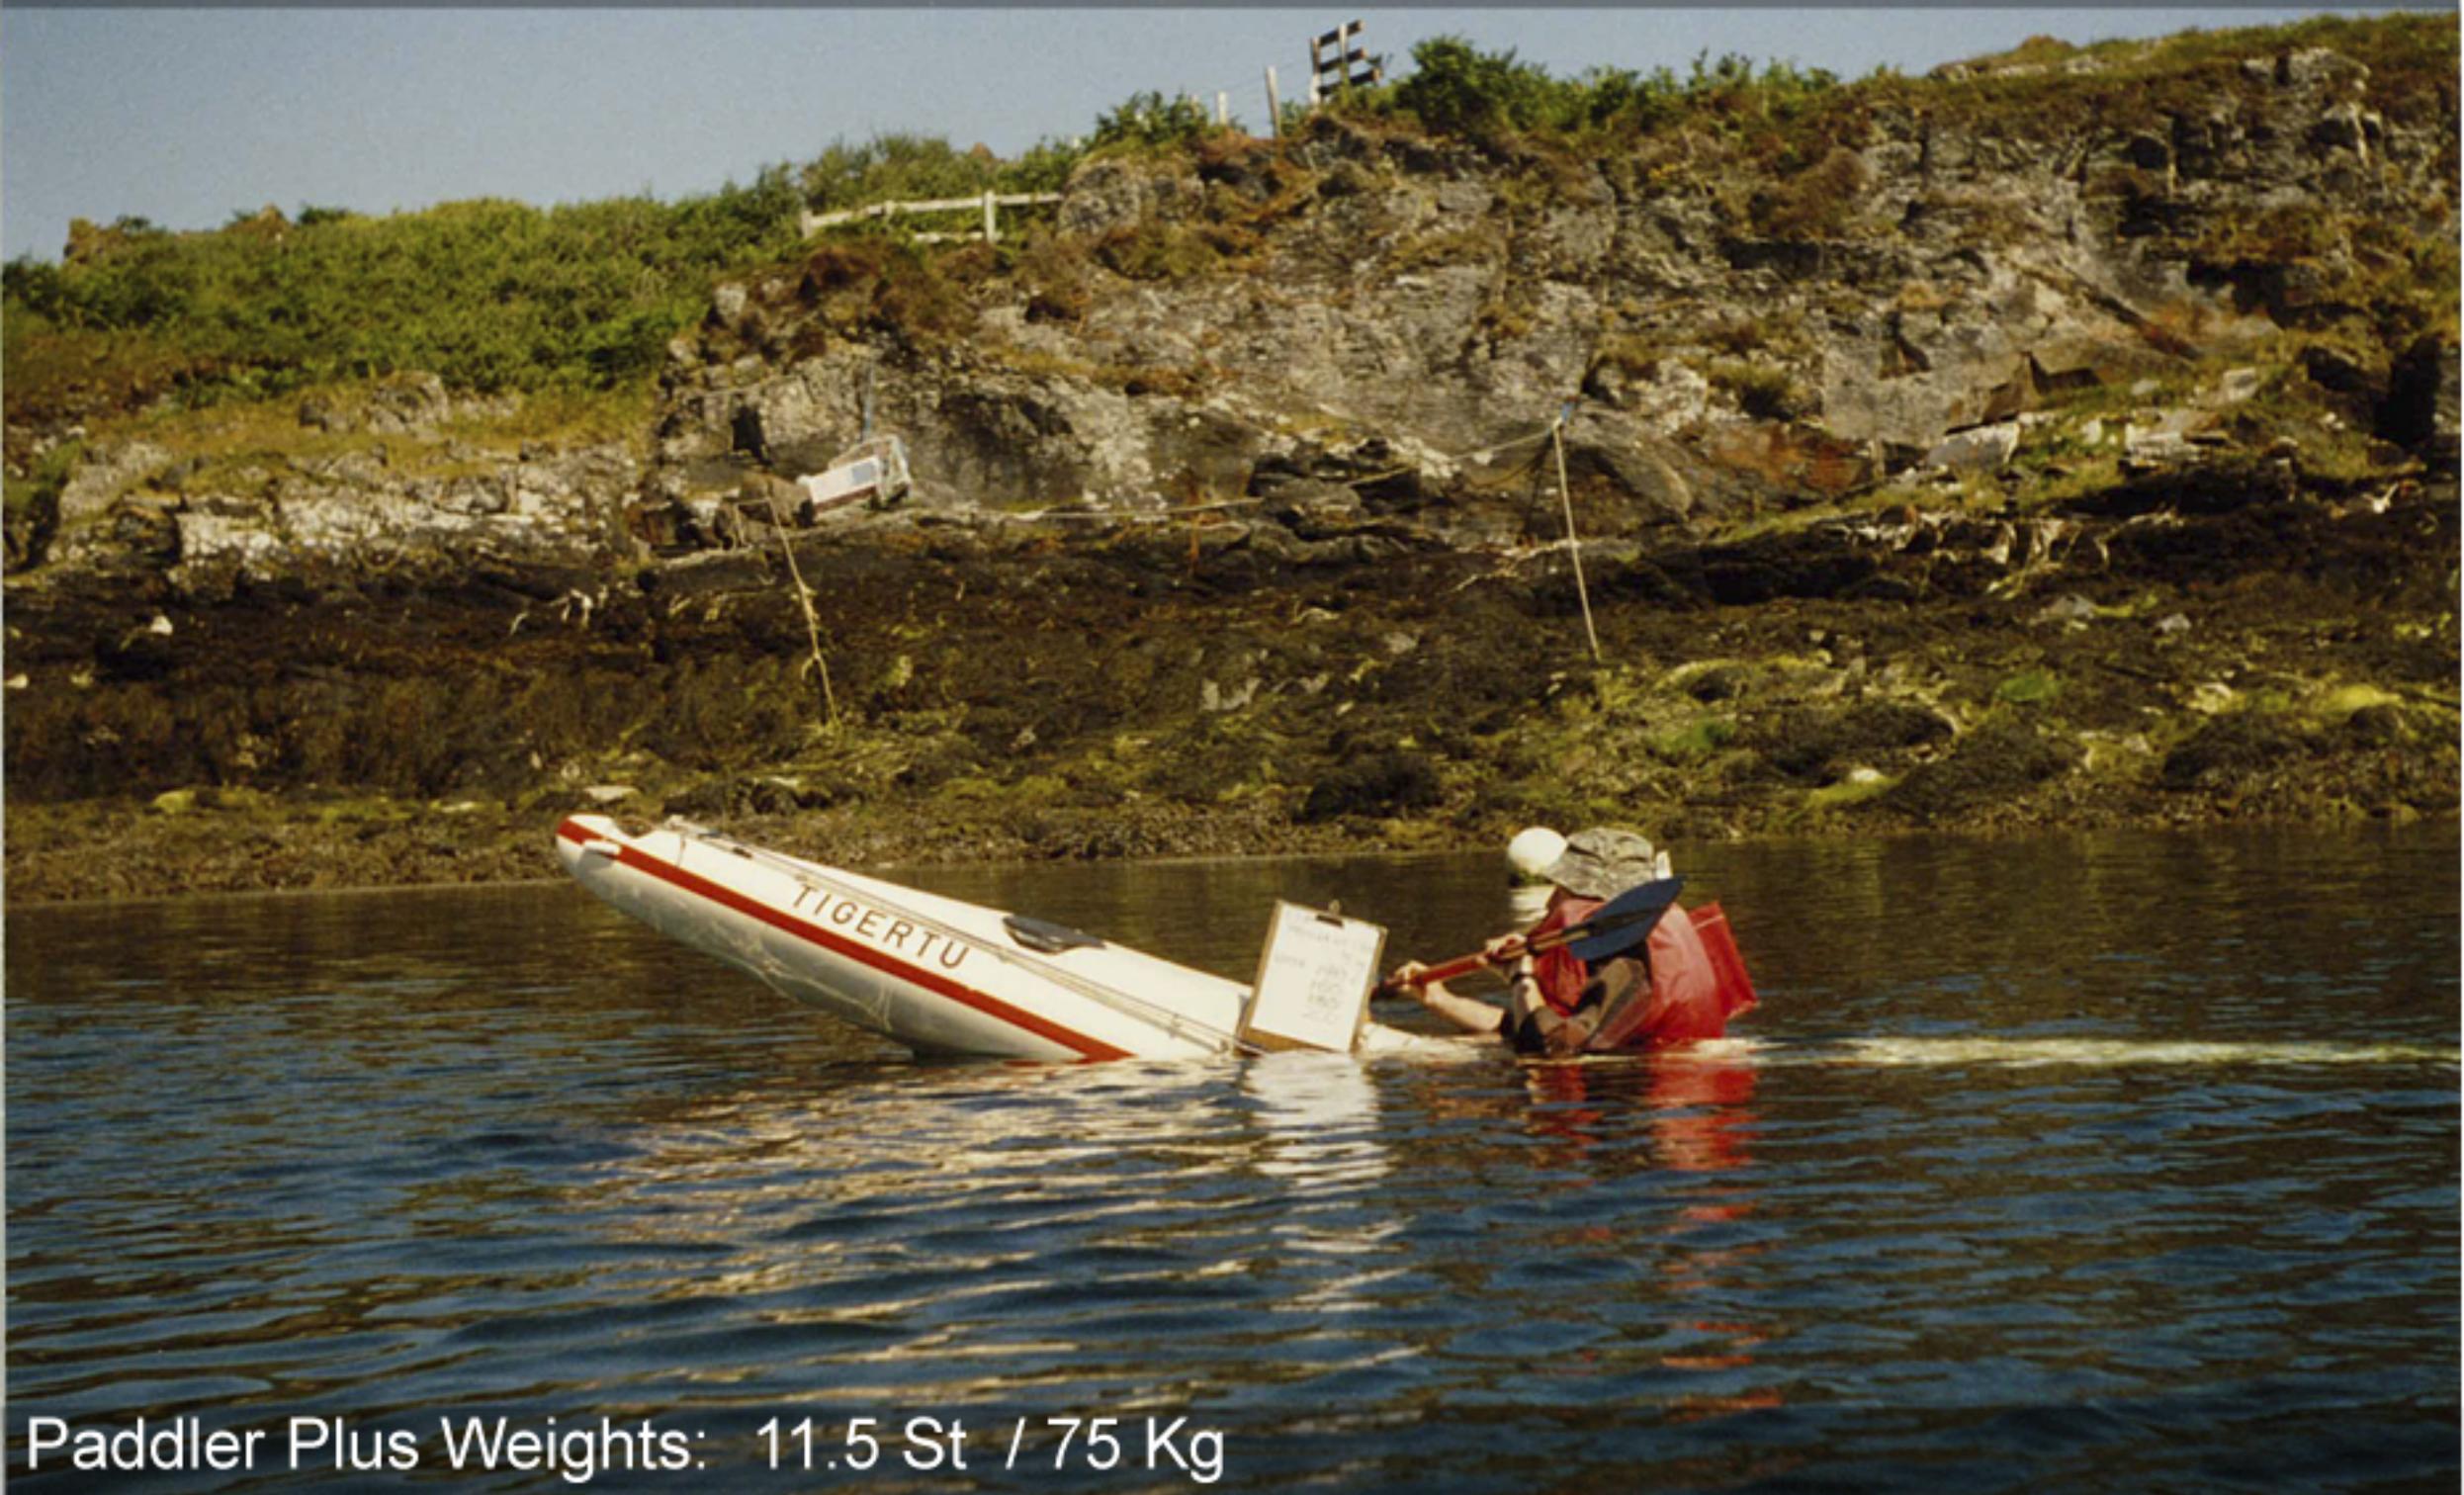
Paddler Plus Weights: 11.5 St / 75 Kg
Water in Hull: >200 litres

The first is that the Sea Tiger shown in photograph 11 subsequently resumed a level attitude once vacated by the paddler due to the fixed buoyancy blocks in the bow and stern. From this condition it was recovered (emptied of almost all hull water) by the 'Hatches Off' recovery method.

When the stern compartment of the Nordkapp was flooded, the cockpit was very close to sea level. This occurred with 75 and 88 litres in the rear compartment. The Sea Tiger reached a similar situation when 200 litres were present in the hull. During the test, the Sea Tiger cockpit flooded at this stage, and the kayak settled at about 250 degrees from the horizontal, with the paddler still sitting in the cockpit (P 11). NO comparable photograph was obtained for the Nordkapp i.e. with cockpit, plus one or other compartment, flooded. P 11 is therefore NOT equivalent to P 30.

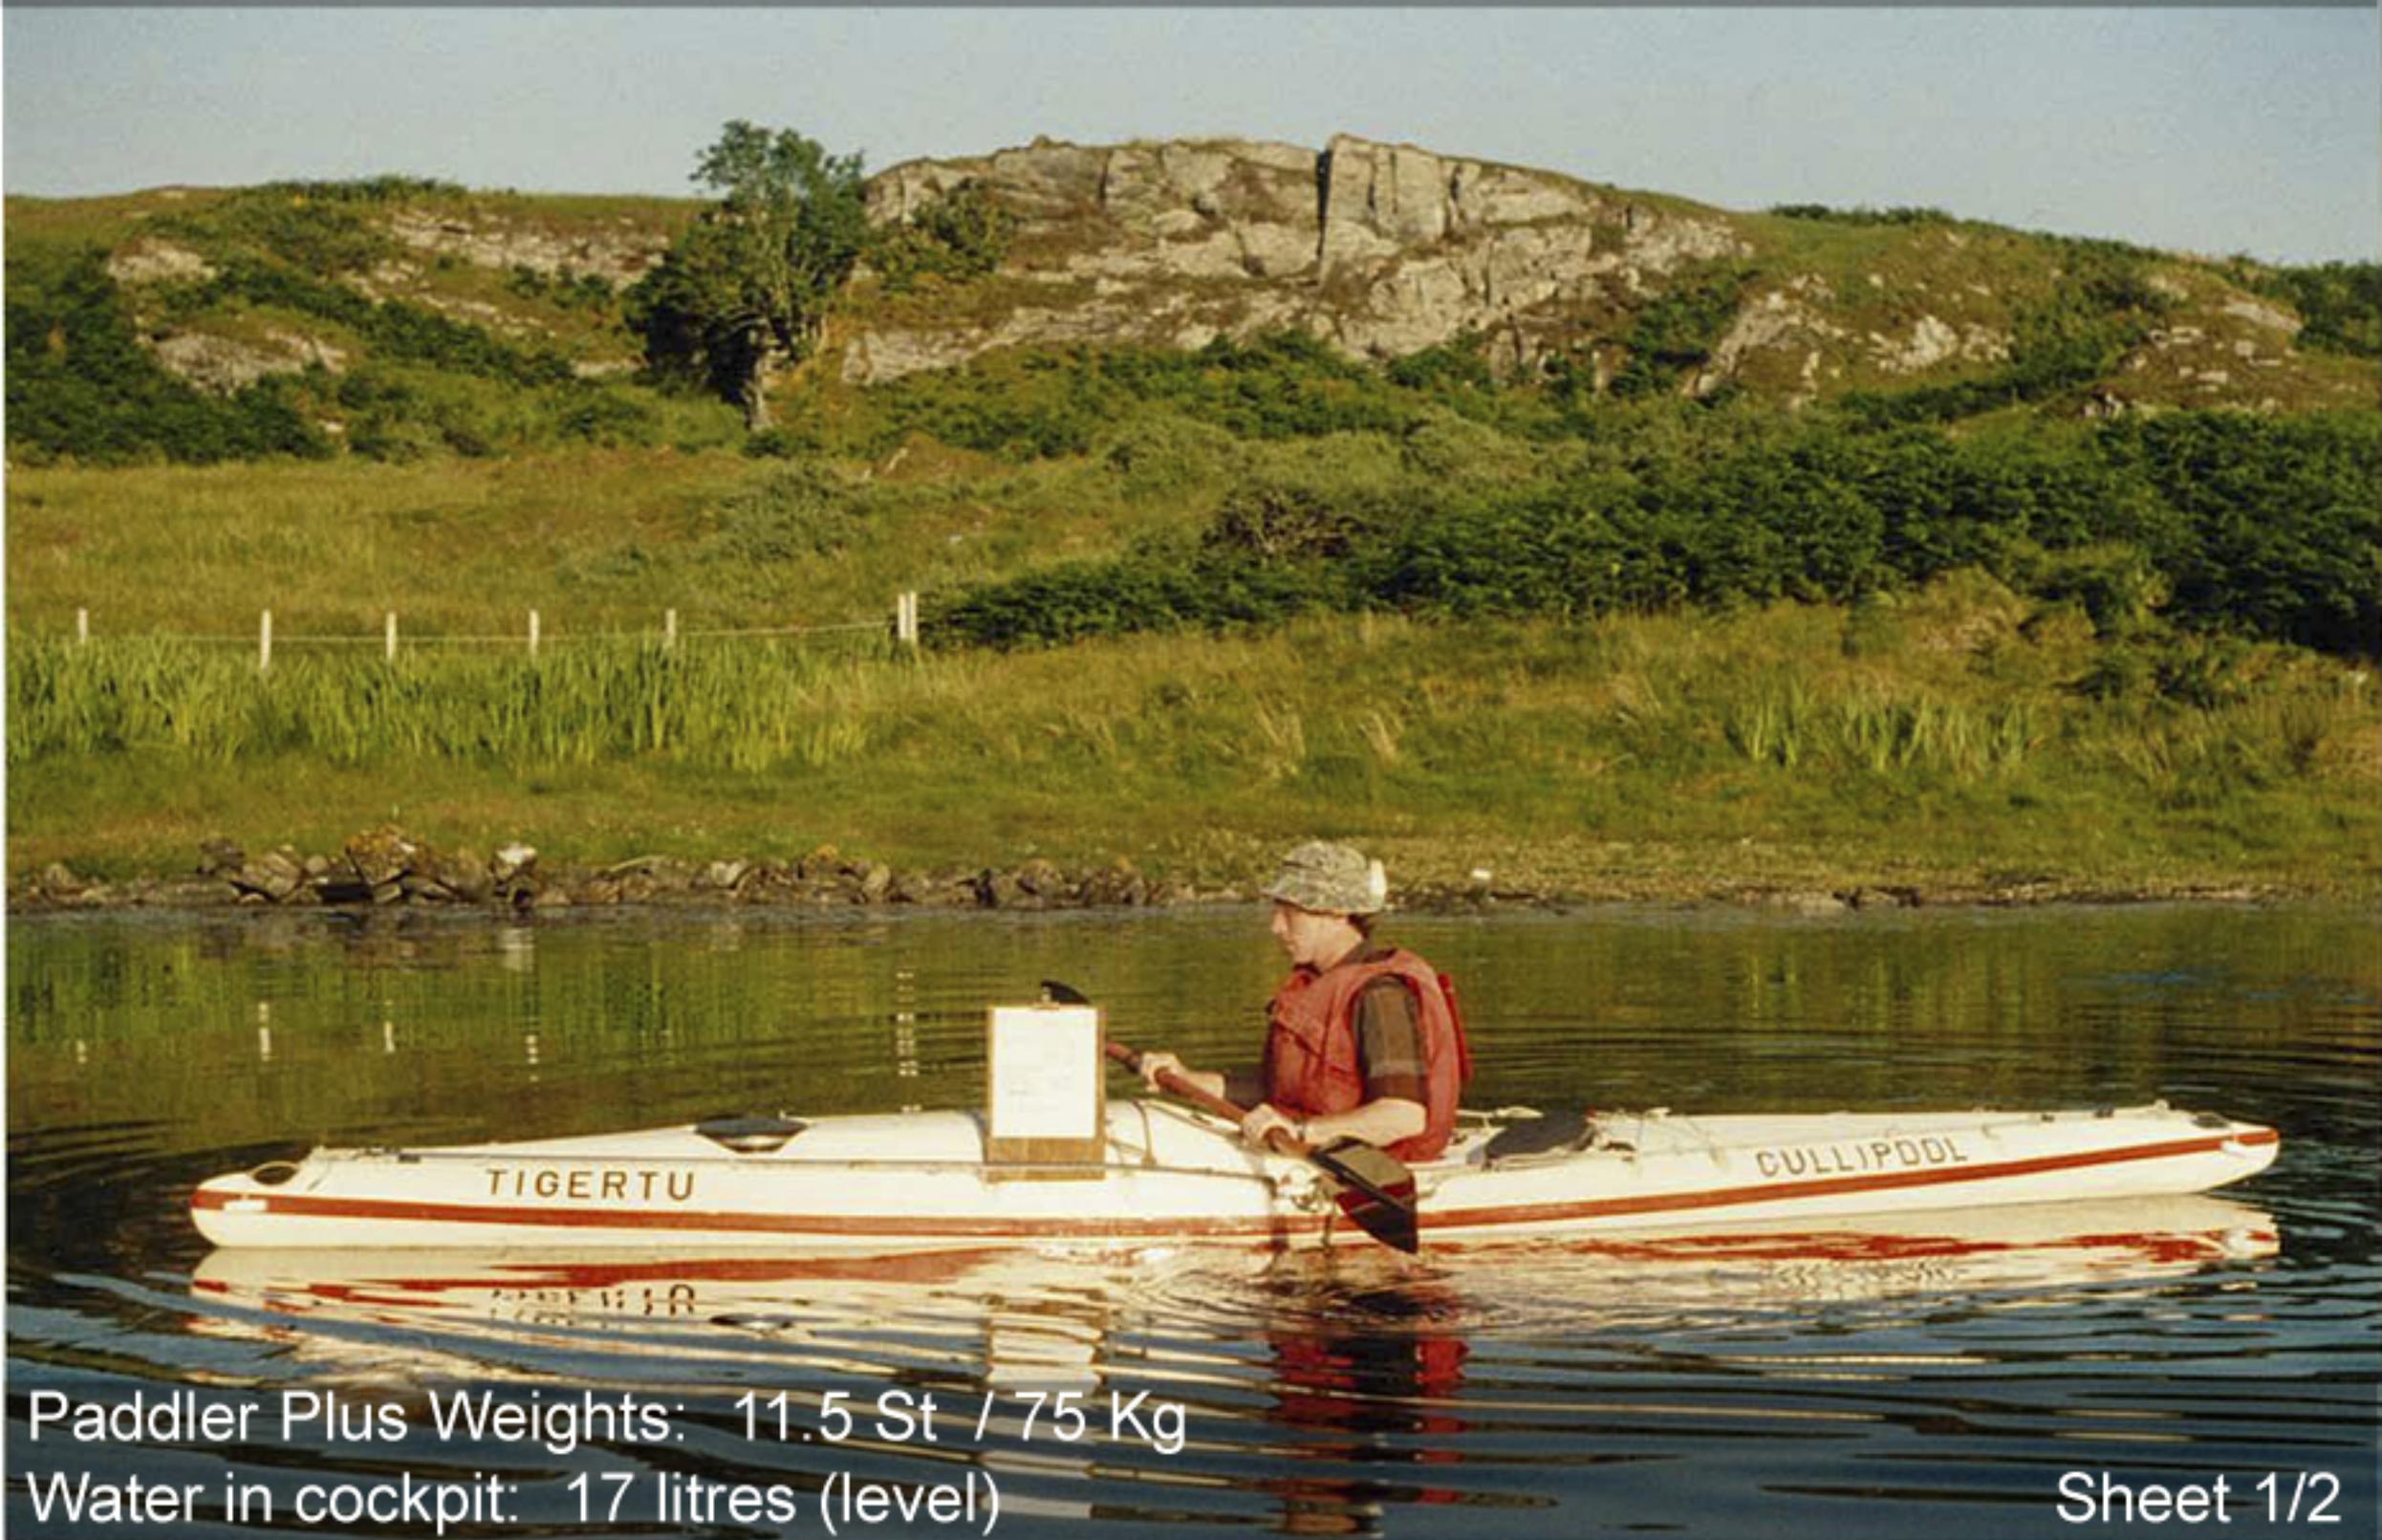
Sheet 1/2

Paddler Plus Weights: 11.5 St / 75 Kg
Water in cockpit: 17 litres (level)

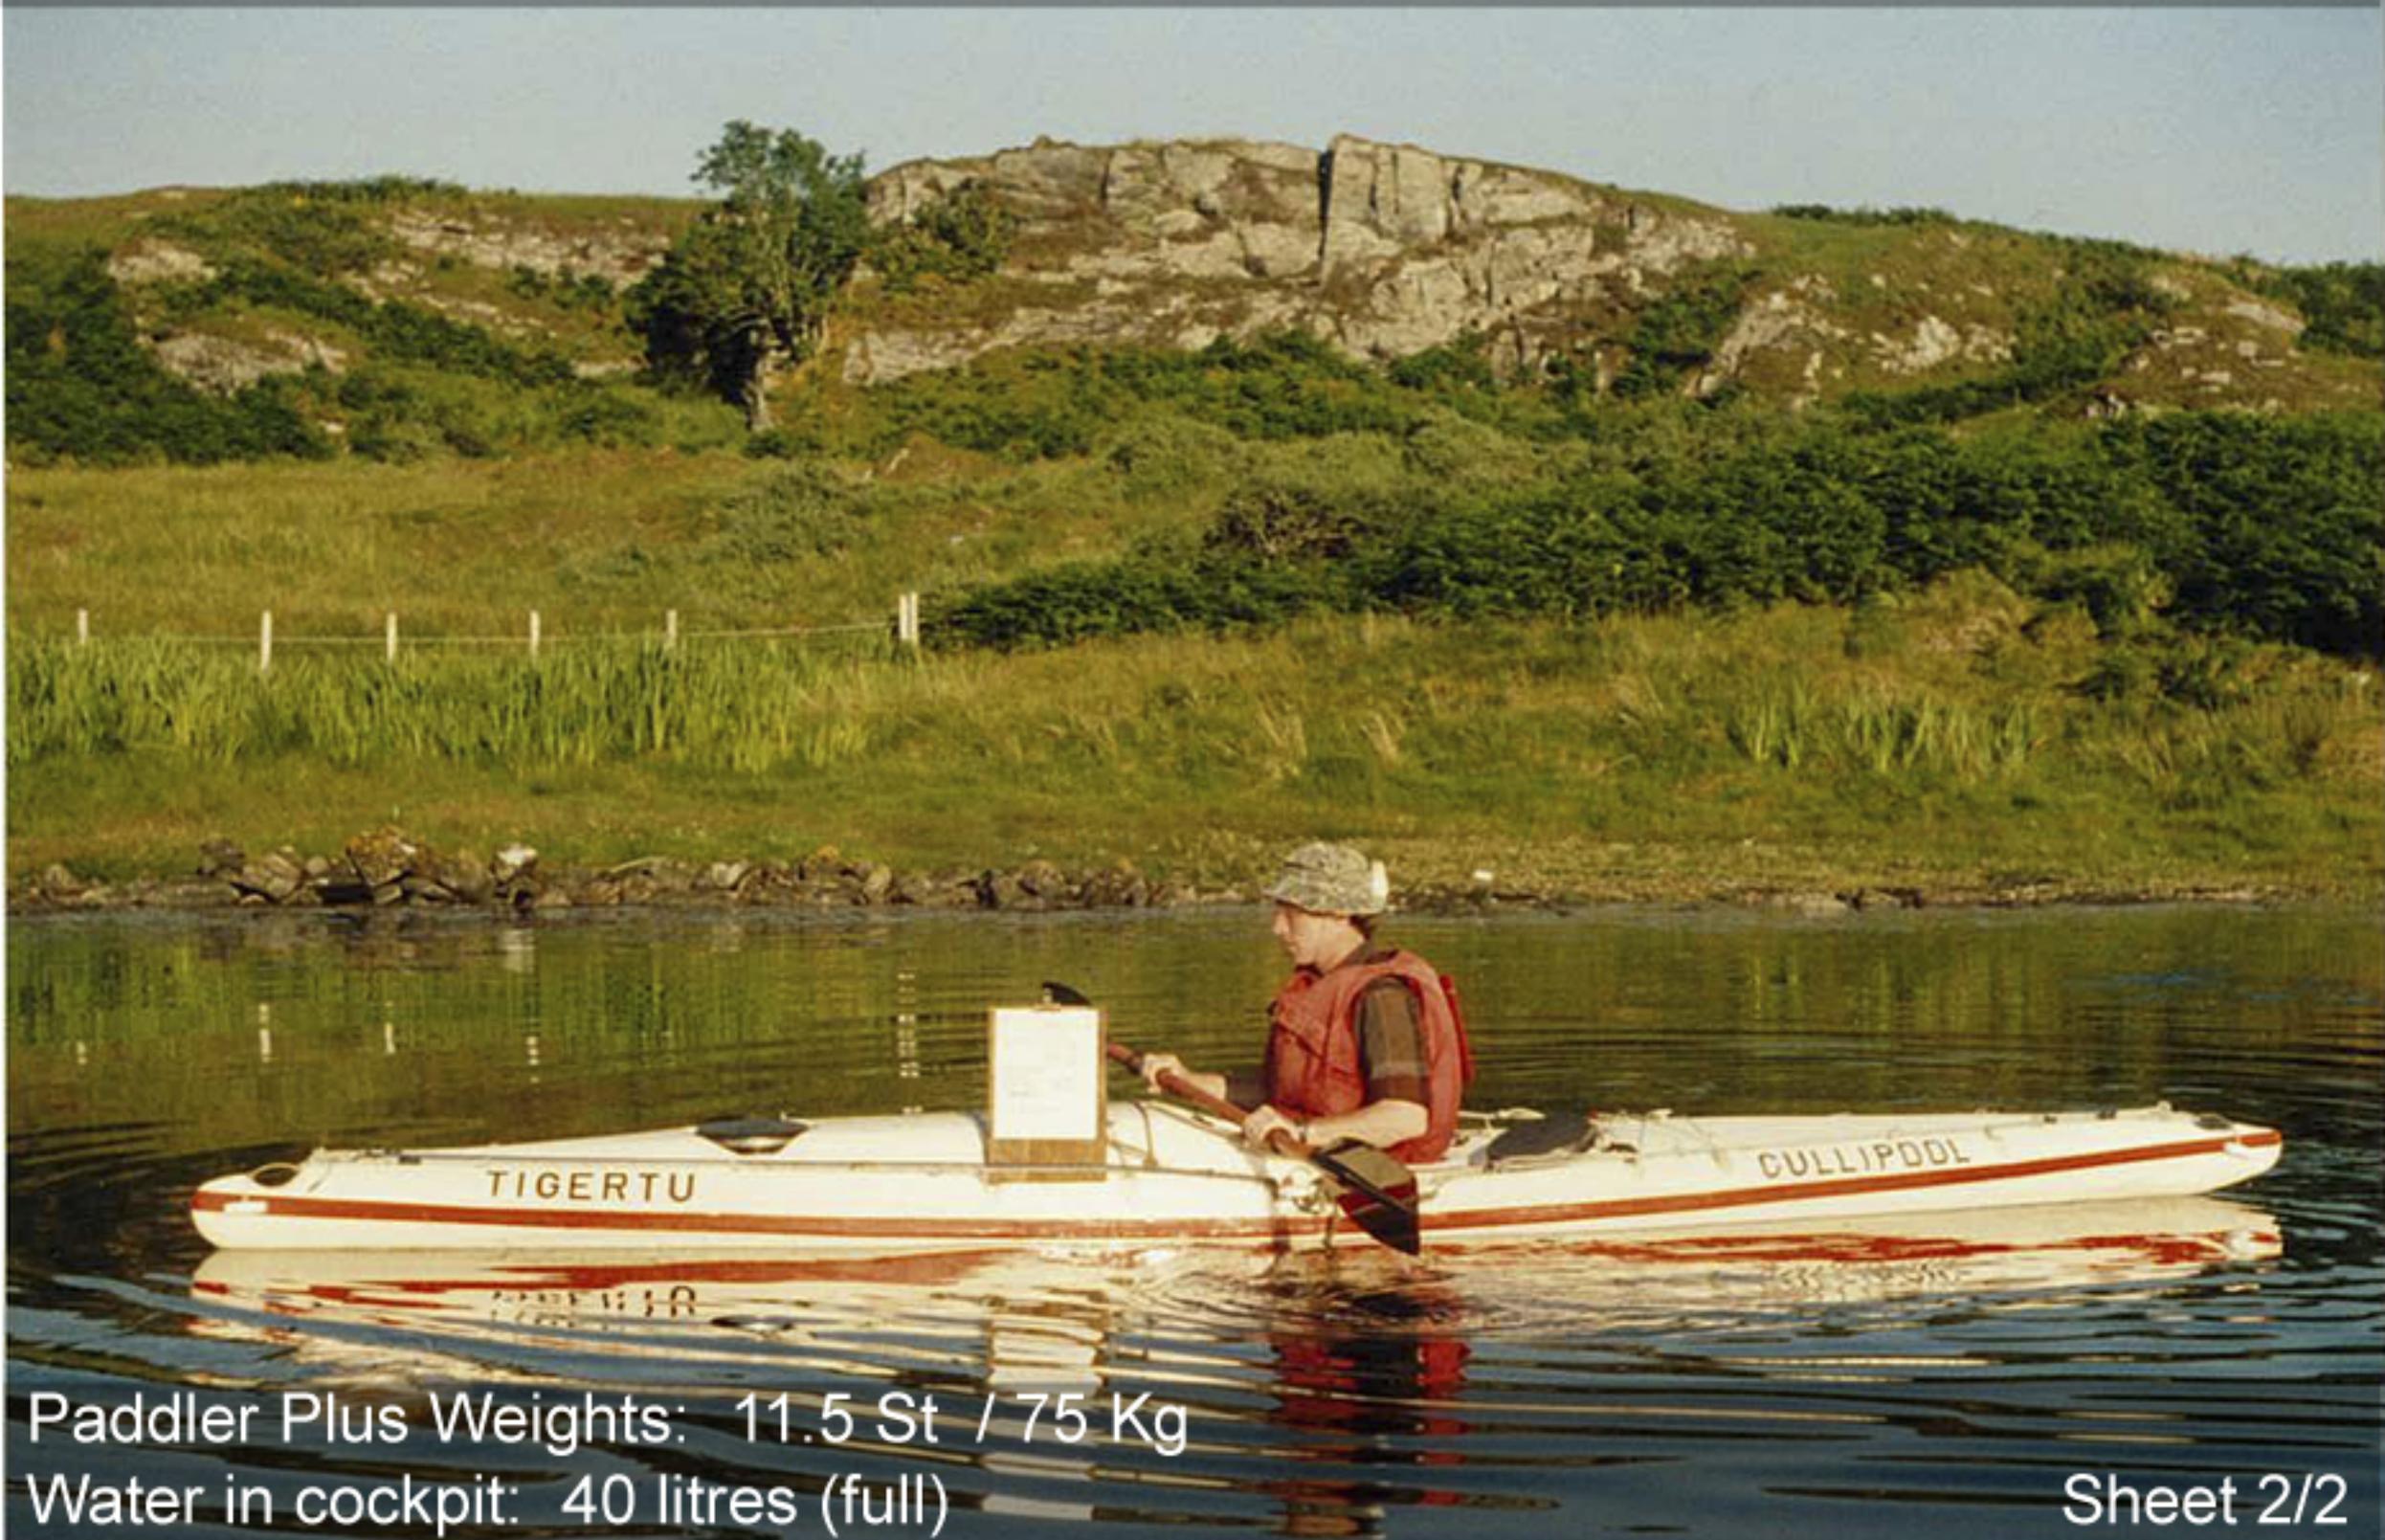
Paddler Plus Weights: 11.5 St / 75 Kg
Water in cockpit: 40 litres (full)

It is my experience with a Safety Cockpit that lateral stability is not noticeably affected when a loaded kayak is paddled in waves with the cockpit filled with sea - water (Ref. 4). The flooding experiment showed that the Safety Cockpit of the Sea Tiger contained one third the volume of water of the Nordkapp cockpit (40 litres and 120 litres respectively).
