EXPERIMENTAL PROGRESSIVE FLOODING OF TWO SEA KAYAKS

1. Fore and Aft Bulkheads (Nordkapp)

2. Confluent Hull with Safety Cockpit (Sea Tiger)

2nd September 1989

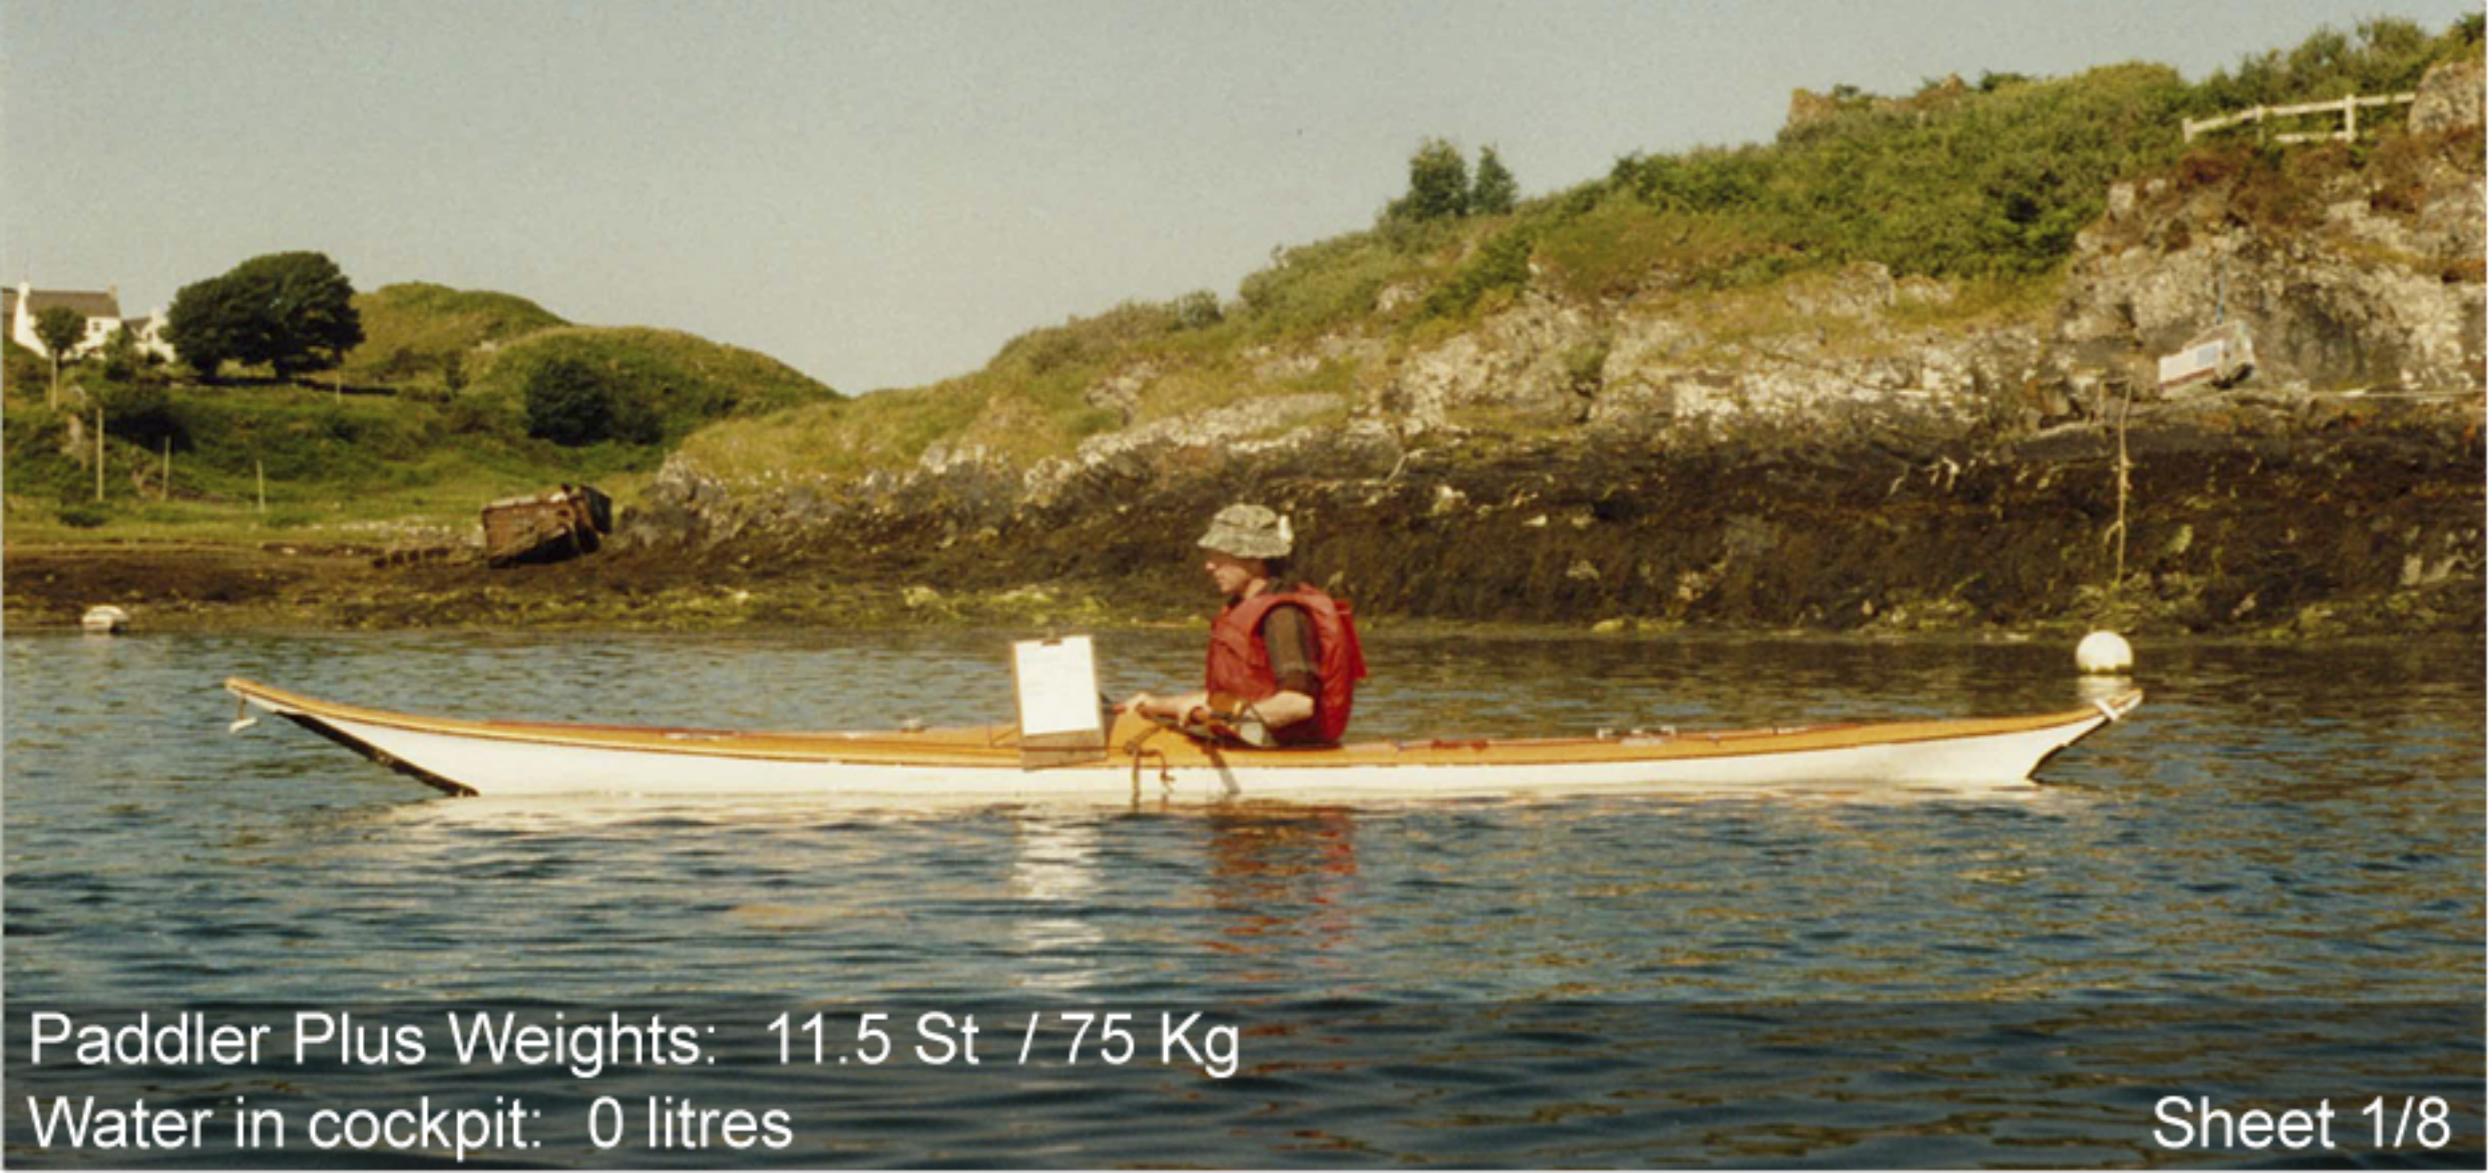
Sheet 1/8

Paddler Plus Weights: 11.5 St / 75 Kg

Water in cockpit: 0 litres

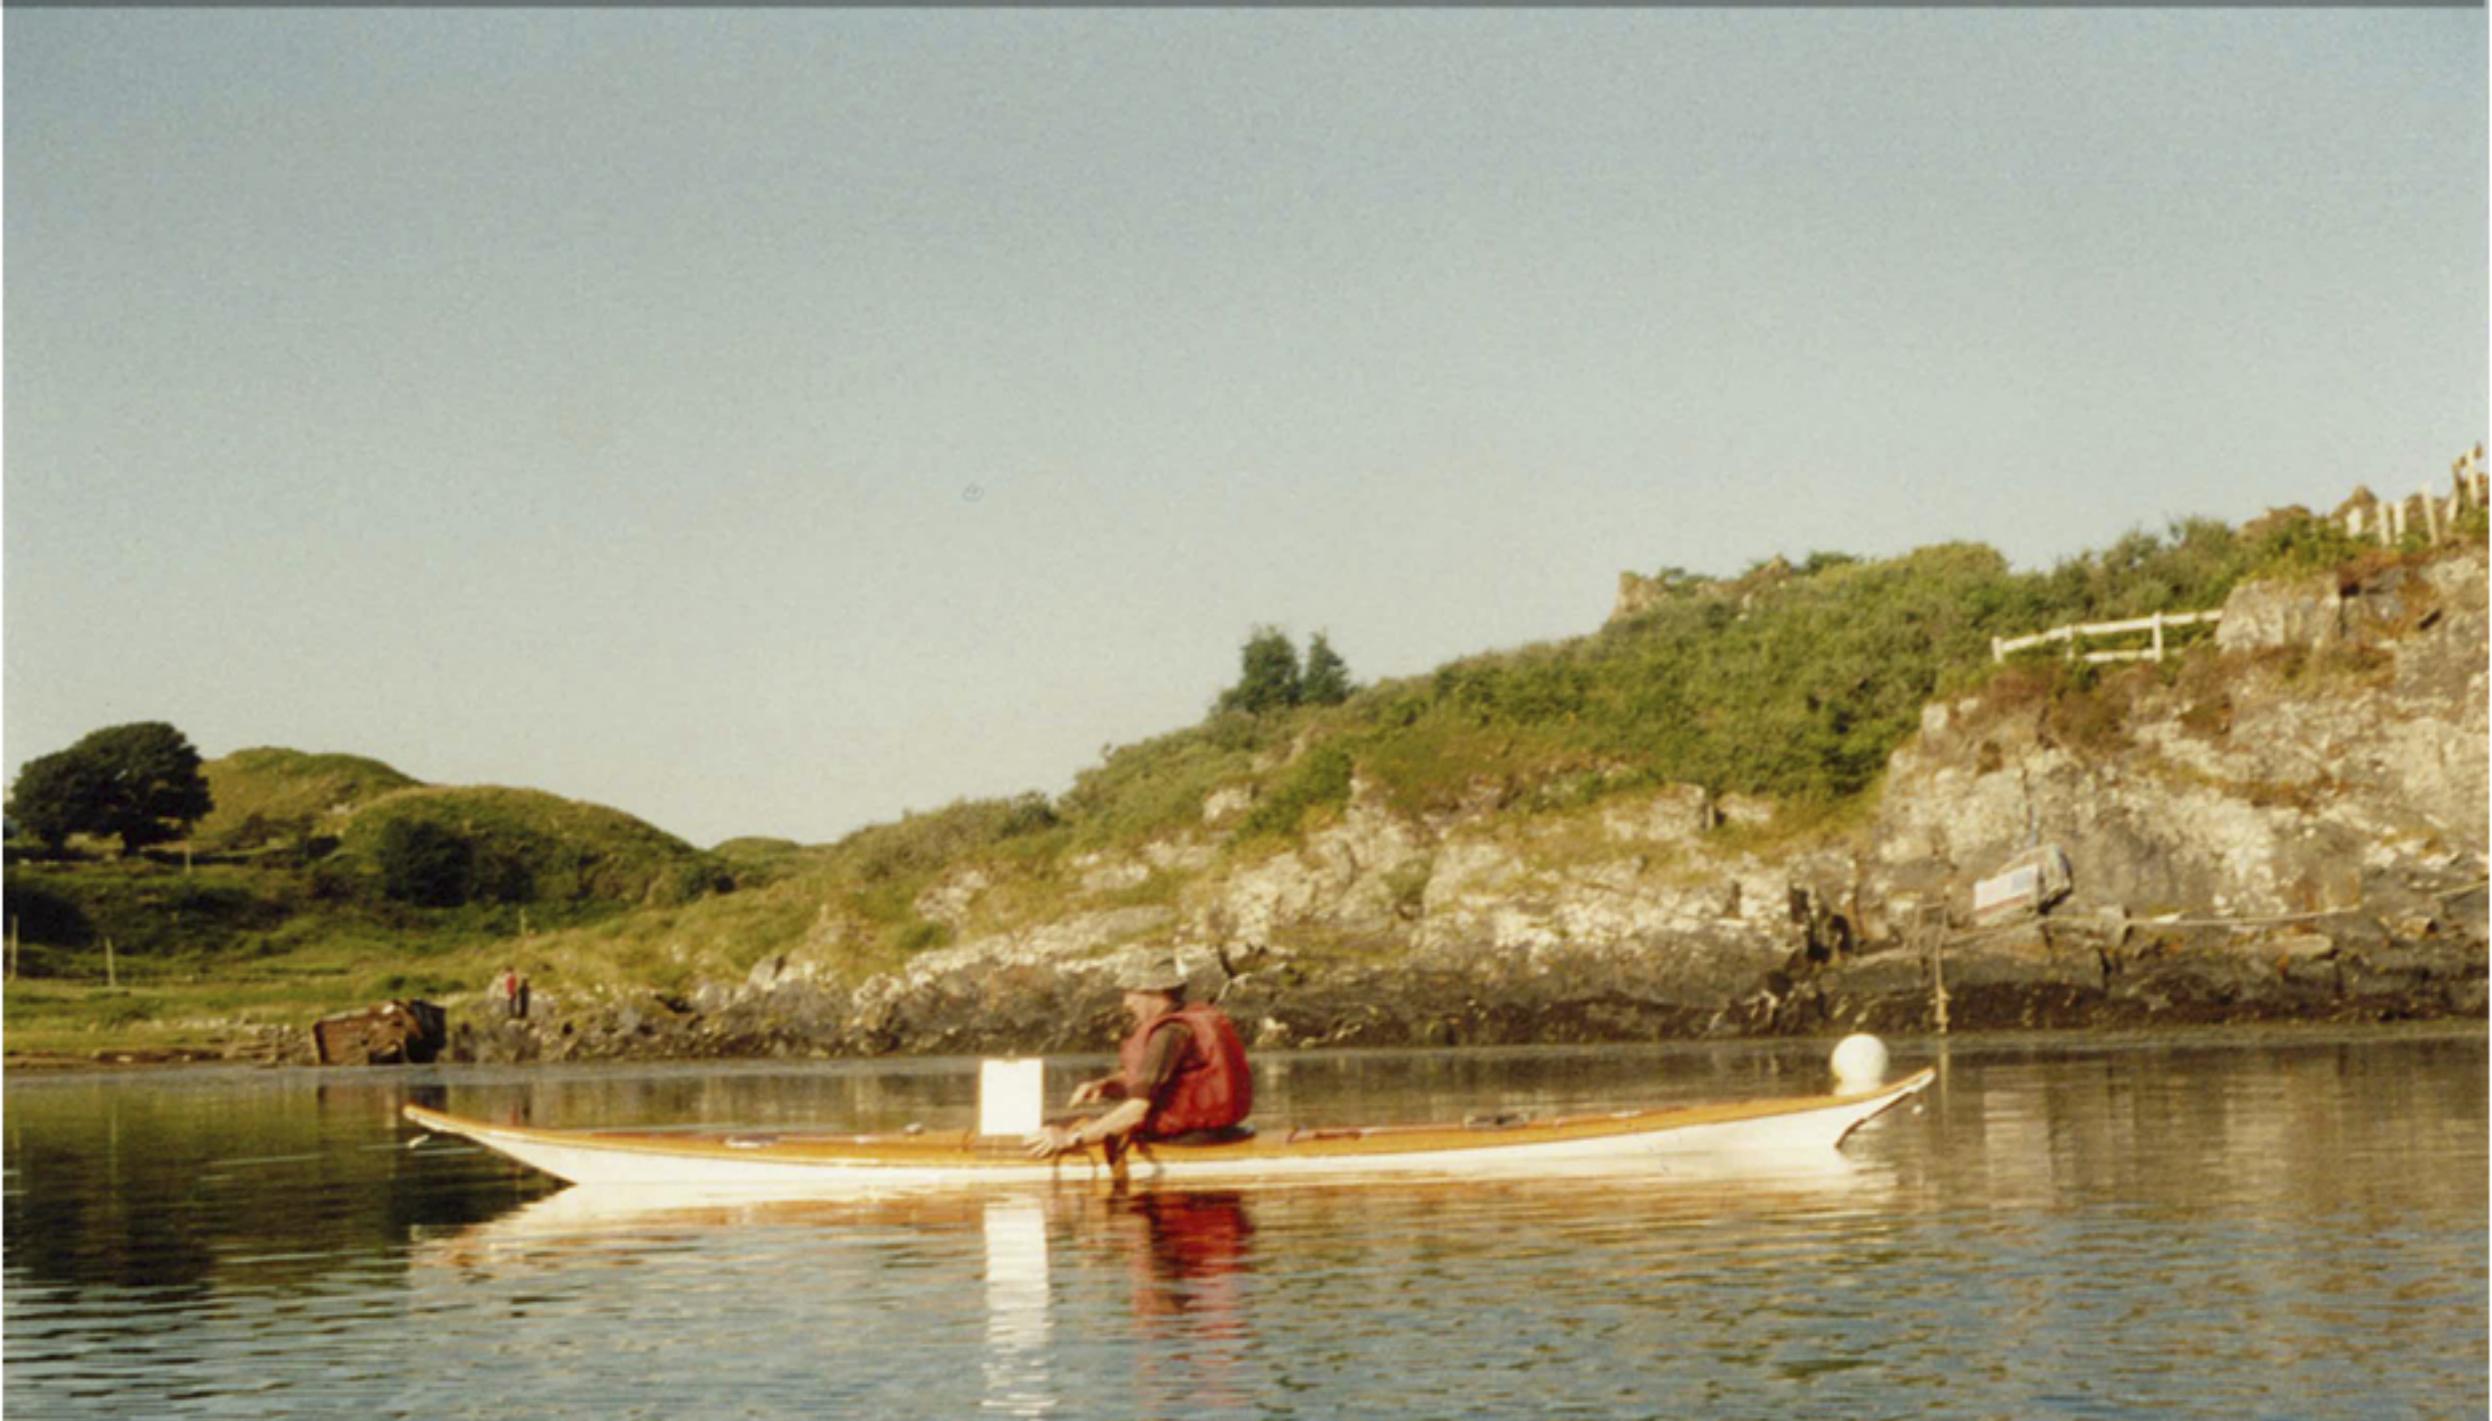
Paddler Plus Weights: 11.5 St / 75 Kg
Water in cockpit: 20 litres

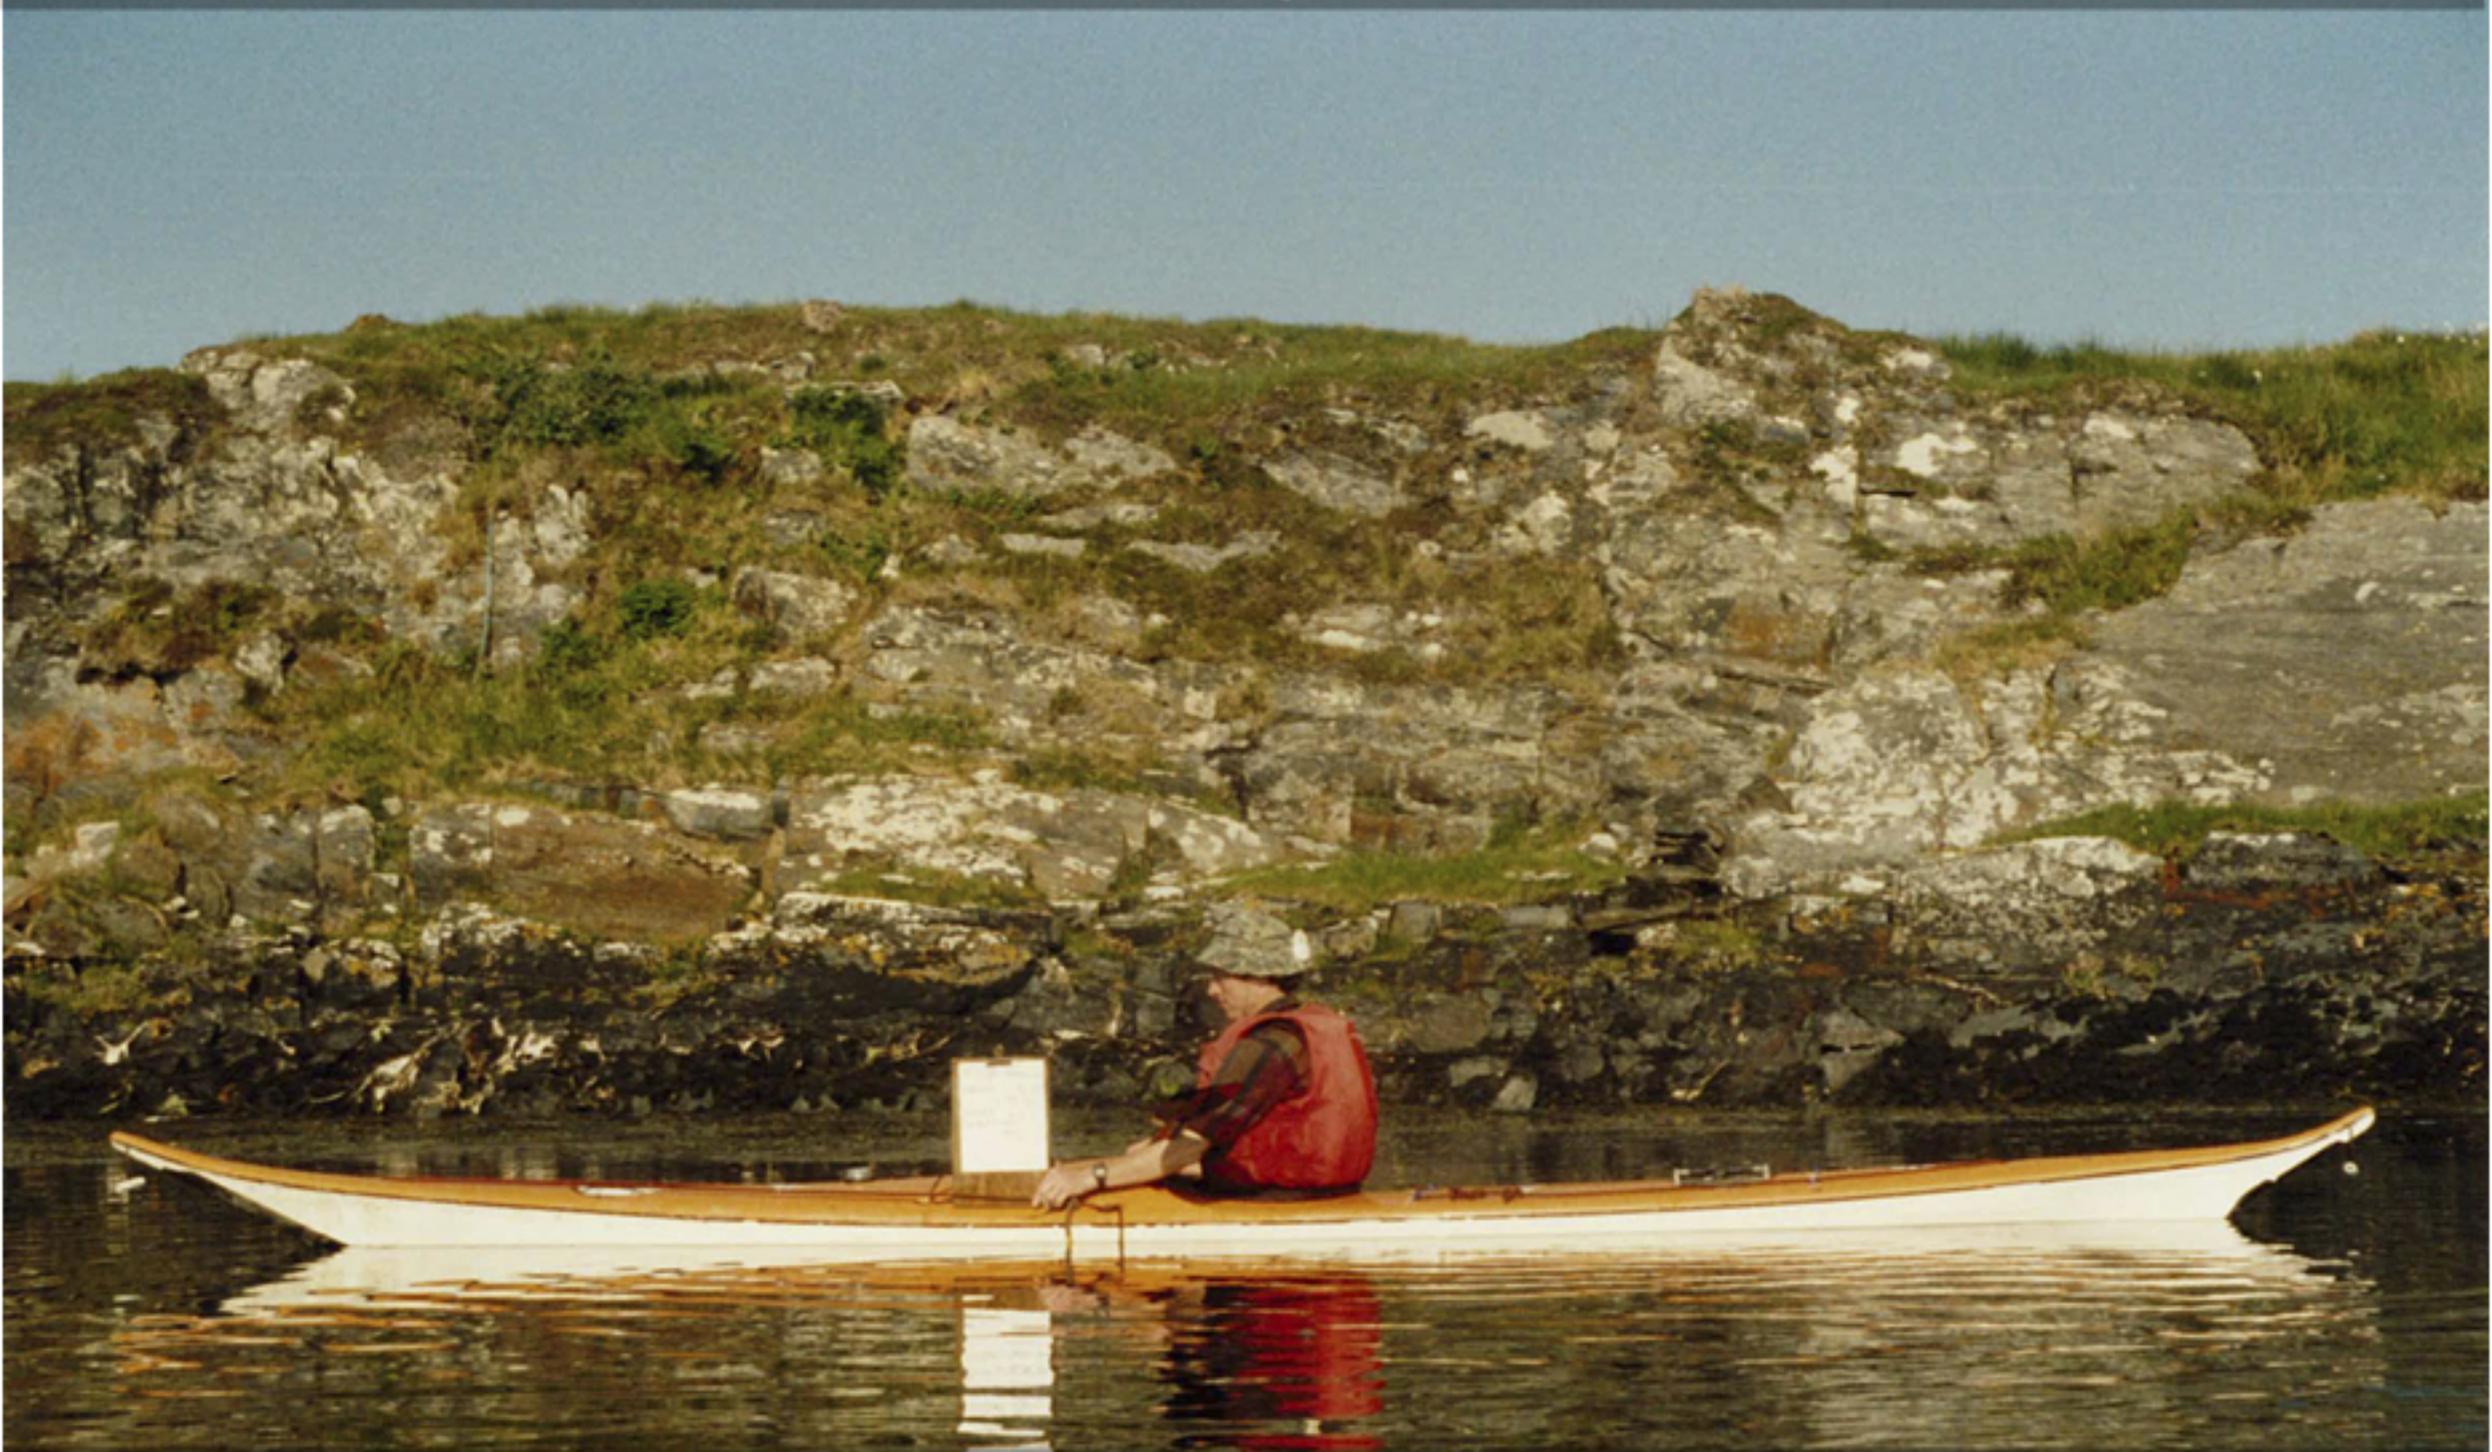
Paddler Plus Weights: 11.5 St / 75 Kg
Water in cockpit: 40 litres

The Sea Tiger maintained an even fore and aft trim until a loading of 160 litres (P9). The Nordkapp became noticeably out of trim with small amounts, 20 litres, of water in either end (P15, P26).

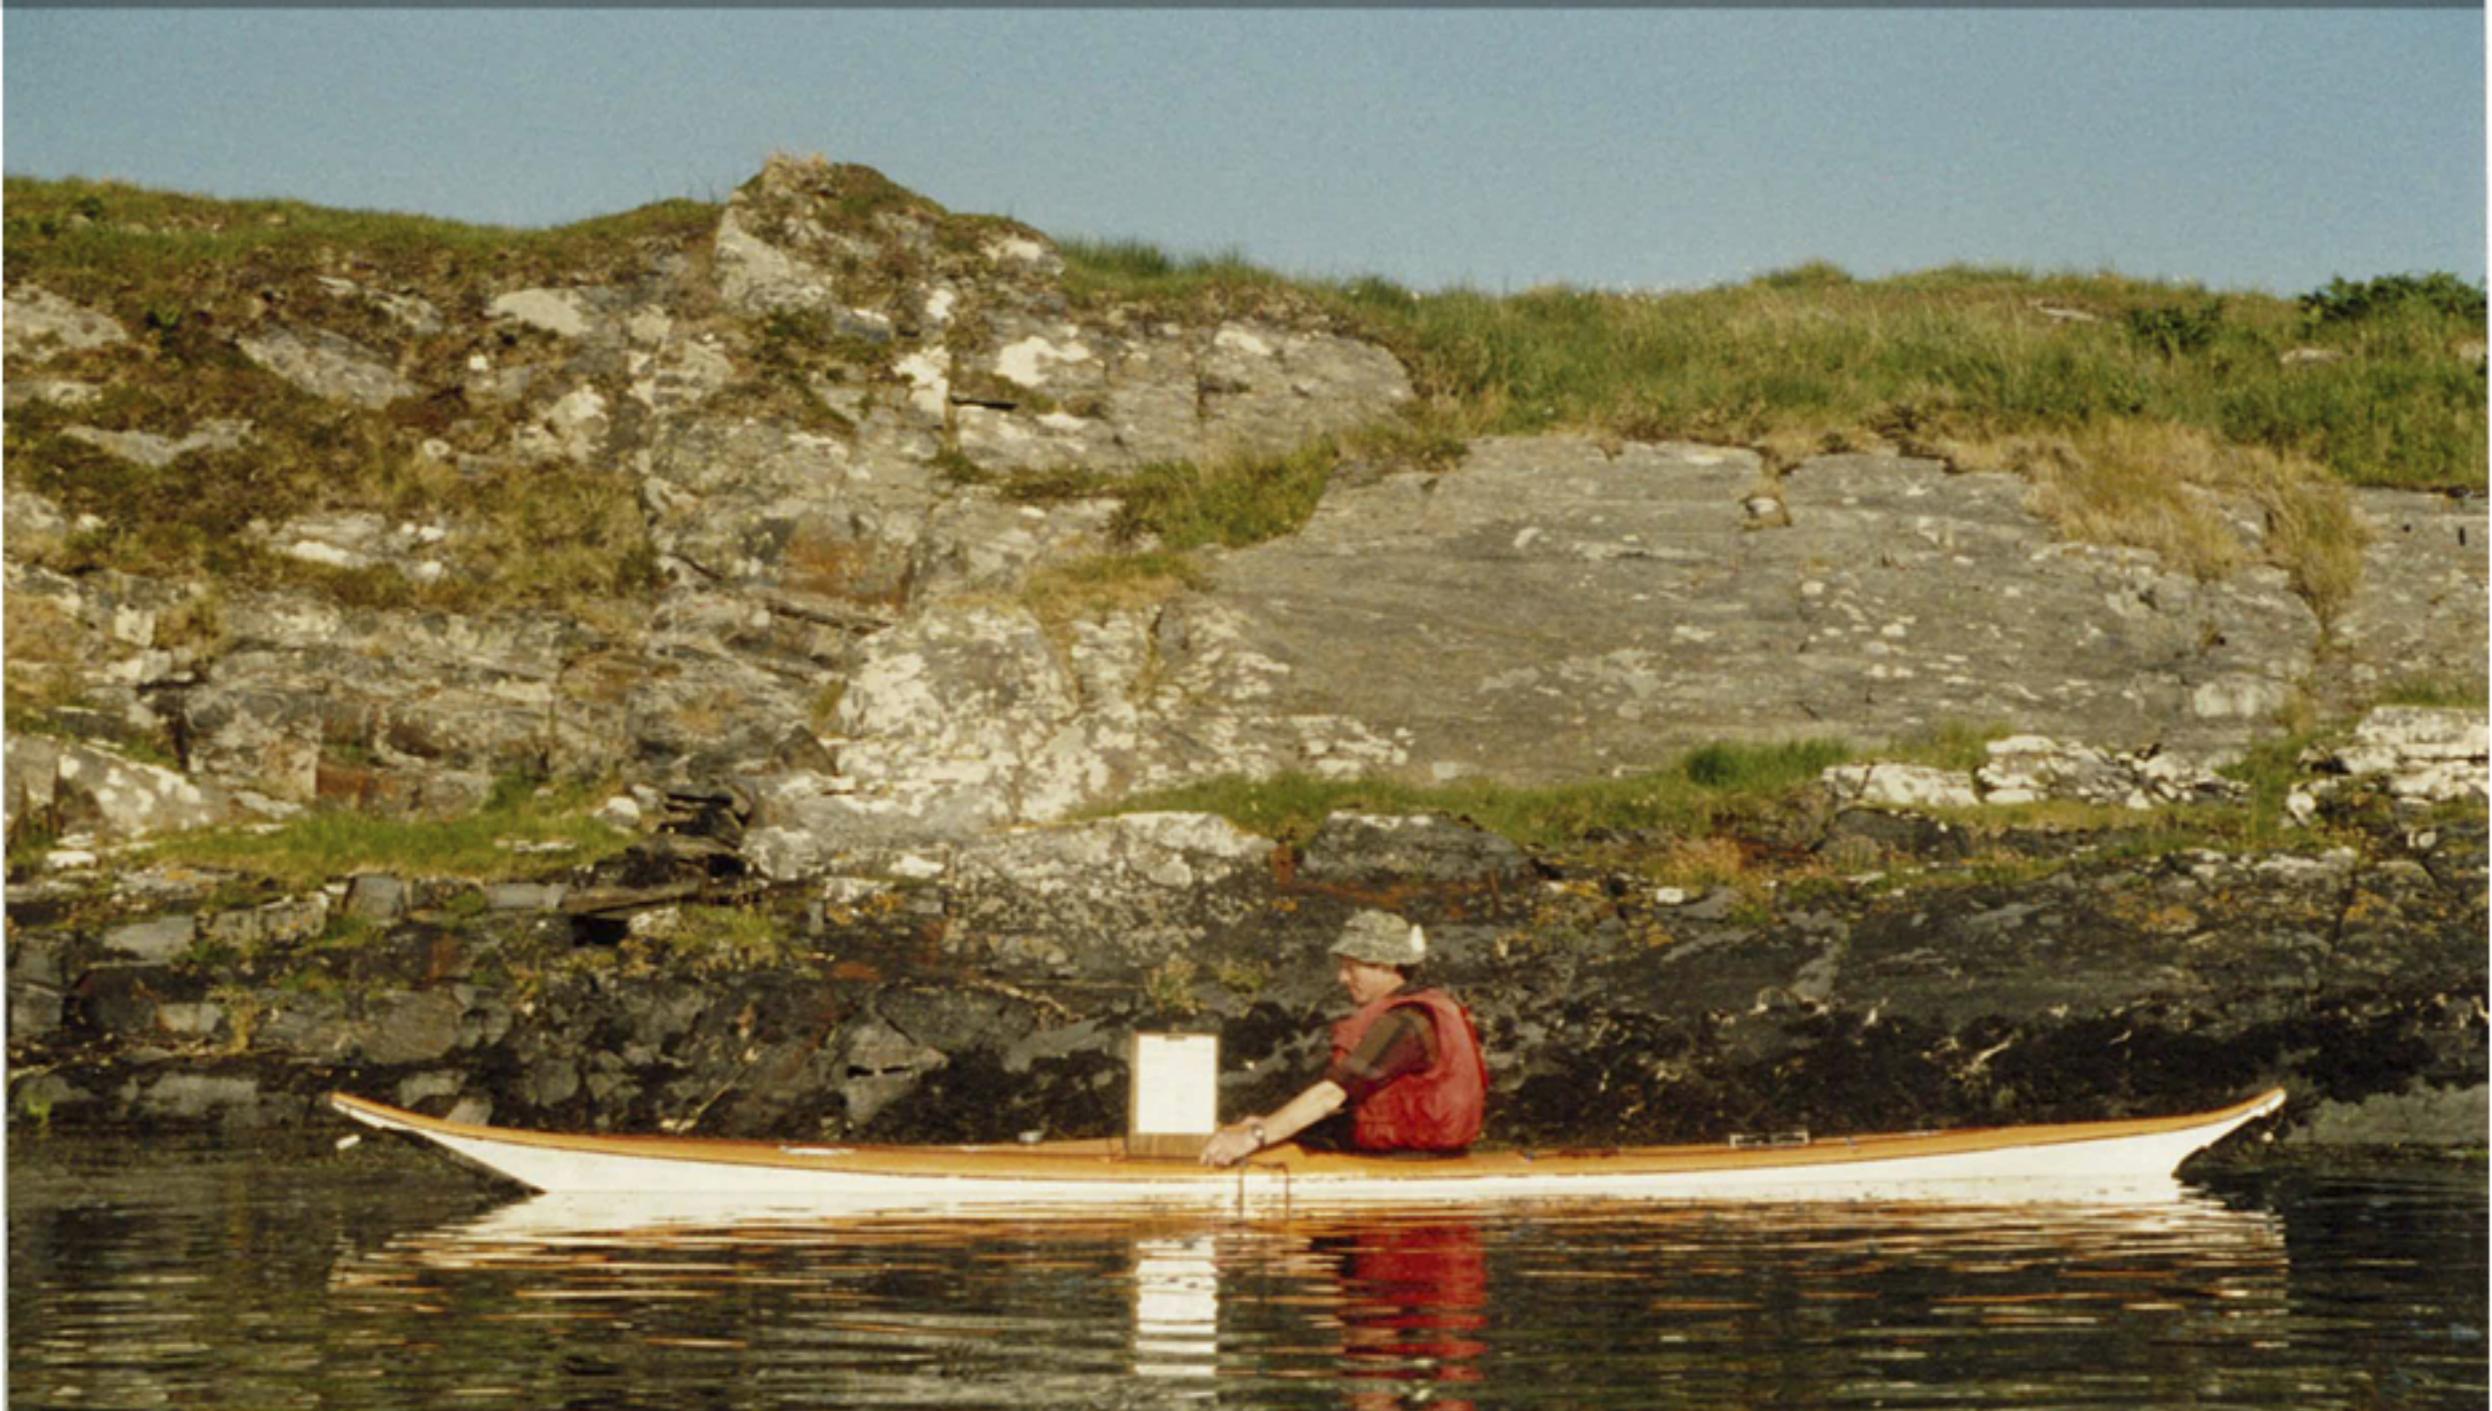
Paddler Plus Weights: 11.5 St / 75 Kg
Water in Hull: 60 litres

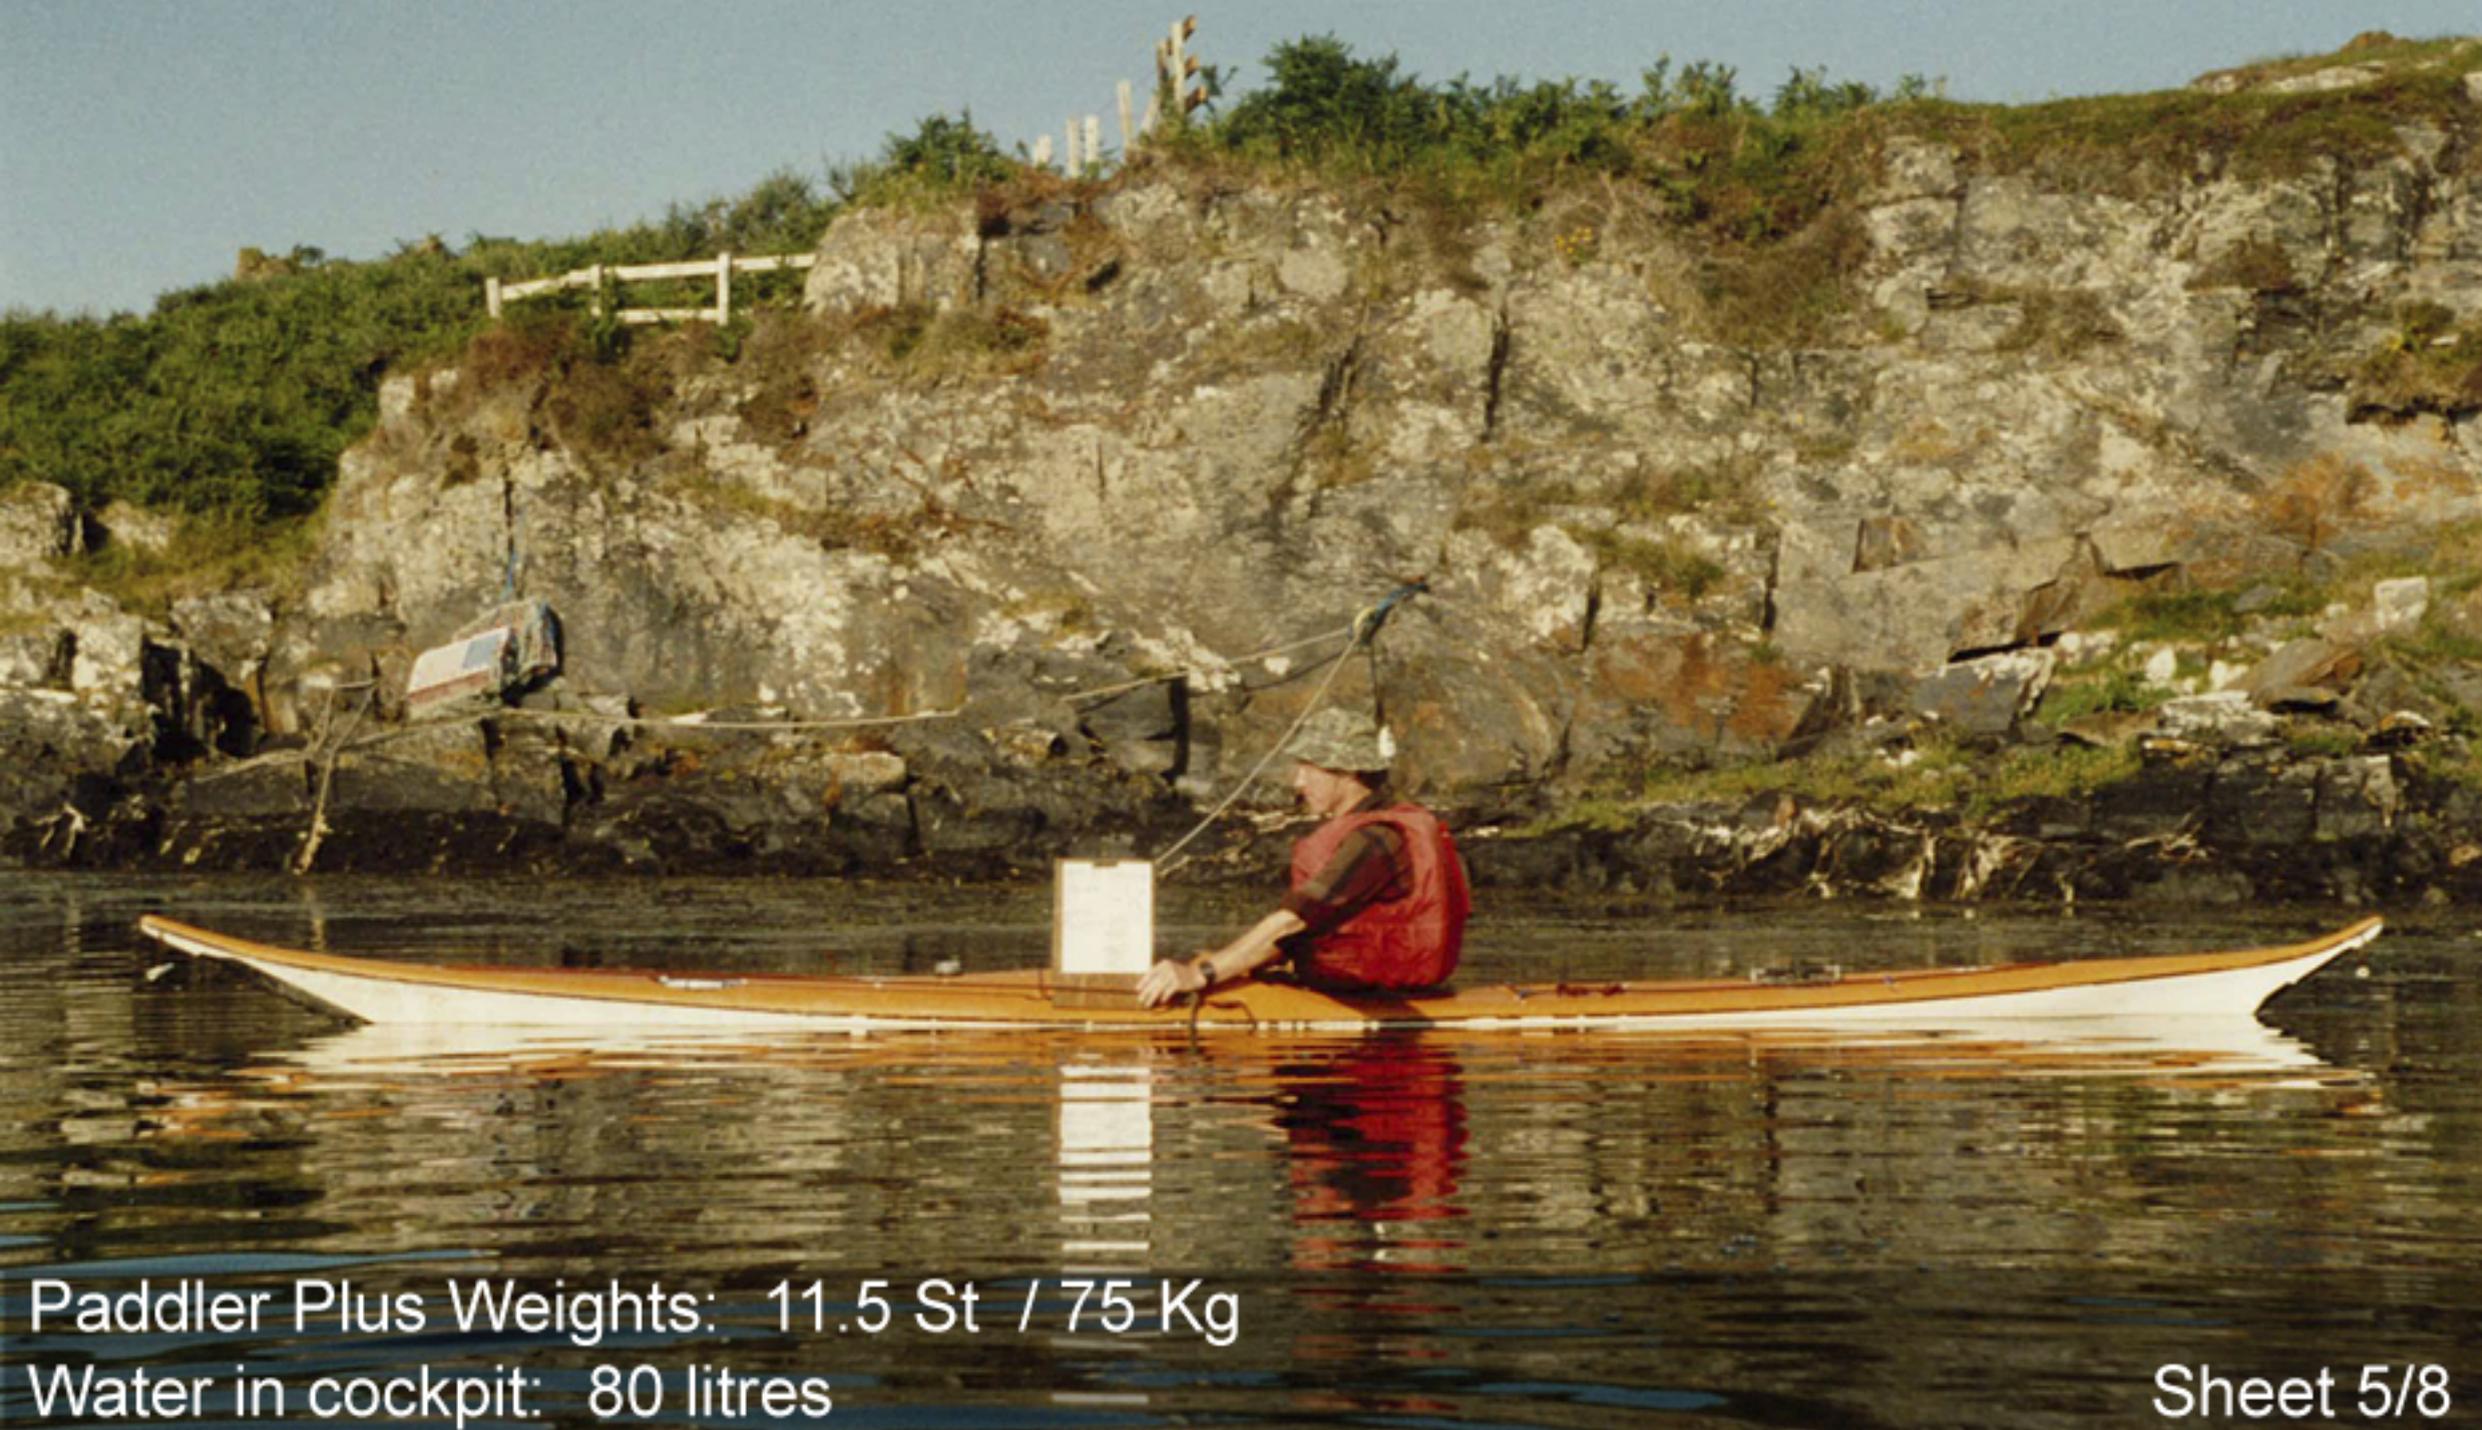
Sheet 5/8

Paddler Plus Weights: 11.5 St / 75 Kg

Water in cockpit: 80 litres

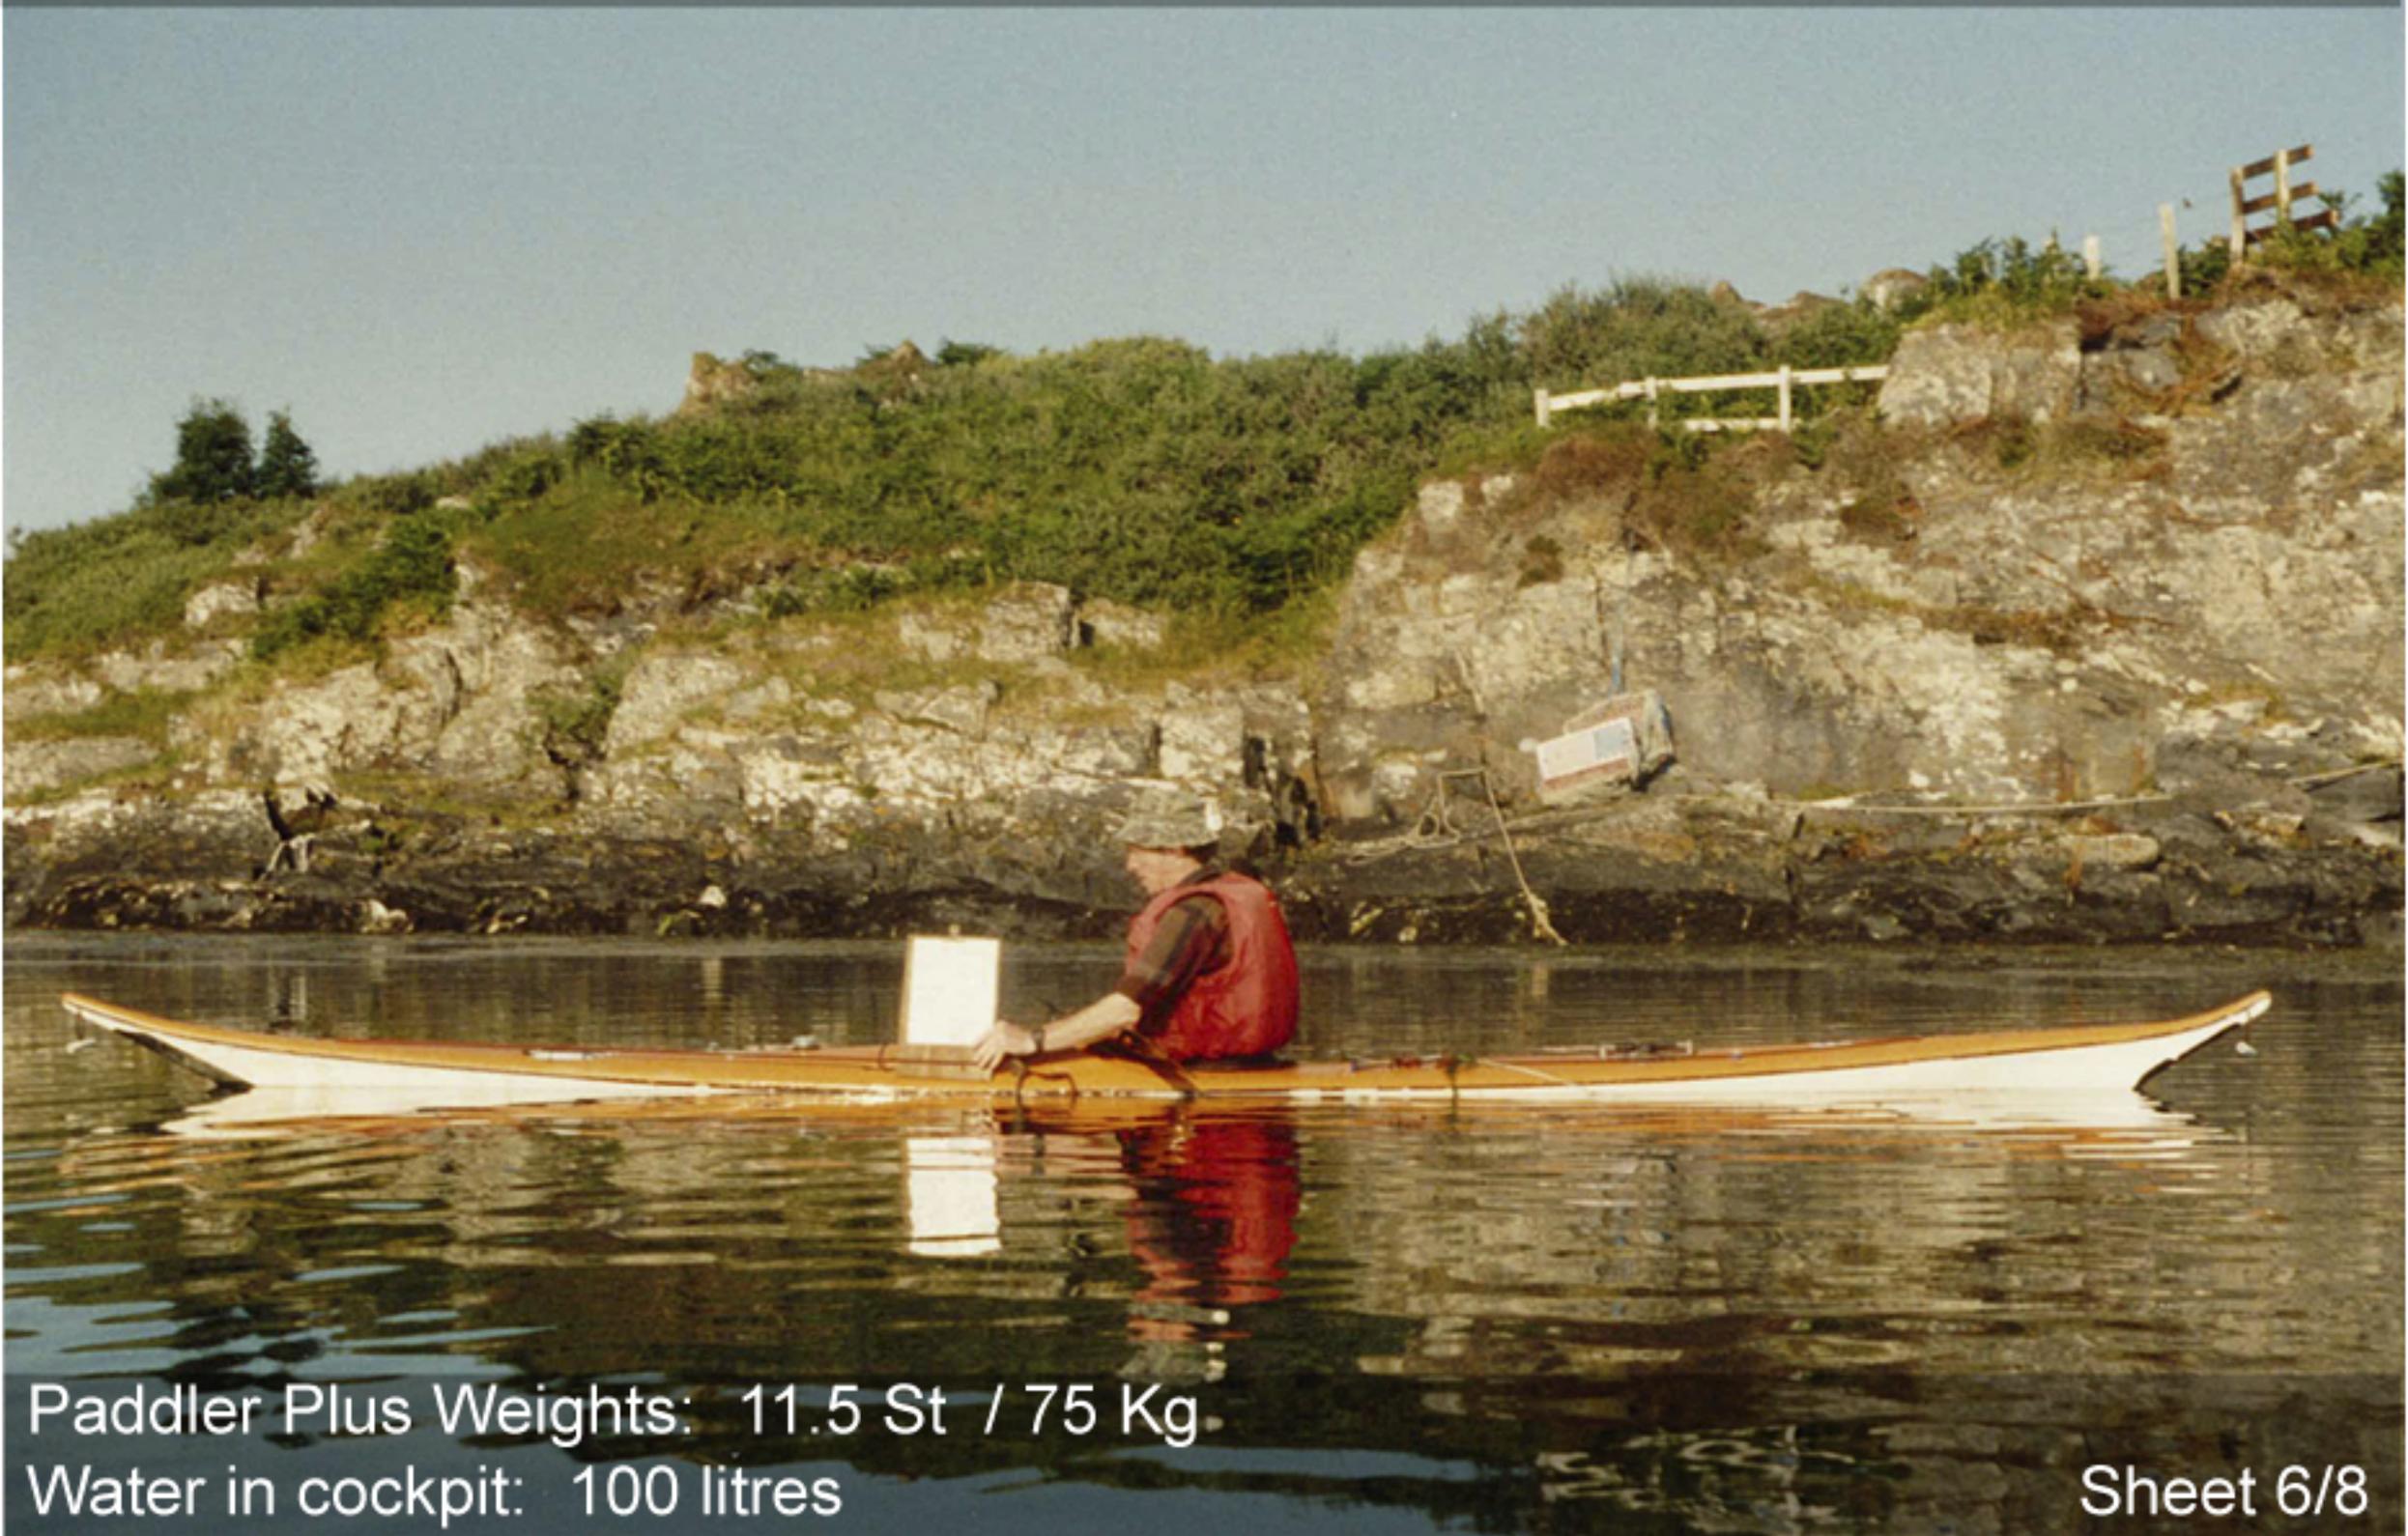
Sheet 6/8

Paddler Plus Weights: 11.5 St / 75 Kg
Water in cockpit: 100 litres

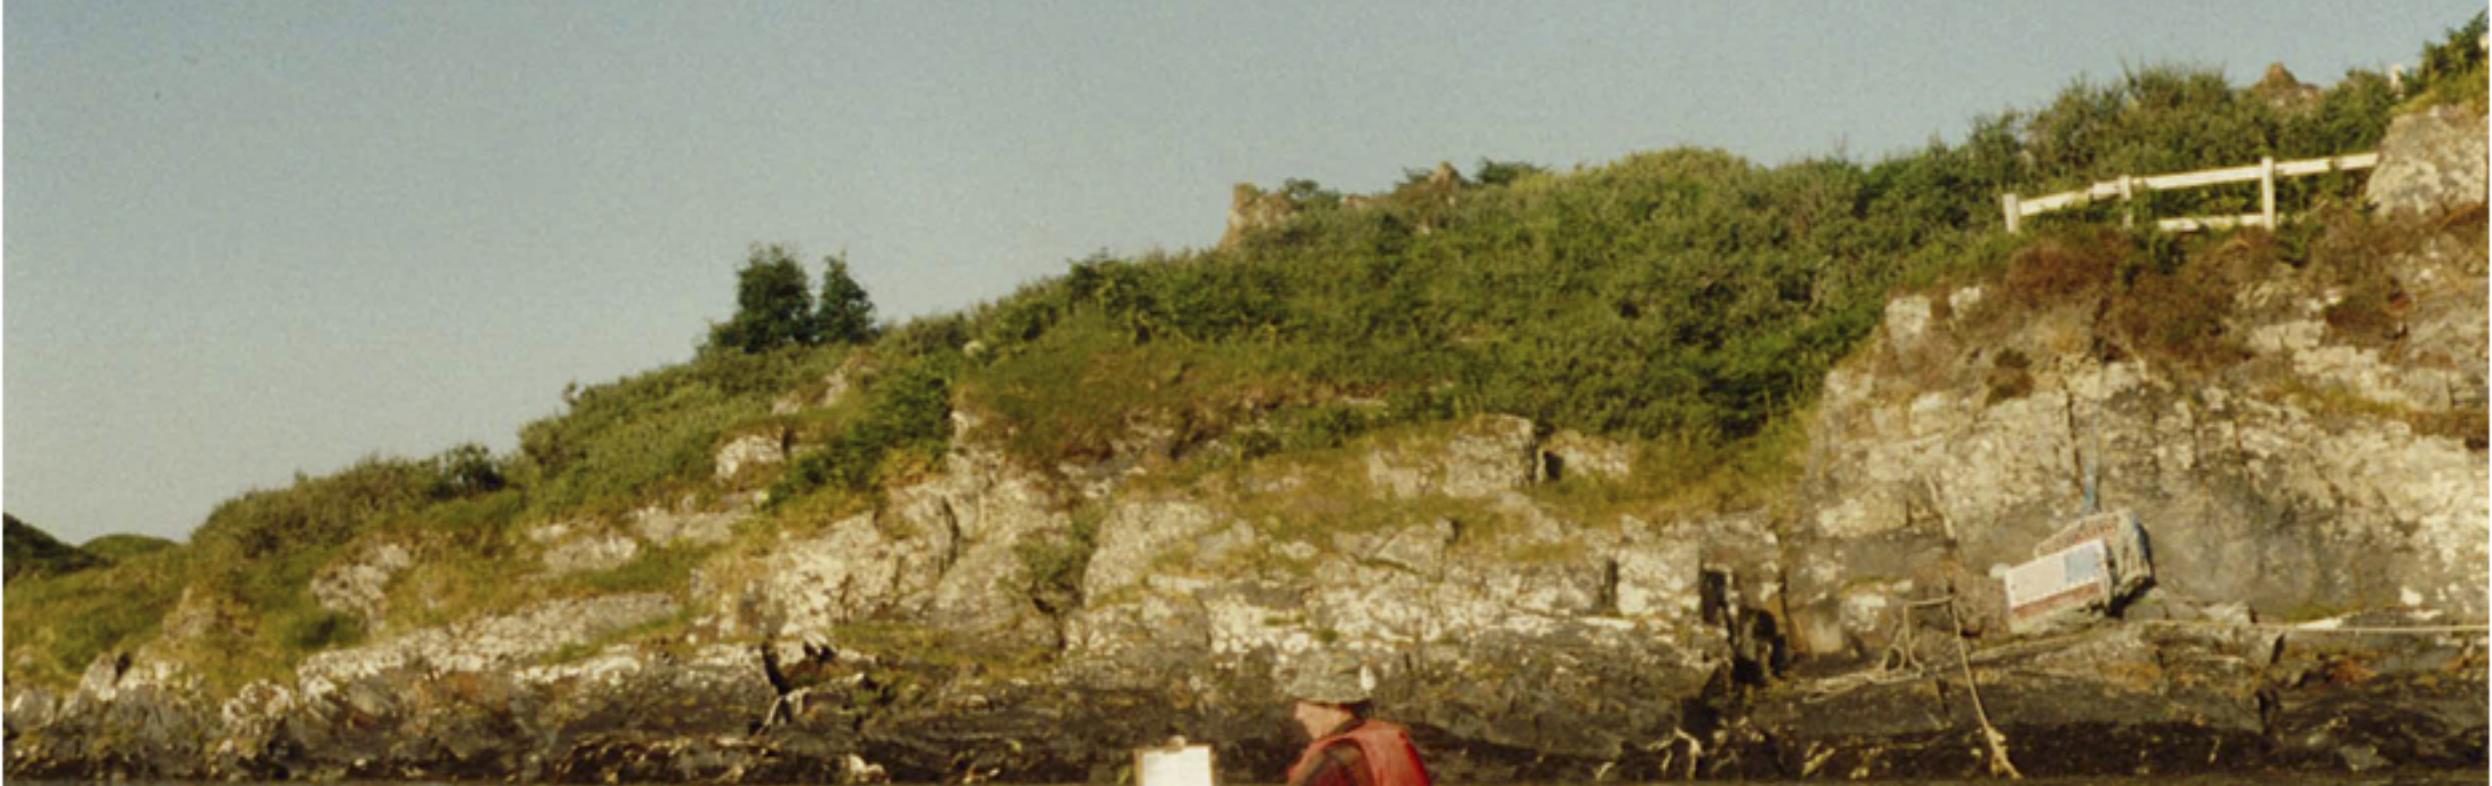
Paddler Plus Weights: 11.5 St / 75 Kg
Water in cockpit: 120 litres
