EXPERIMENTAL PROGRESSIVE FLOODING OF TWO SEA KAYAKS

1. Fore and Aft Bulkheads (Nordkapp)

2. Confluent Hull with Safety Cockpit (Sea Tiger)

2nd September 1989

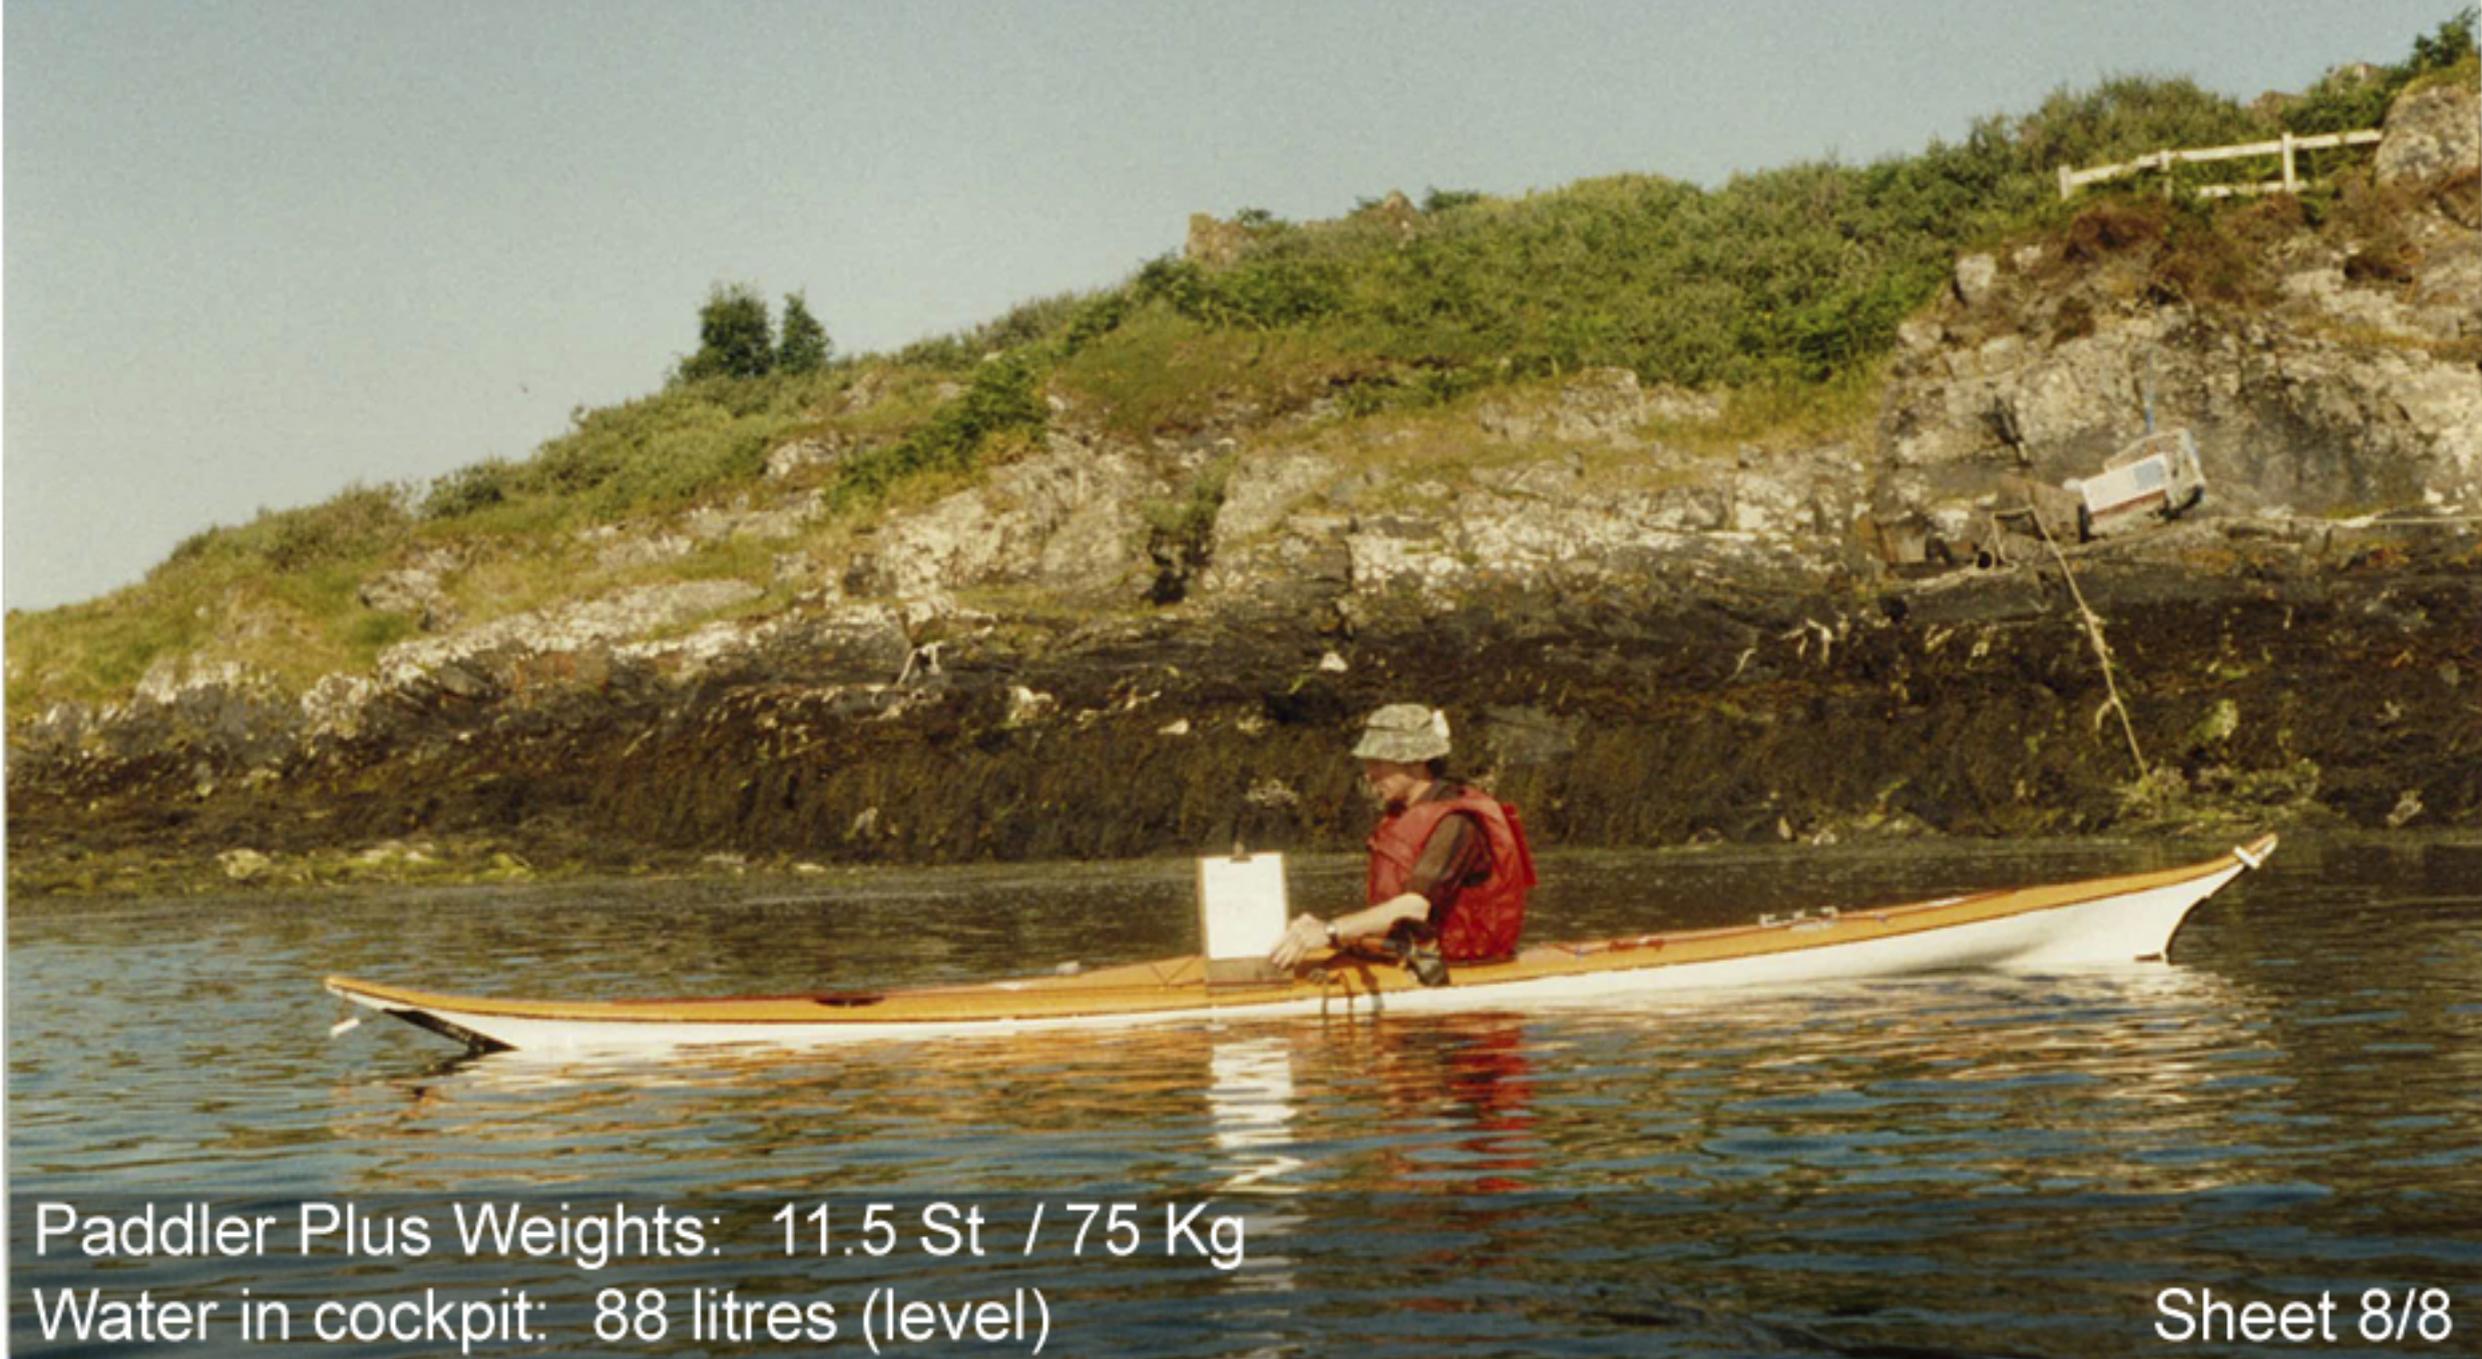
Paddler Plus Weights: 11.5 St / 75 Kg
Water in cockpit: 88 litres (level)

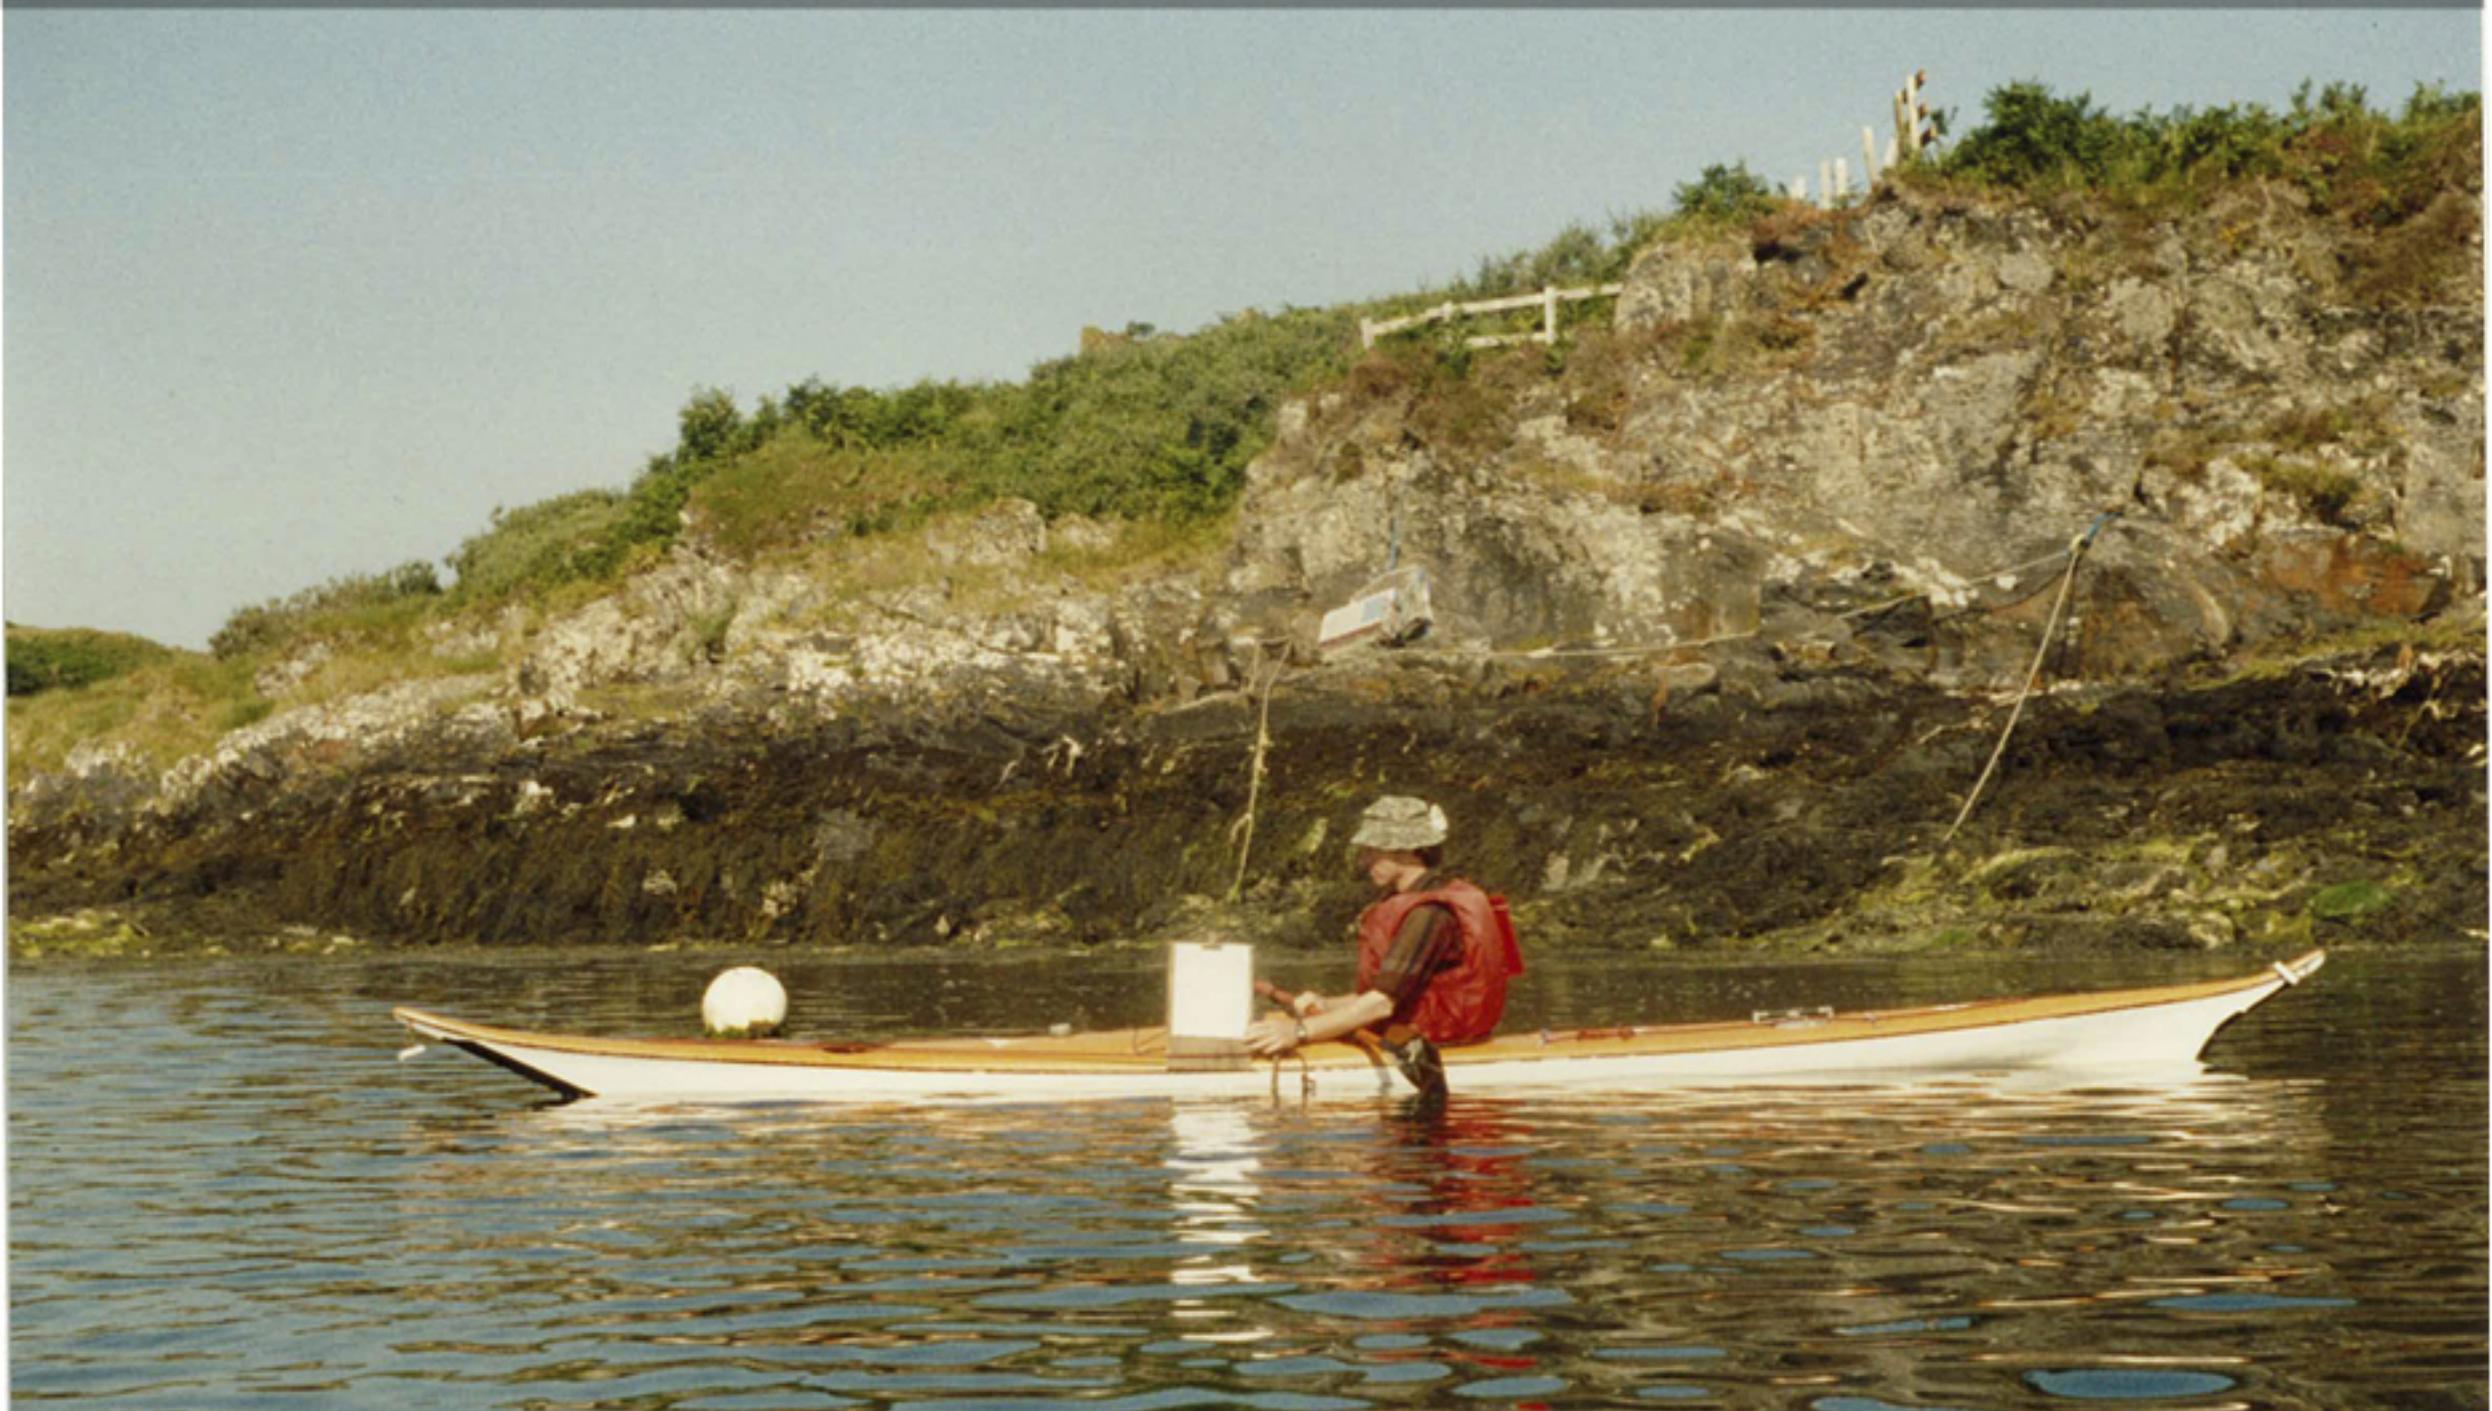
Paddler Plus Weights: 11.5 St / 75 Kg
Water in forward compartment: 20 litres

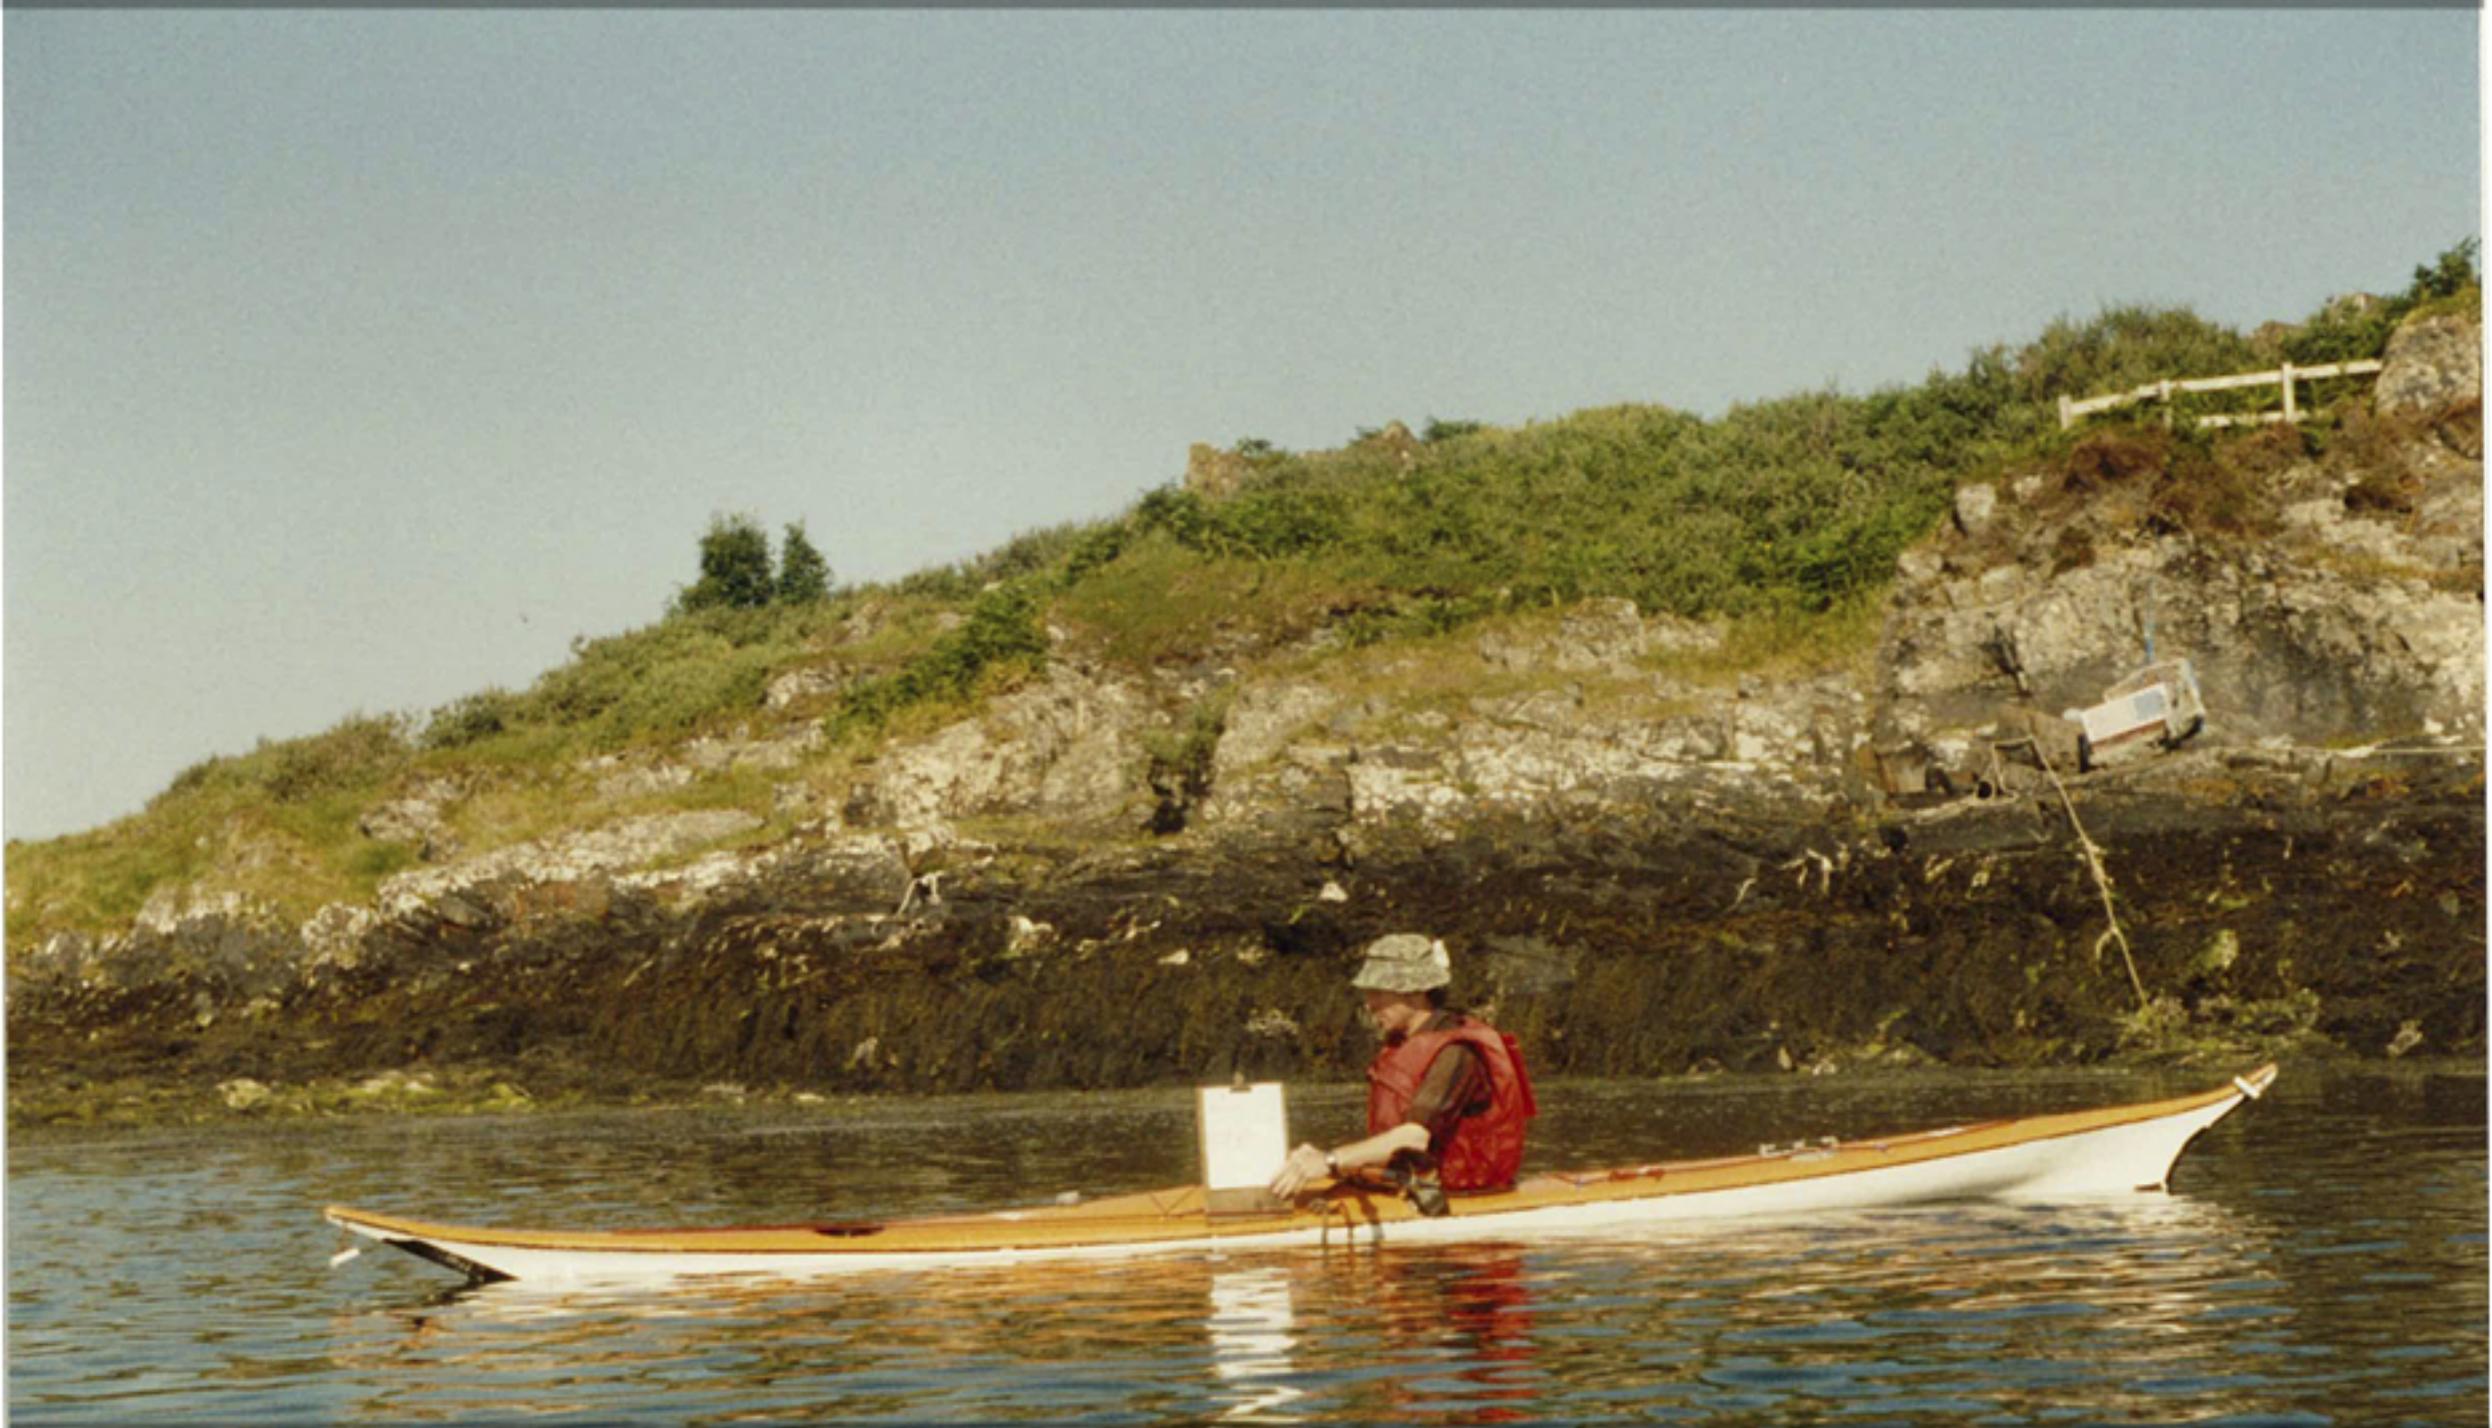
Paddler Plus Weights: 11.5 St / 75 Kg
Water in forward compartment: 40 litres

In the flooding test with the Nordkapp, Lateral stability was felt to be affected when 40 litres of sea water were present in the fore compartment (P 23), and there was sufficient space to allow the water to slop from side to side. This effect on lateral stability disappeared once the compartment was totally flooded (P 25). The same effect may apply to the flooded cockpit area - so that the condition in P 20 may be more stable than that in P 21. Measurement of lateral stability was beyond the scope of the flooding test reported here.

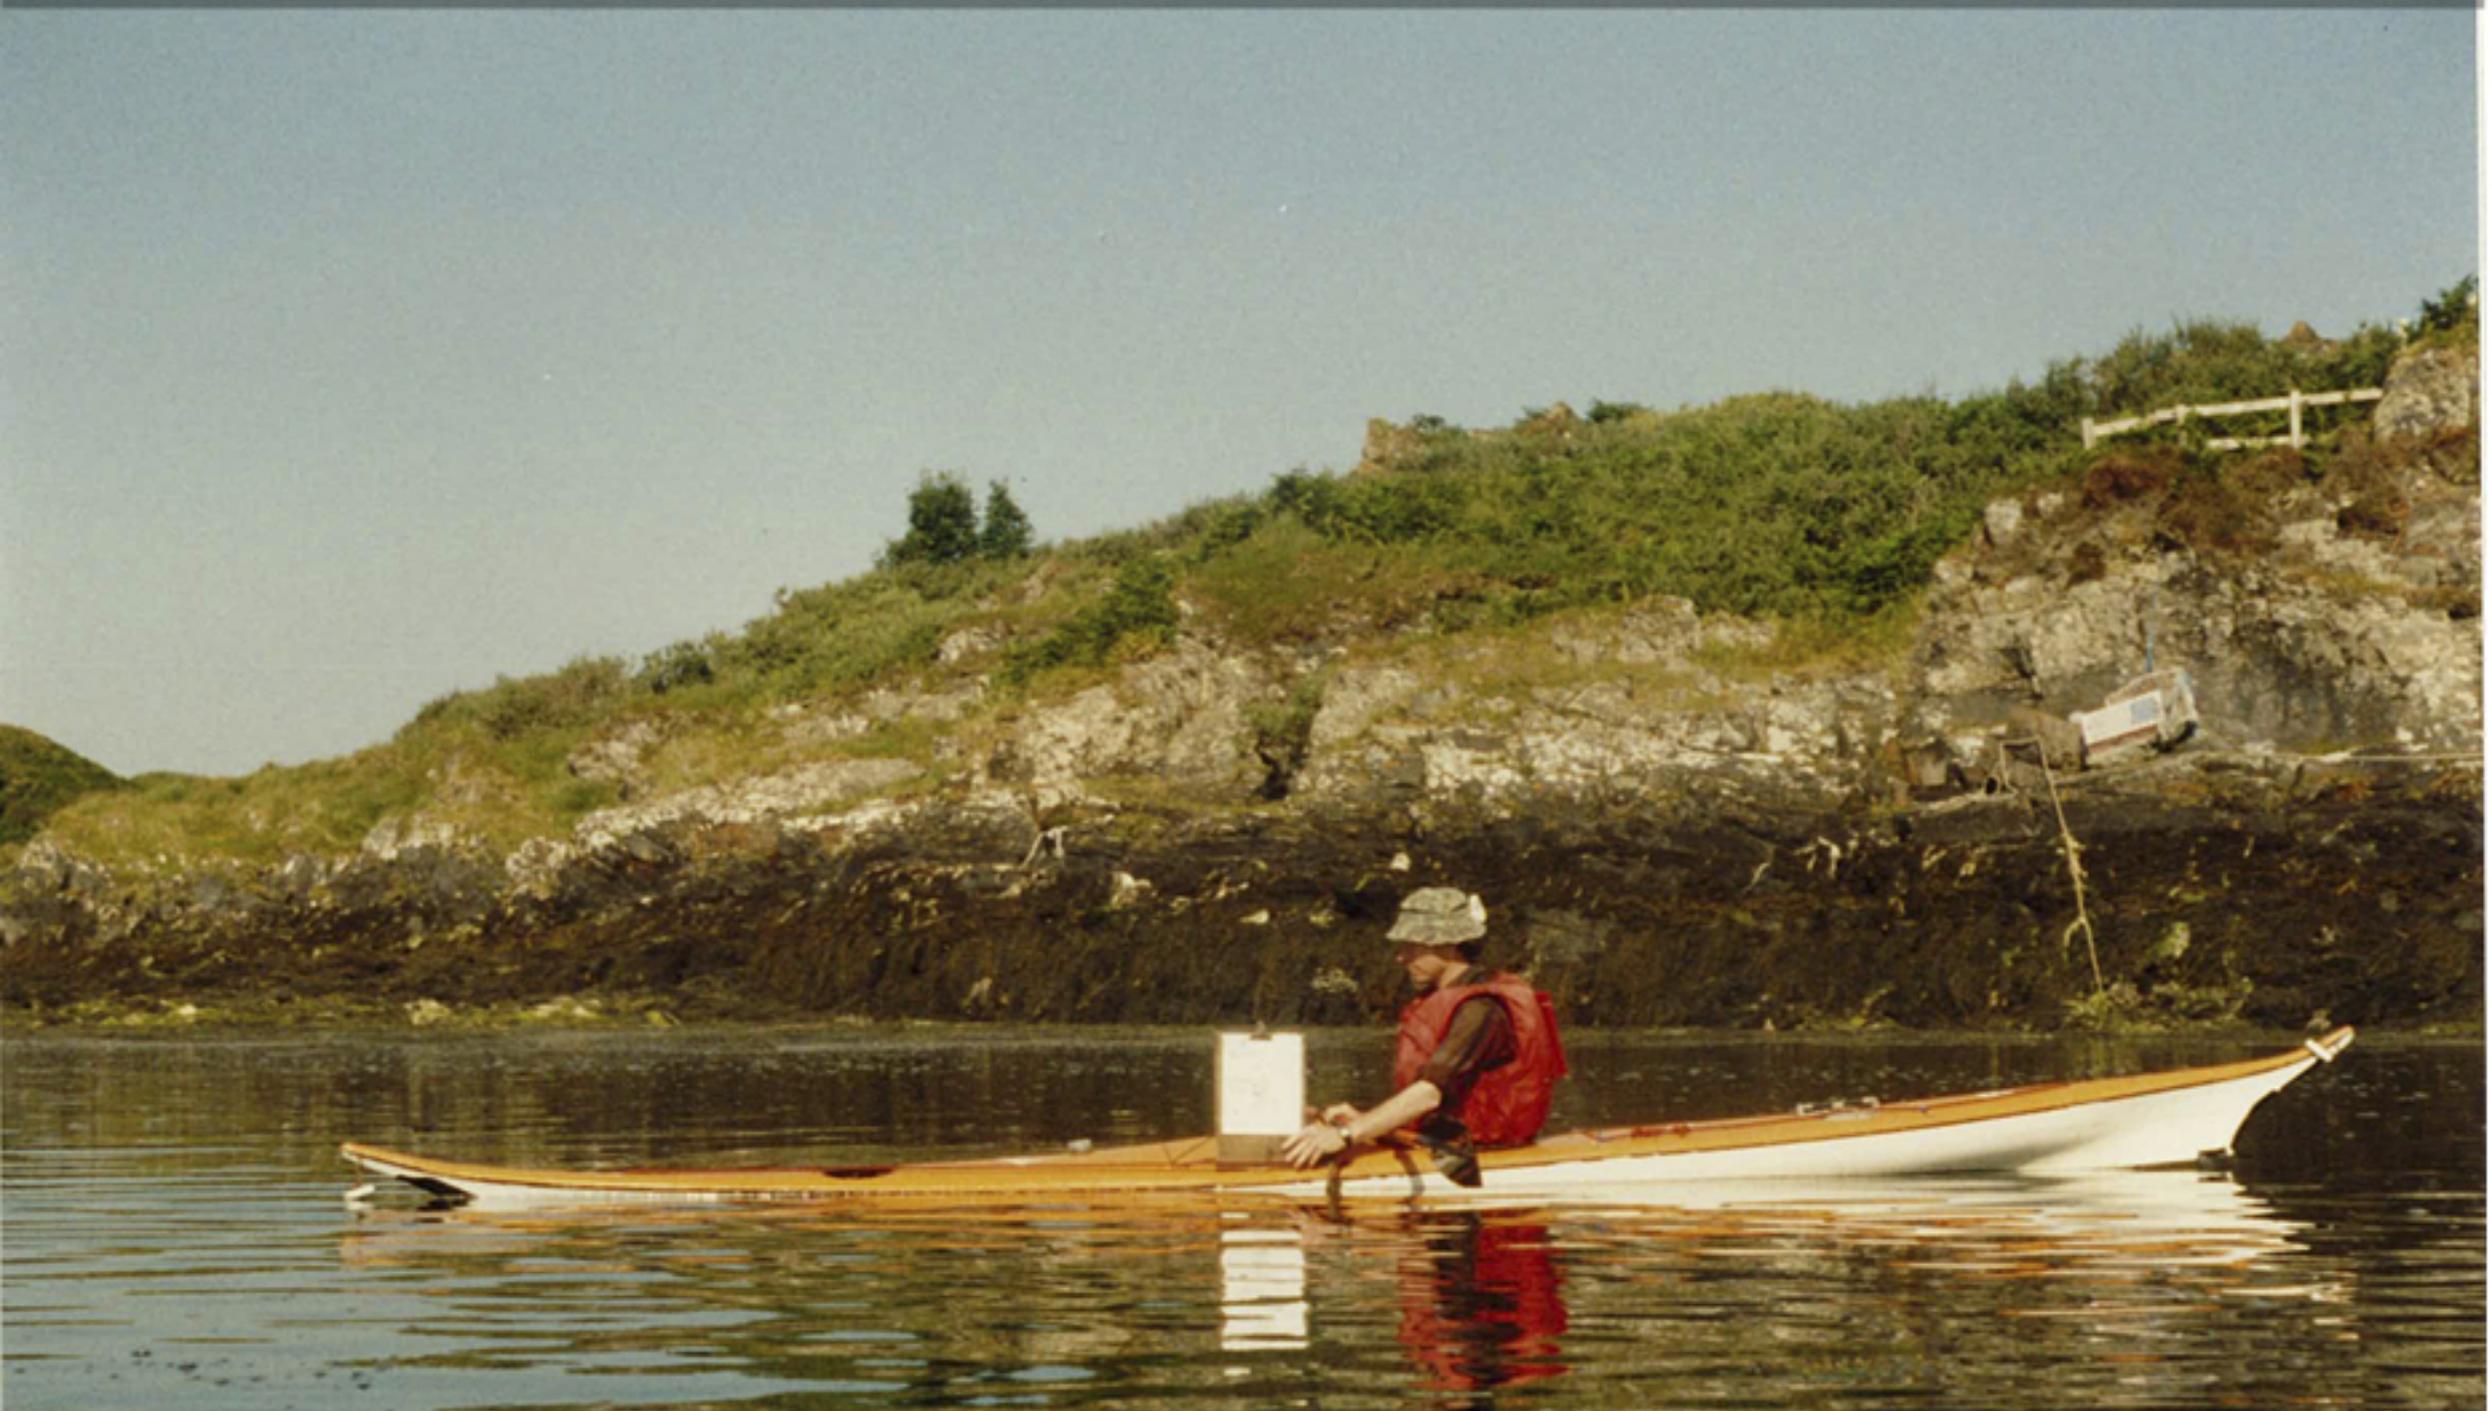
Paddler Plus Weights: 11.5 St / 75 Kg
Water in forward compartment: 59.5 litres (flooded)

With the Sea Tiger, no abrupt jerk was felt as trapped water surged fore and aft inside the hull against and past, the Safety Cockpit. Fore and aft surging felt less as the volume increased in the Sea Tiger beyond 120 litres and up to 160 litres of sea water in the hull space ([P 7 to P 9](#)). Similarly in the Nordkapp, once either fore or aft compartments became filled (59.5 litres fore, [P 24](#), and 75 litres aft, [P 29](#)).

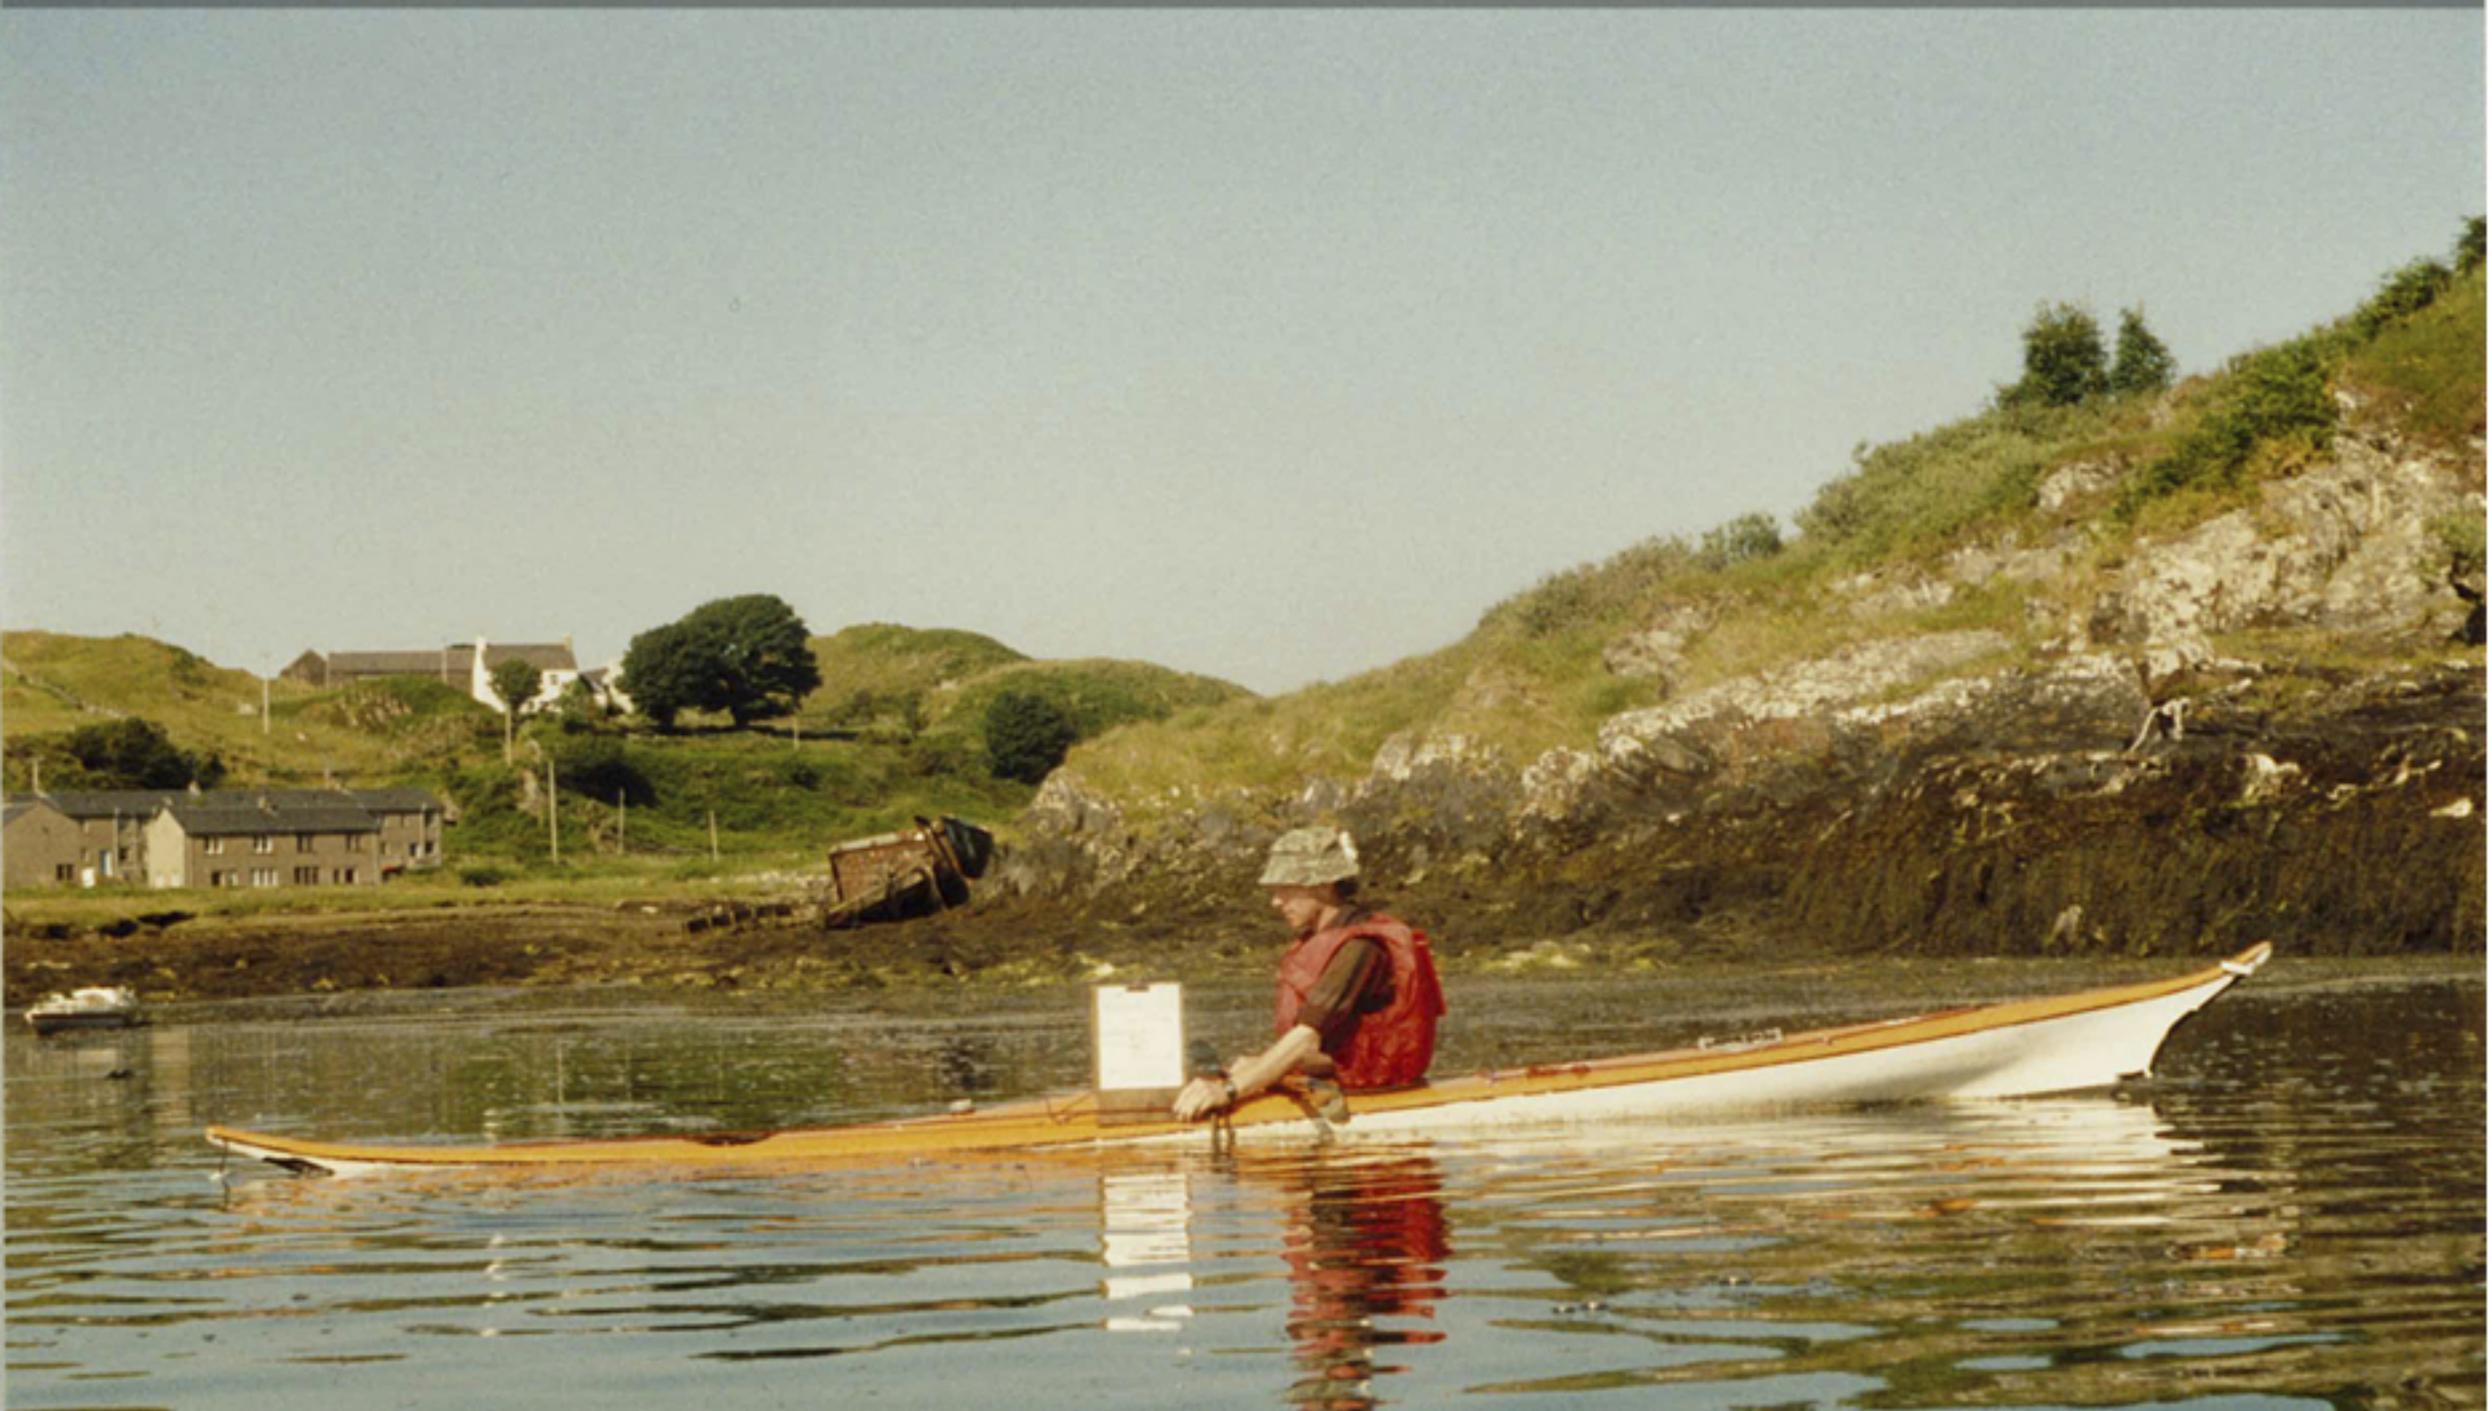
Paddler Plus Weights: 11.5 St / 75 Kg
Water in forward compartment: full

The second and third omissions are those logically following photographs 25 and 30 where the Nordkapp was flooded completely in either end compartment. The logical progression would have been to photograph the same condition as the Sea Tiger in Photograph 11, that is, with the addition of a flooded cockpit, as would be expected to happen in an actual flooding incident. This was not done on the day of the testing as it would have taken too much time because recovery would only have been possible with difficulty by towing the kayak ashore for emptying.

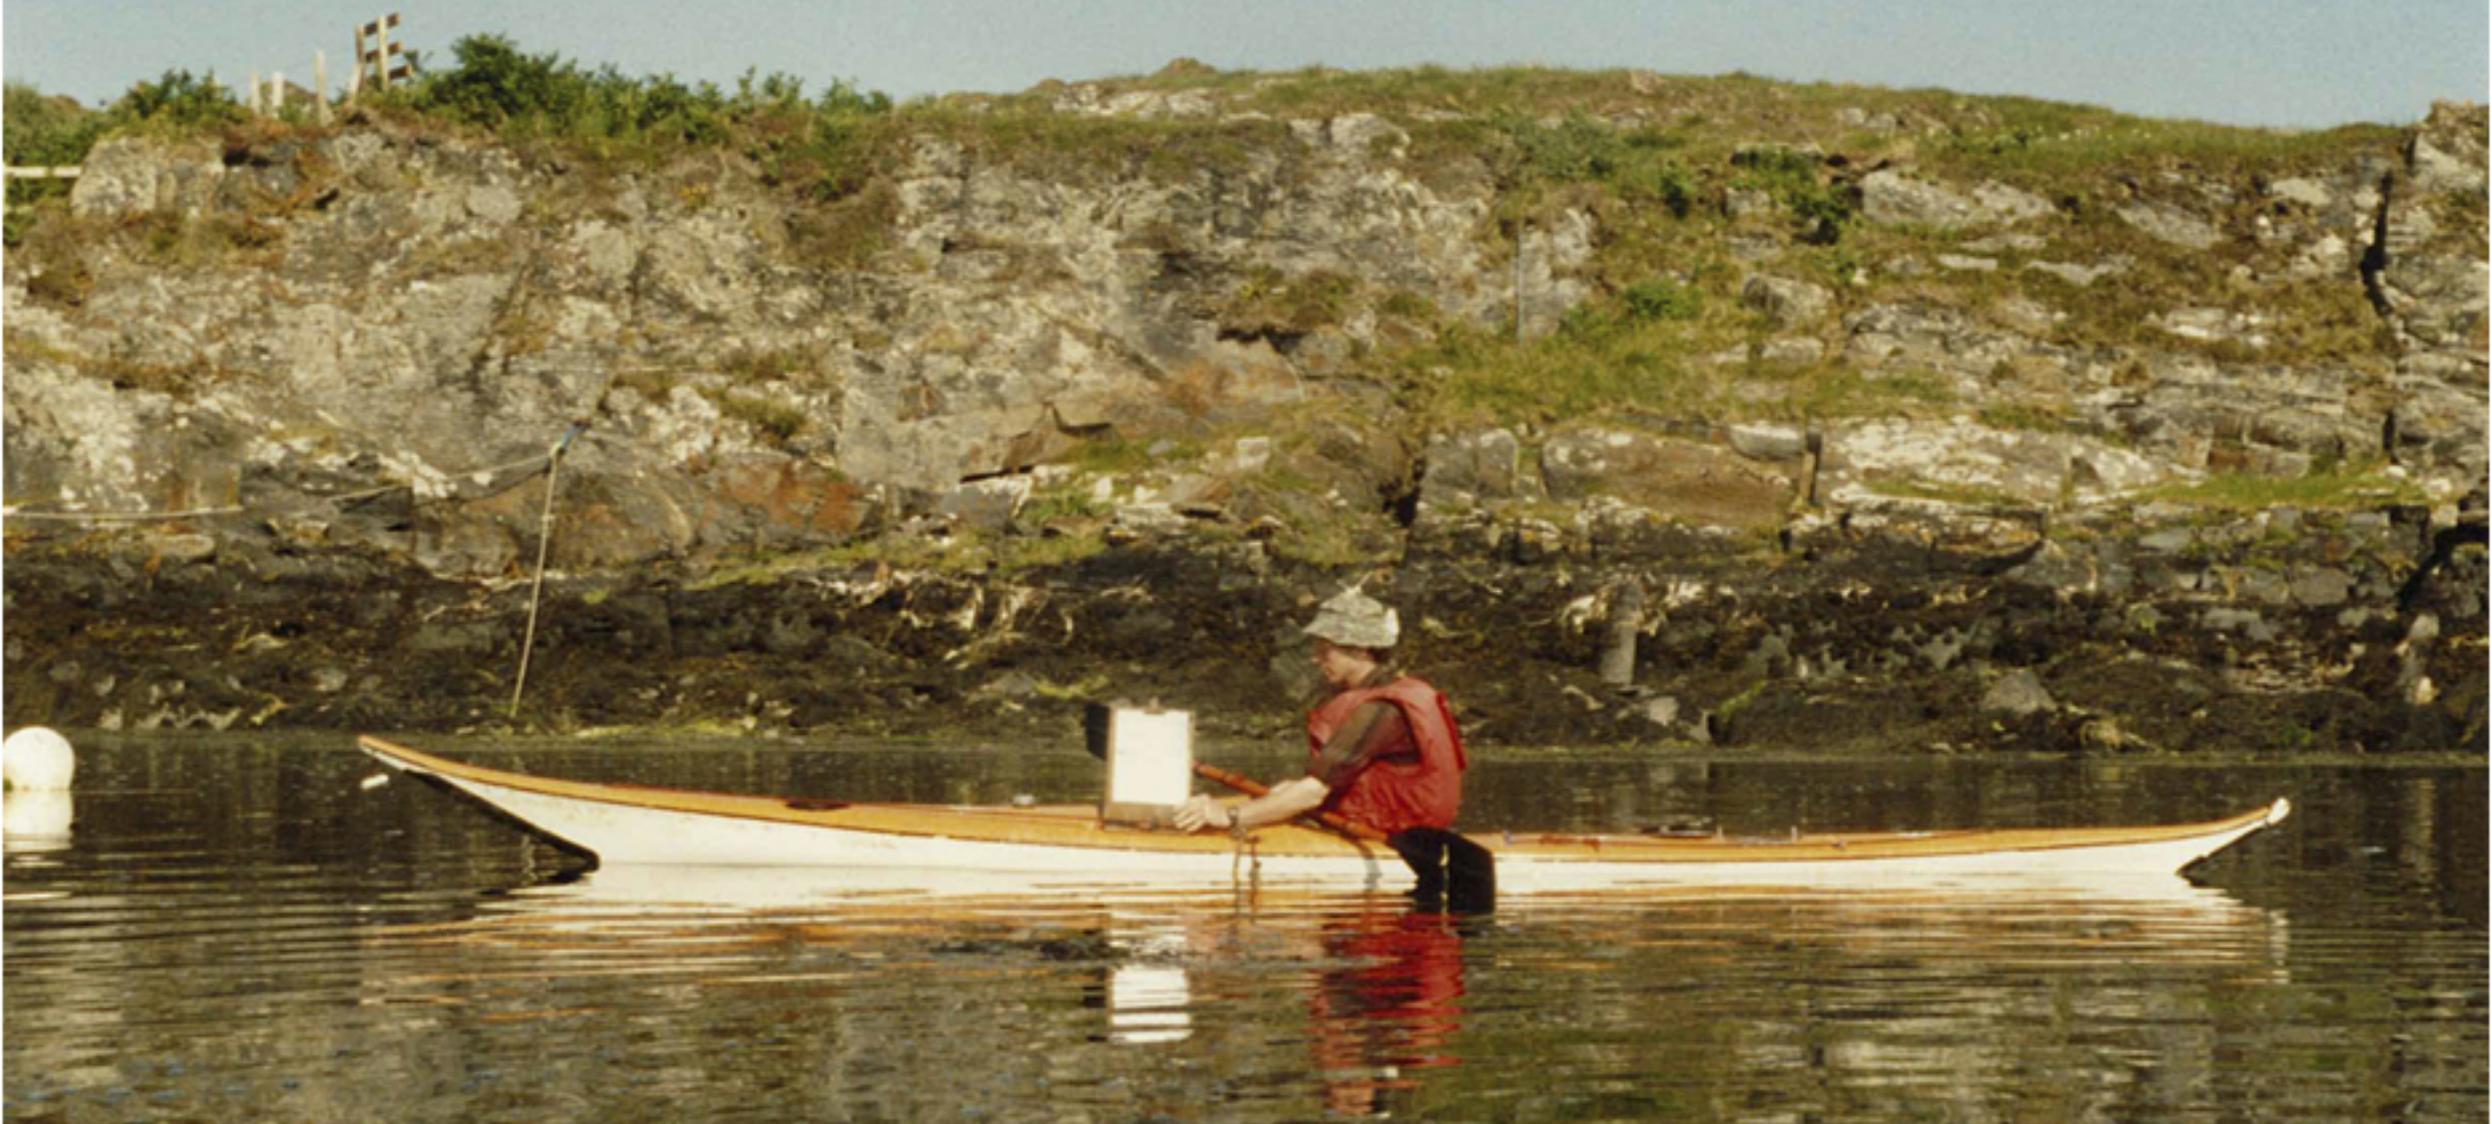
Sheet 1/5

Paddler Plus Weights: 11.5 St / 75 Kg
Water in aft compartment: 20 litres

The Sea Tiger maintained an even fore and aft trim until a loading of 160 litres (P9). The Nordkapp became noticeably out of trim with small amounts, 20 litres, of water in either end (P15, P26).
