EXPERIMENTAL PROGRESSIVE FLOODING OF TWO SEA KAYAKS

1. Fore and Aft Bulkheads (Nordkapp)

2. Confluent Hull with Safety Cockpit (Sea Tiger)

2nd September 1989

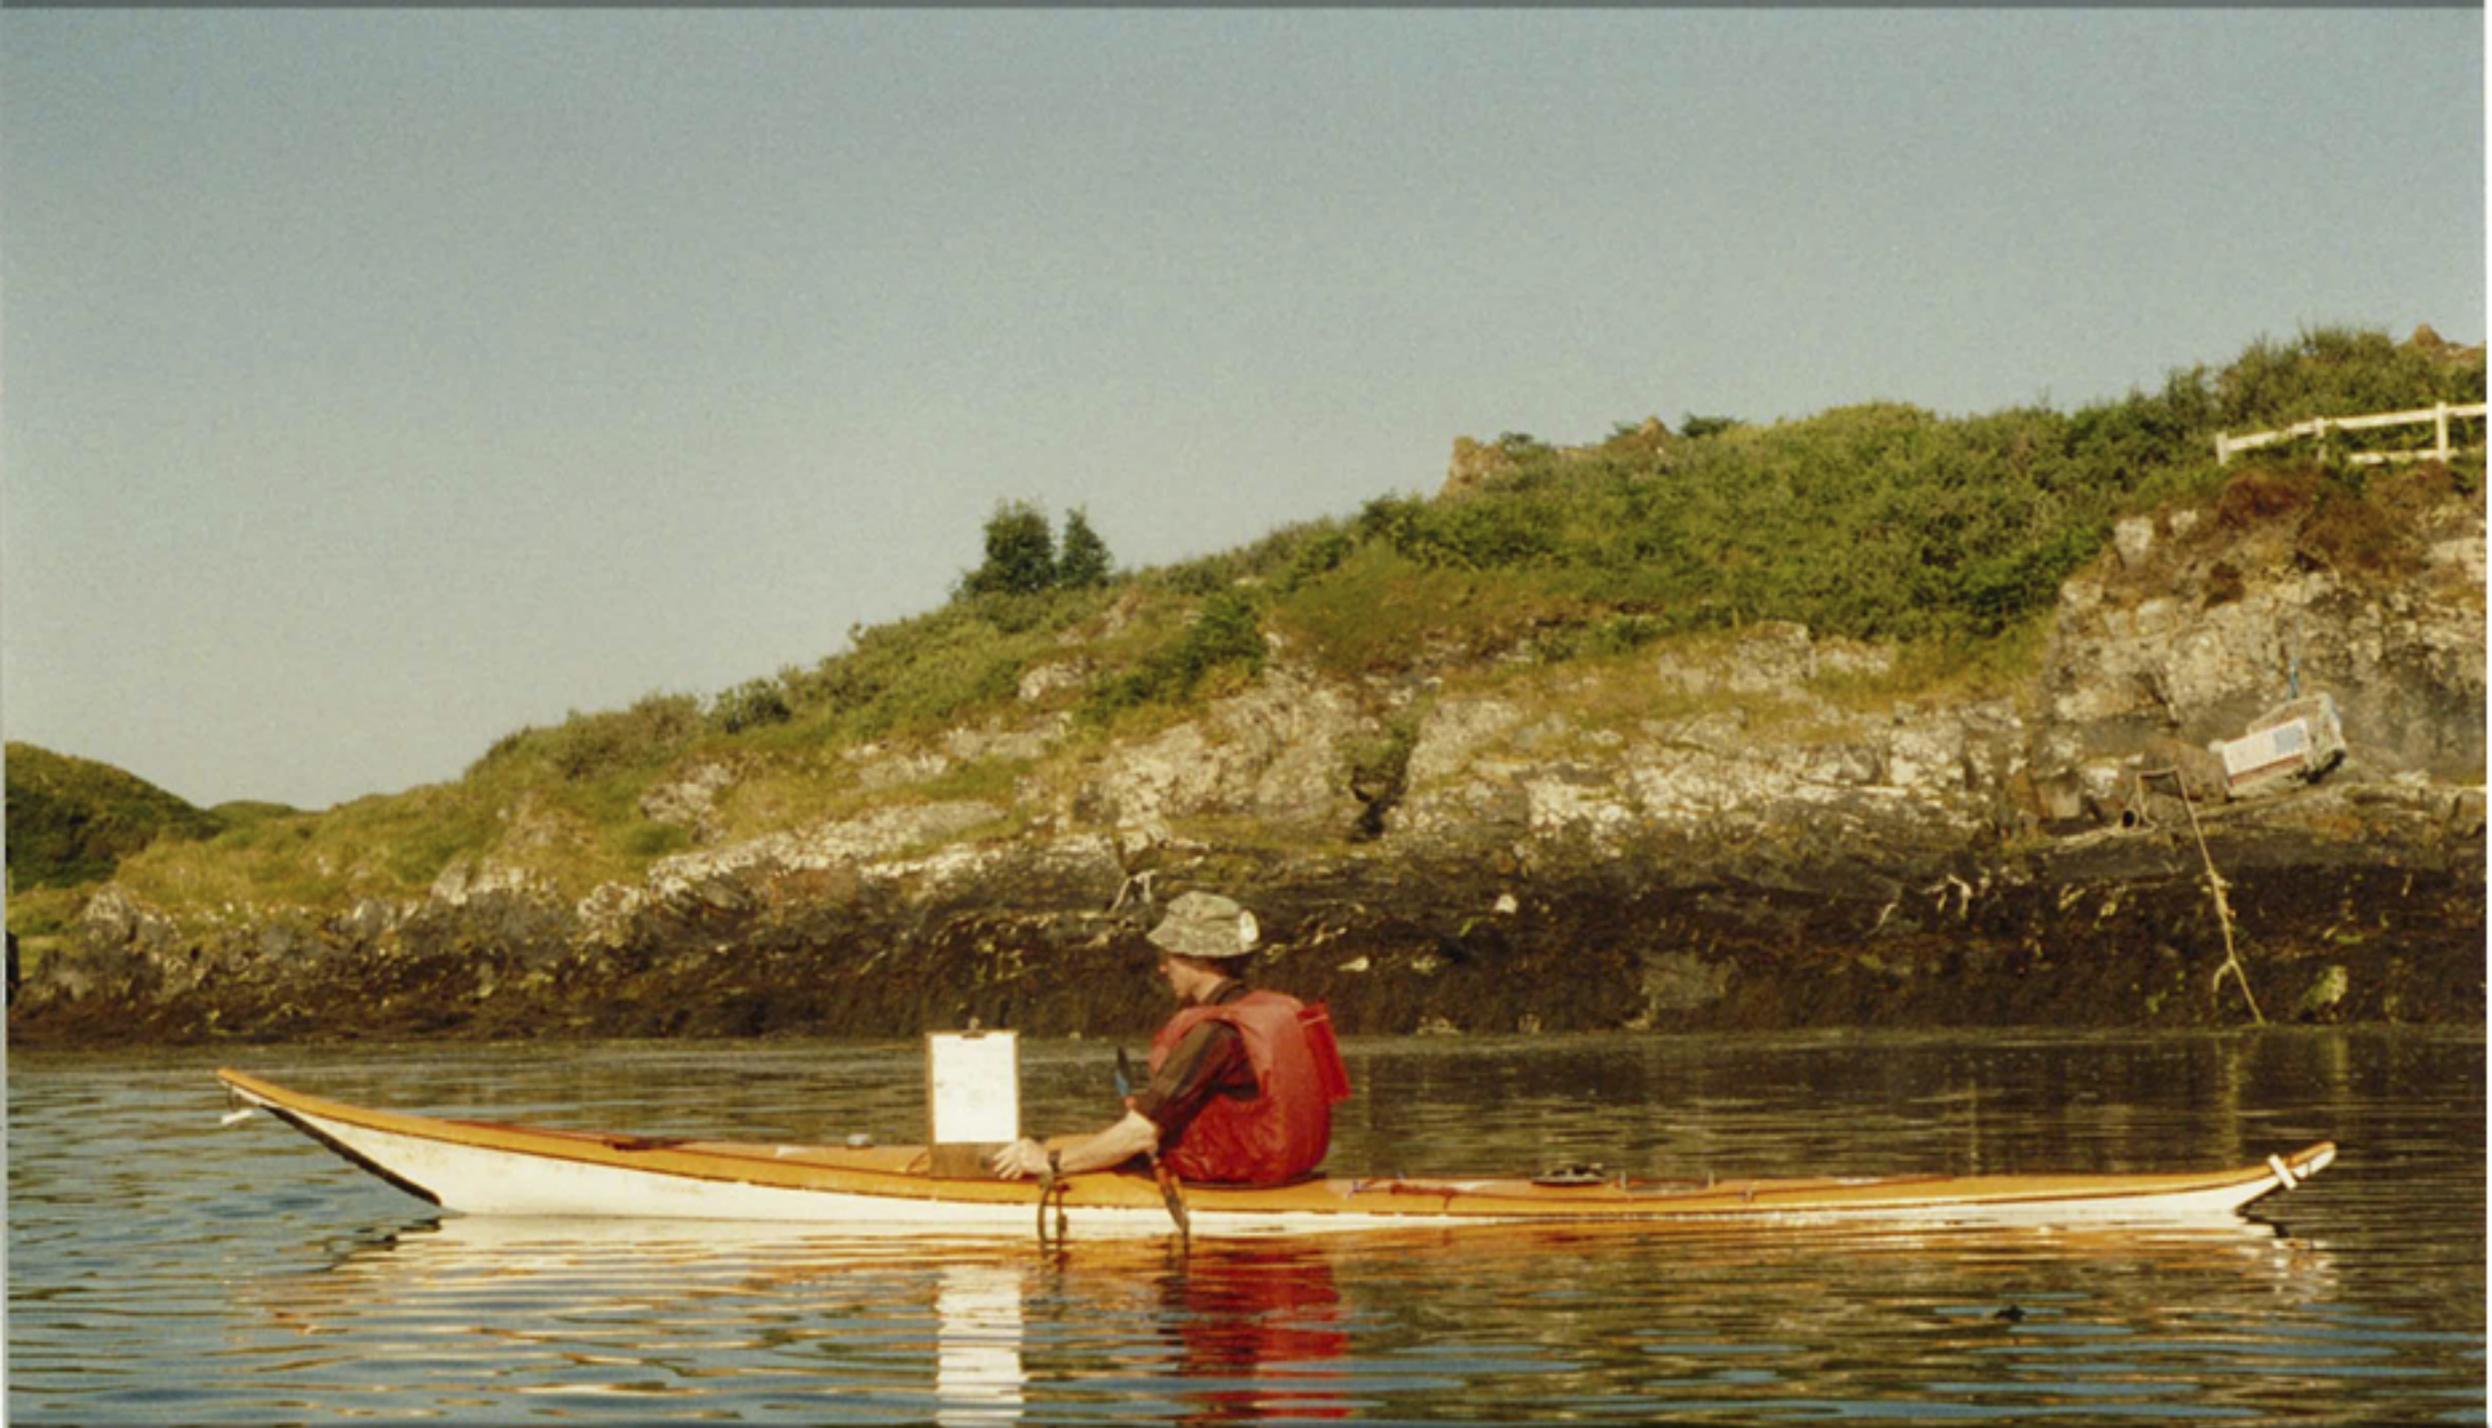
Paddler Plus Weights: 11.5 St / 75 Kg
Water in aft compartment: 40 litres

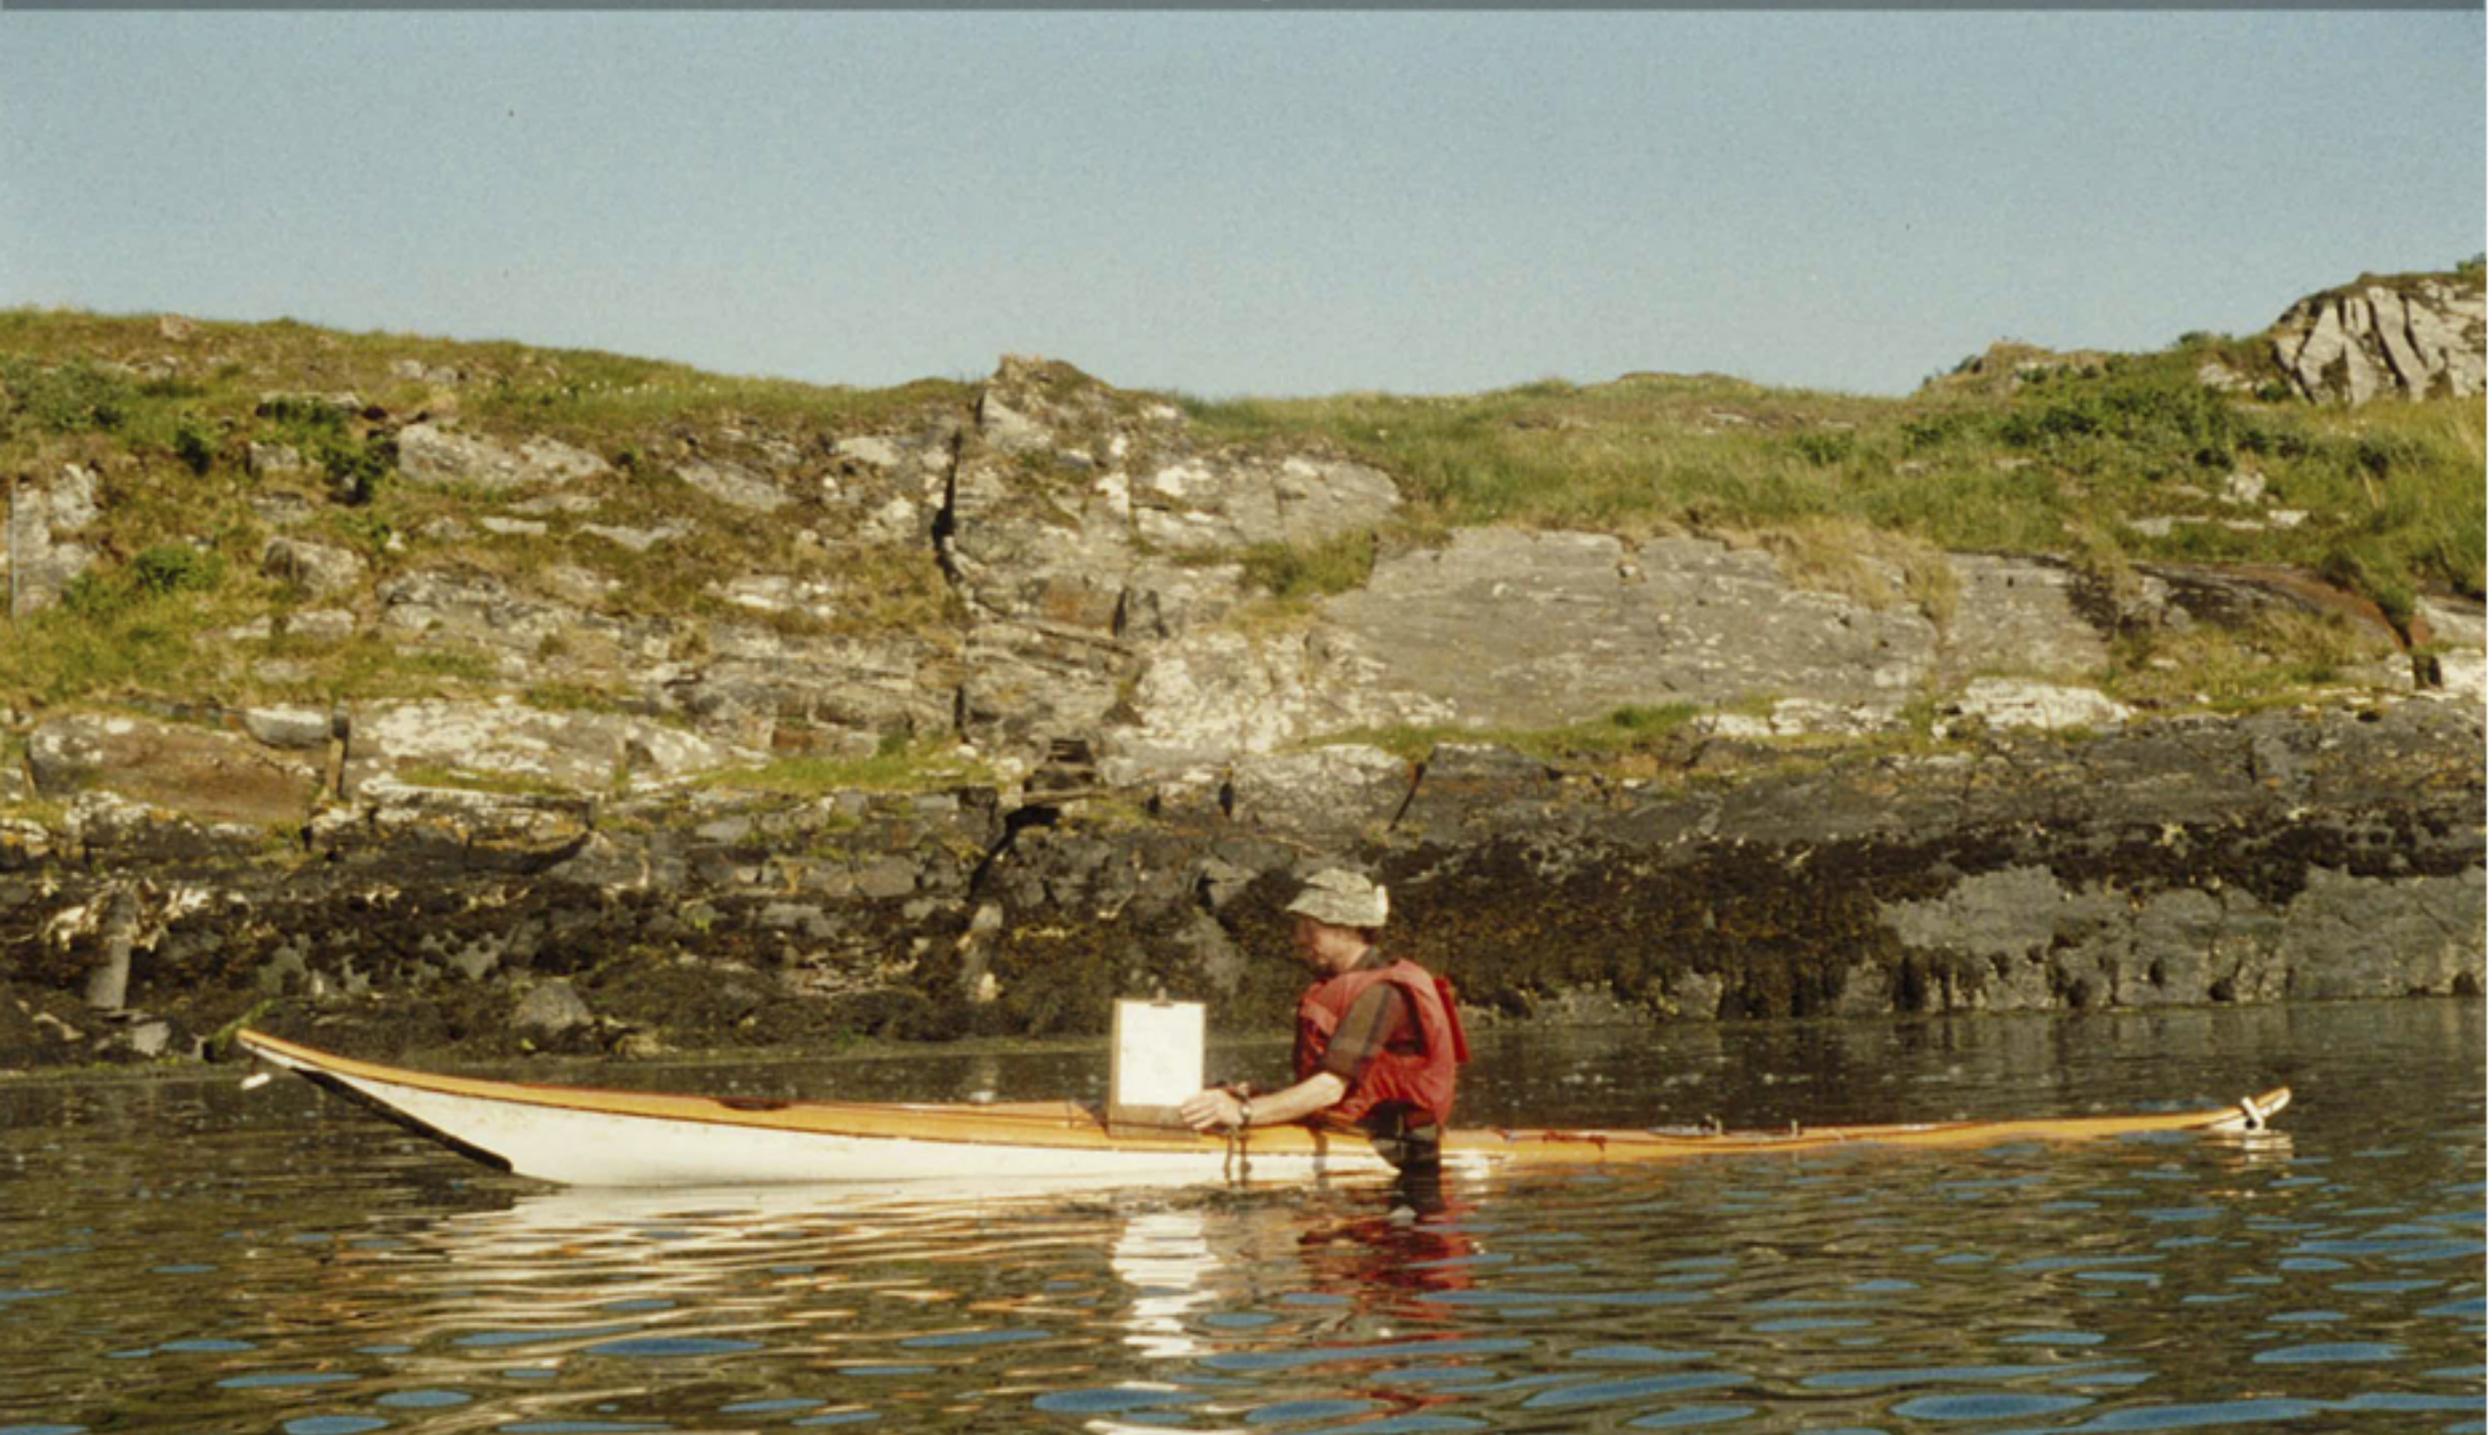
Paddler Plus Weights: 11.5 St / 75 Kg
Water in aft compartment: 60 litres

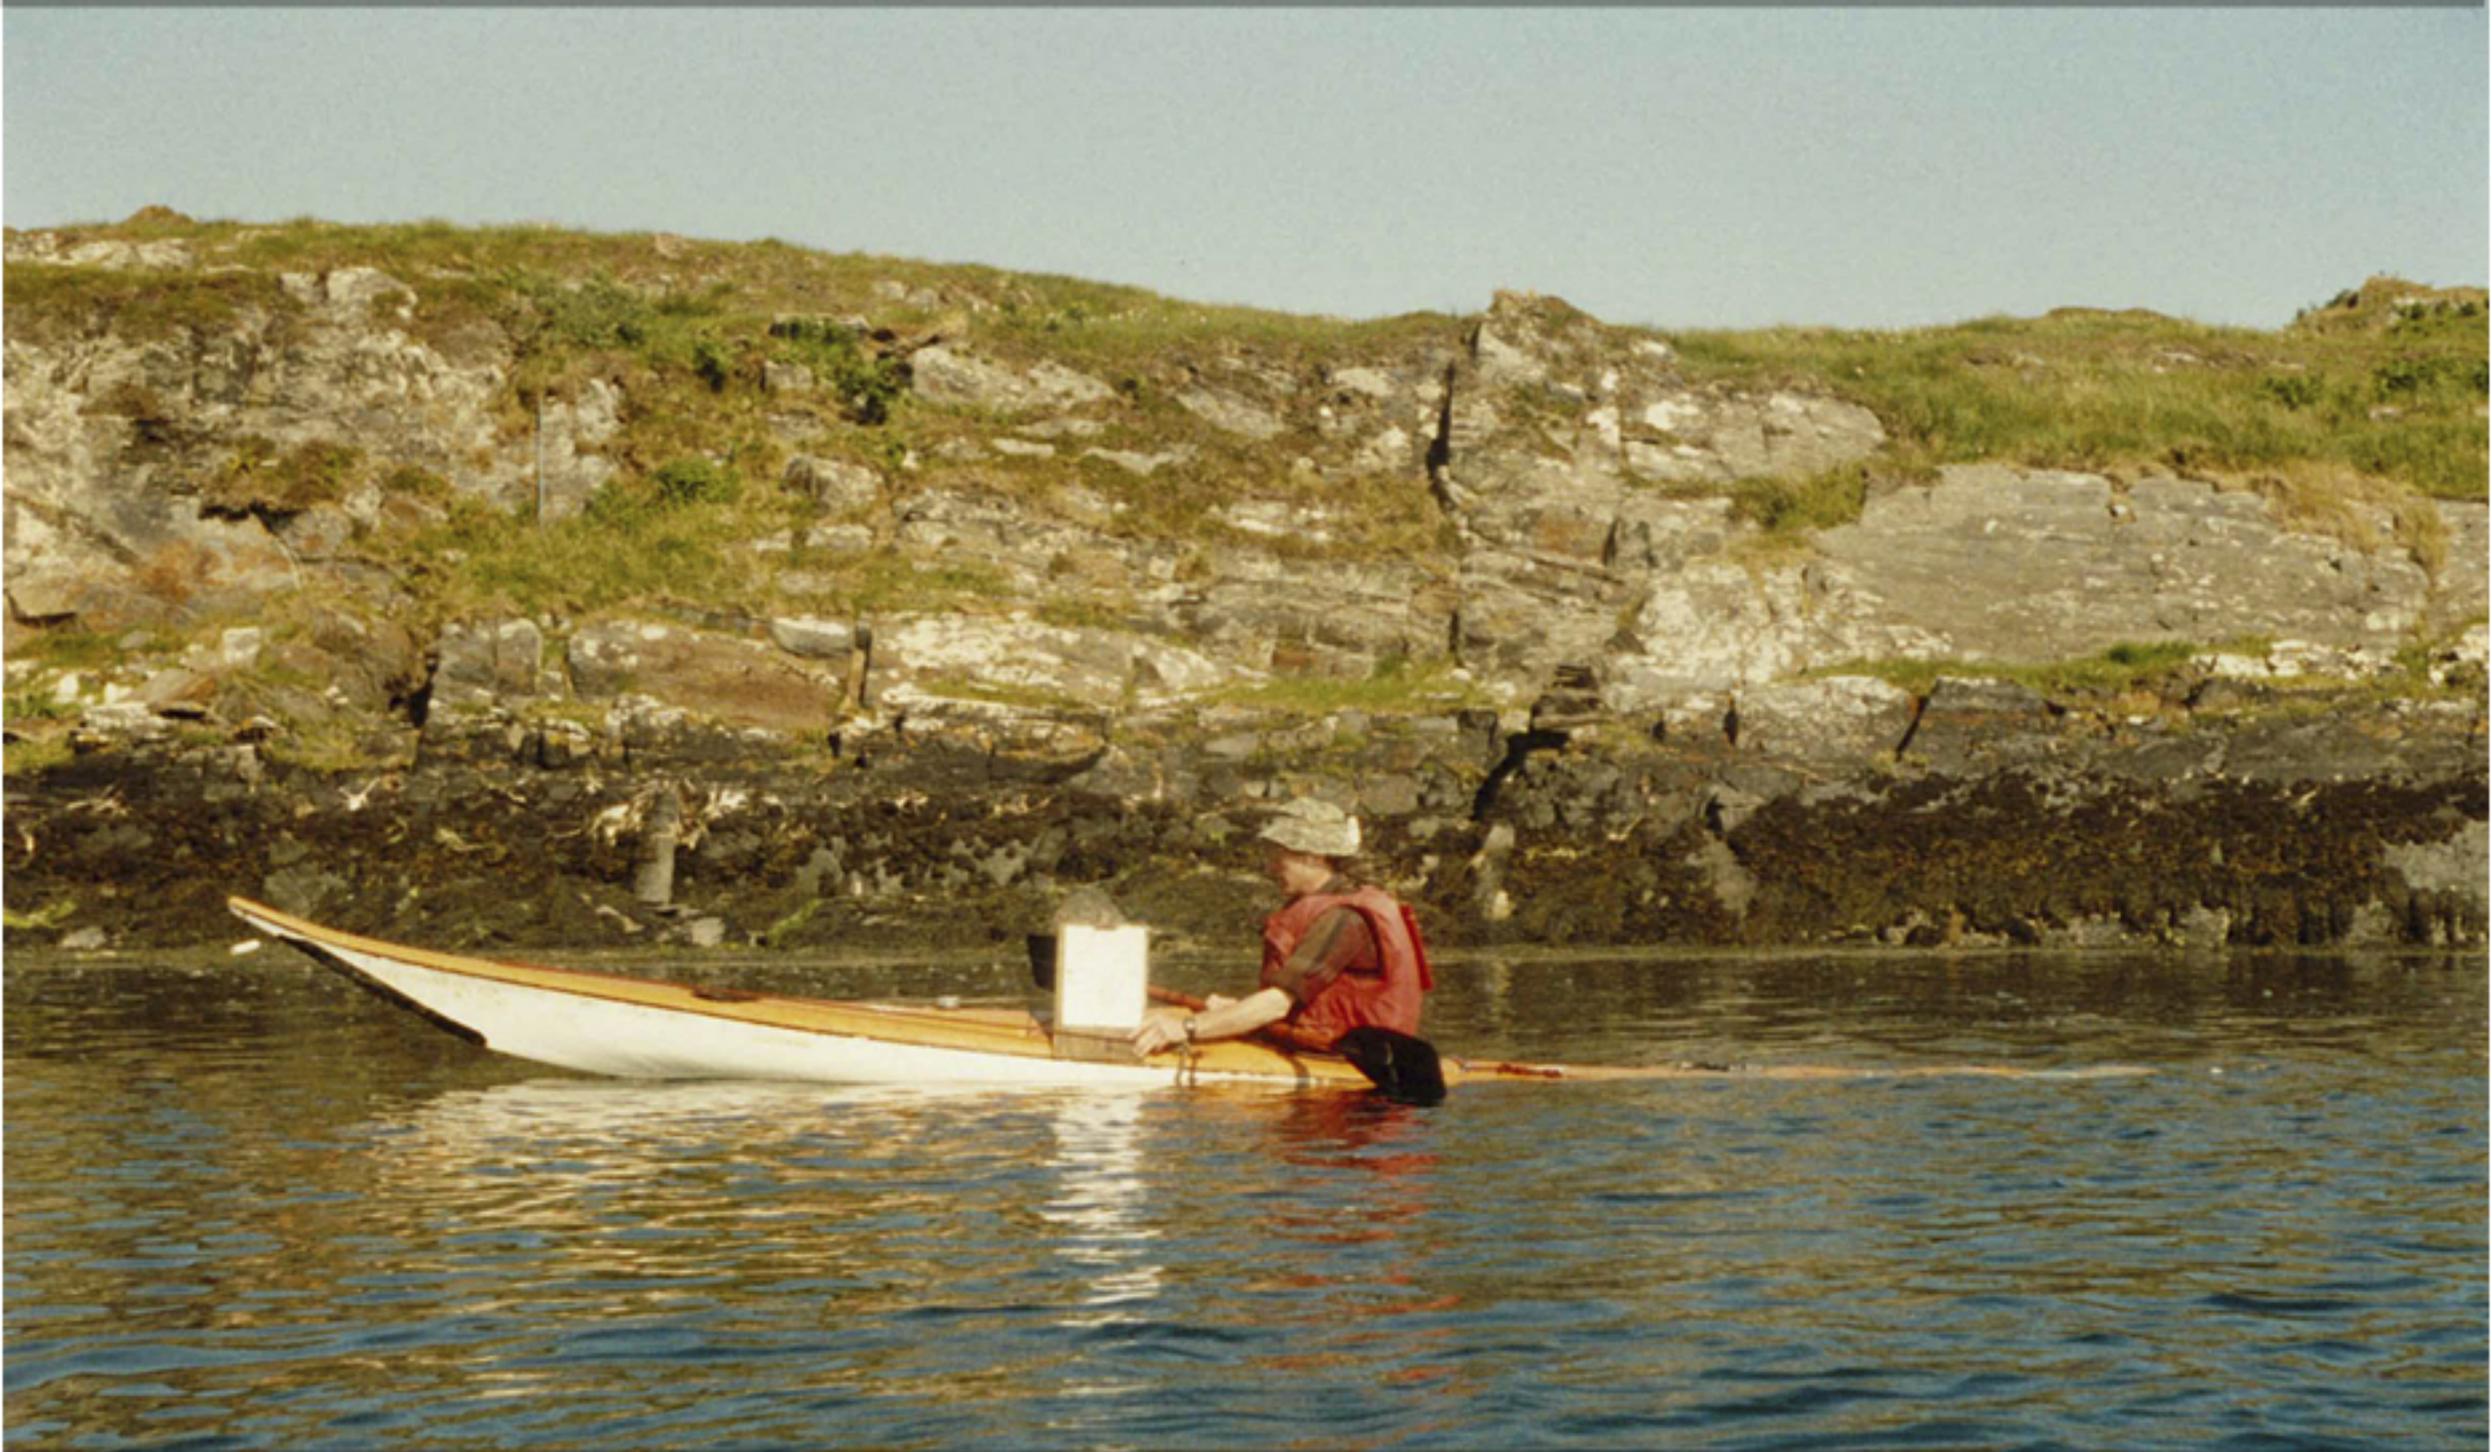
Paddler Plus Weights: 11.5 St / 75 Kg
Water in aft compartment: >75 litres (flooded)

When the stern compartment of the Nordkapp was flooded, the cockpit was very close to sea level. This occurred with 75 and 88 litres in the rear compartment. The Sea Tiger reached a similar situation when 200 litres were present in the hull. During the test, the Sea Tiger cockpit flooded at this stage, and the kayak settled at about 250 degrees from the horizontal, with the paddler still sitting in the cockpit (P 11). NO comparable photograph was obtained for the Nordkapp i.e. with cockpit, plus one or other compartment, flooded. P 11 is therefore NOT equivalent to P 30.

With the Sea Tiger, no abrupt jerk was felt as trapped water surged fore and aft inside the hull against and past, the Safety Cockpit. Fore and aft surging felt less as the volume increased in the Sea Tiger beyond 120 litres and up to 160 litres of sea water in the hull space ([P 7 to P 9](#)). Similarly in the Nordkapp, once either fore or aft compartments became filled (59.5 litres fore, [P 24](#), and 75 litres aft, [P 29](#)).

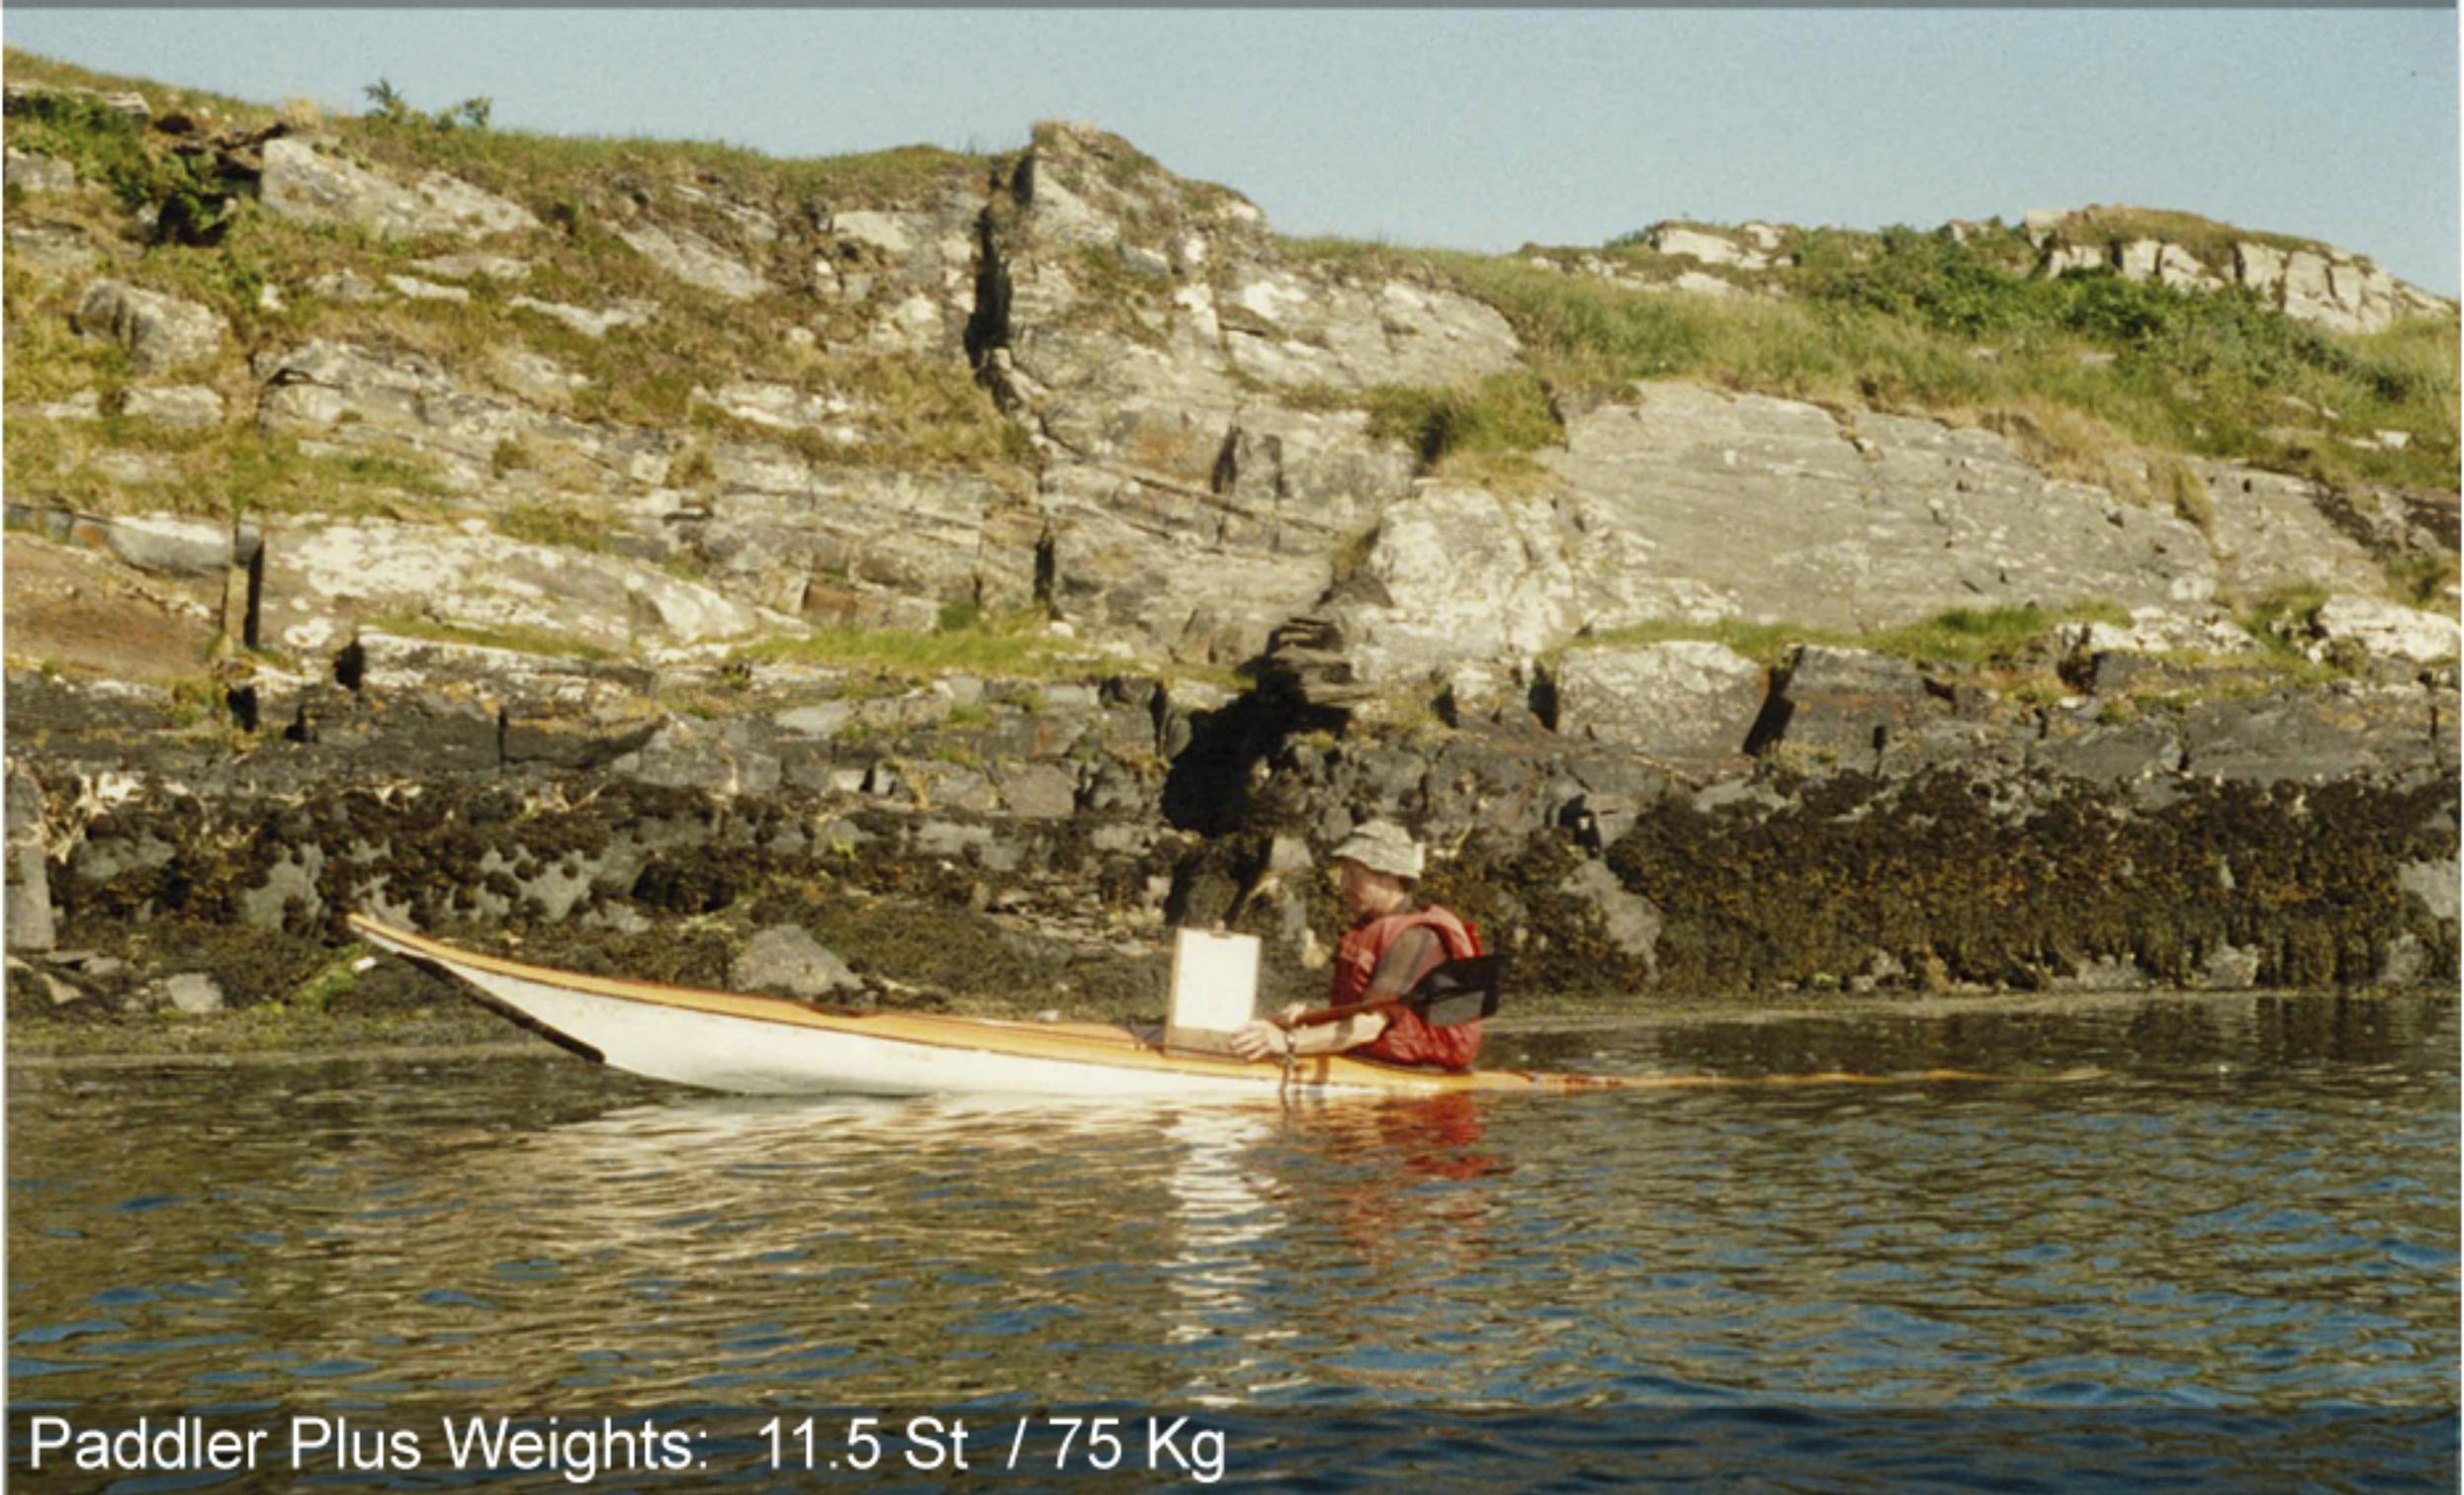
Paddler Plus Weights: 11.5 St / 75 Kg
Water in aft compartment: full

The second and third omissions are those logically following photographs 25 and 30 where the Nordkapp was flooded completely in either end compartment. The logical progression would have been to photograph the same condition as the Sea Tiger in Photograph 11, that is, with the addition of a flooded cockpit, as would be expected to happen in an actual flooding incident. This was not done on the day of the testing as it would have taken too much time because recovery would only have been possible with difficulty by towing the kayak ashore for emptying.
