Sea Tiger Report

Report on comparative tests of “Sea Tiger” sea kayak and other sea kayaks on behalf of the British Canoe Union

**Presented by Duncan R. Winning O.B.E.
22 Brisbane Glen Road,
Largs,
Ayrshire,
Scotland,
KA30 8QX.**

Twelfth June 1990

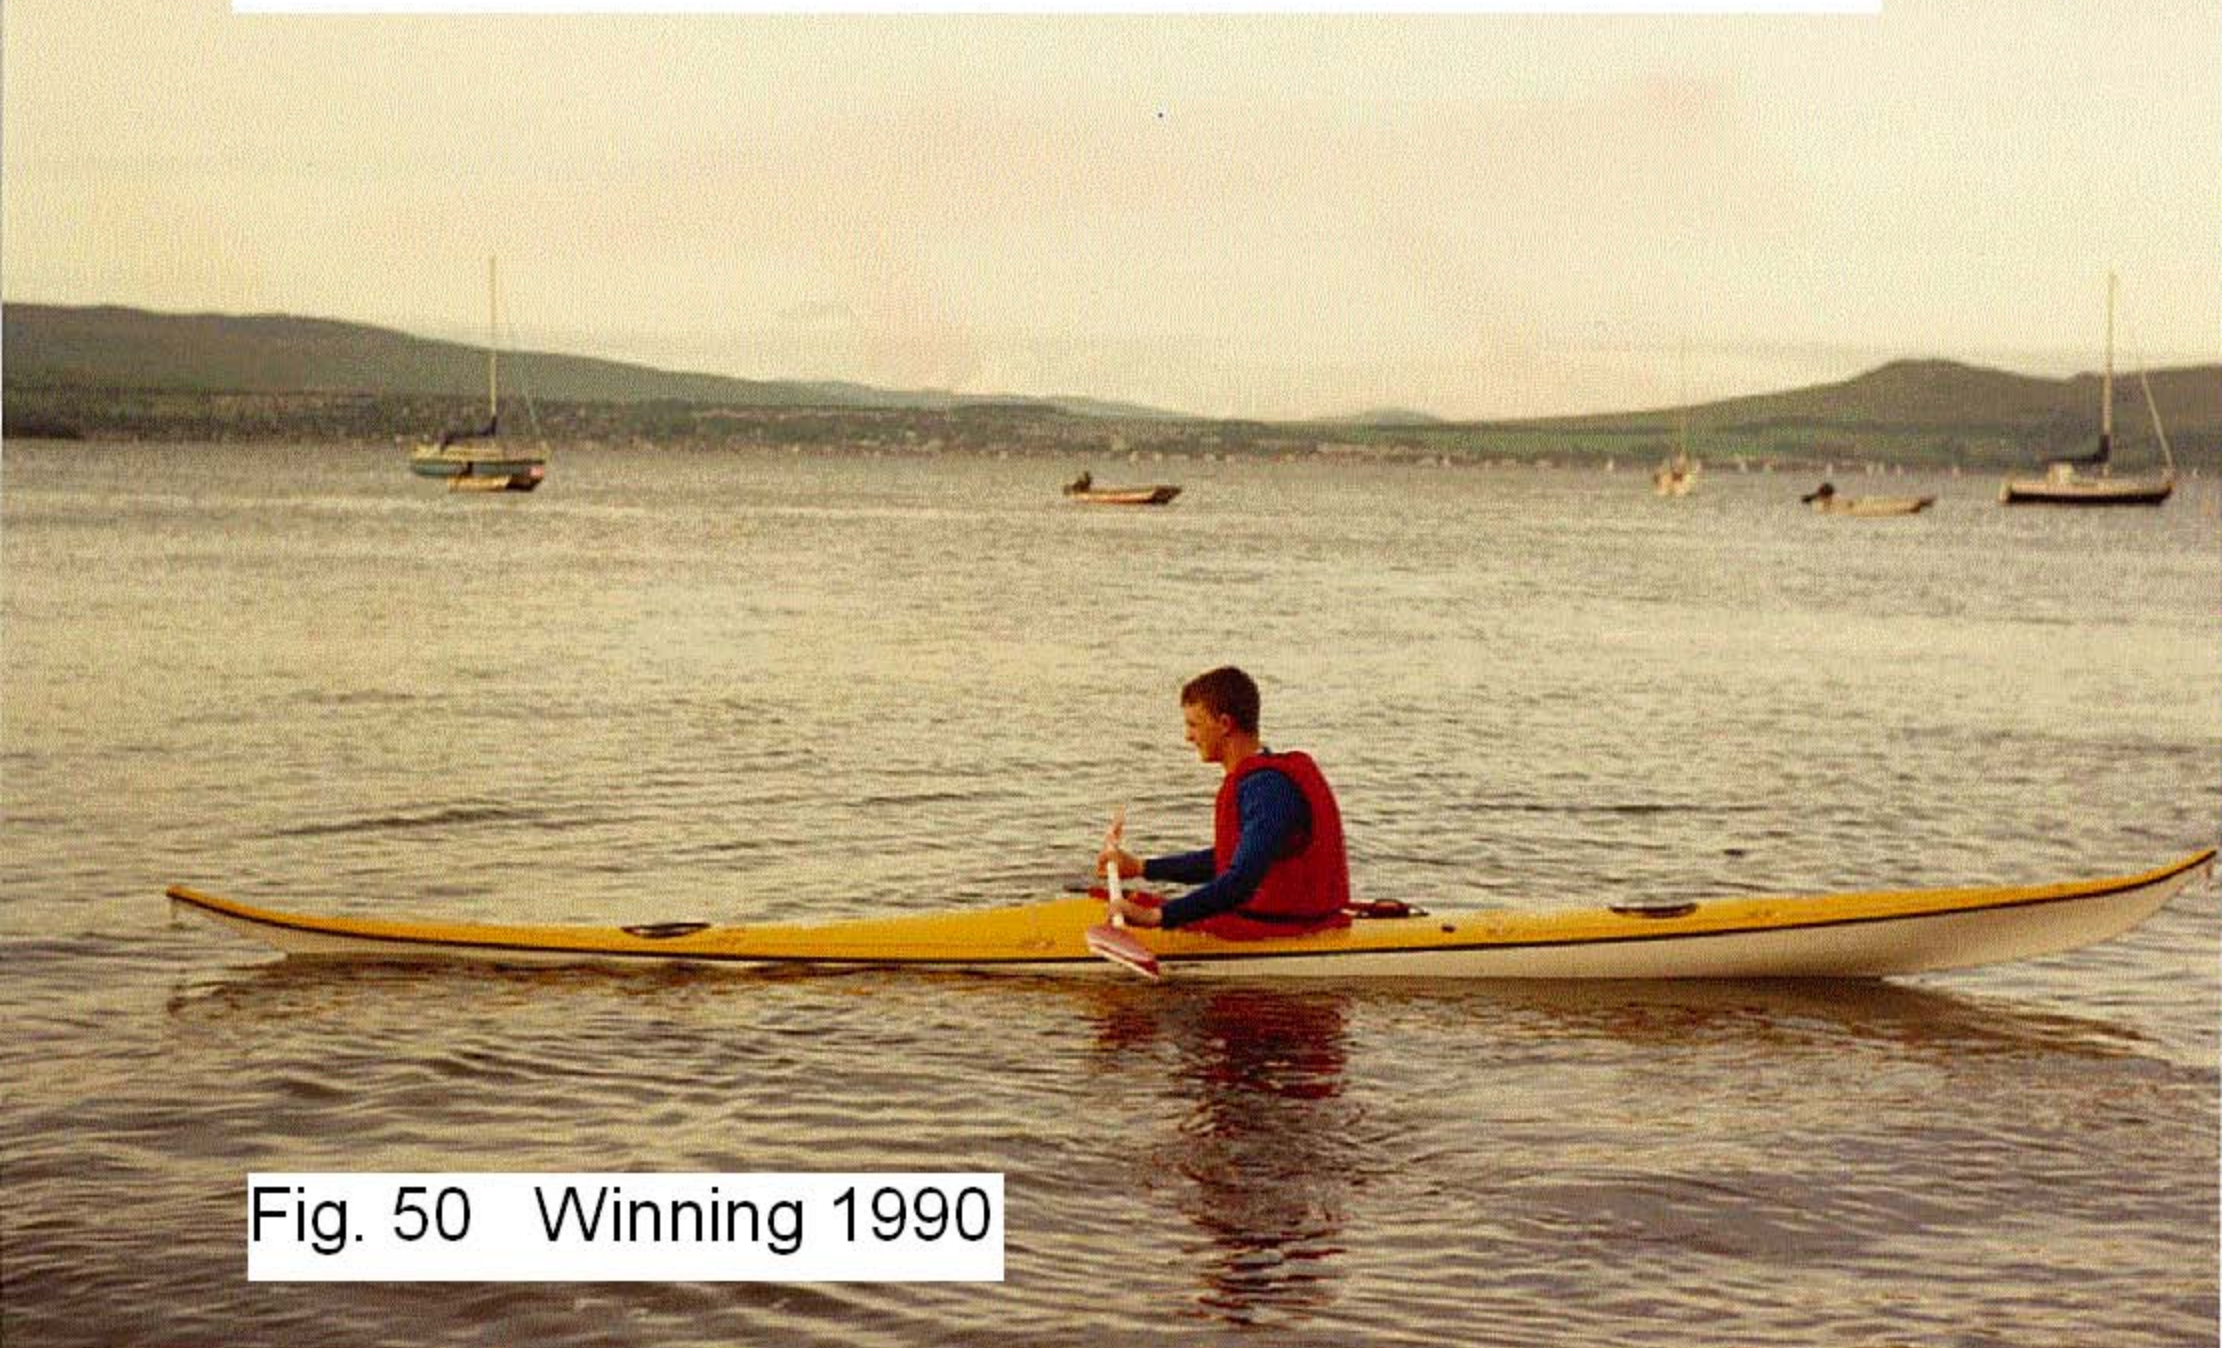
Fig. 50 Winning 1990

Nordkapp 55 litres in bow compartment 30.v.90

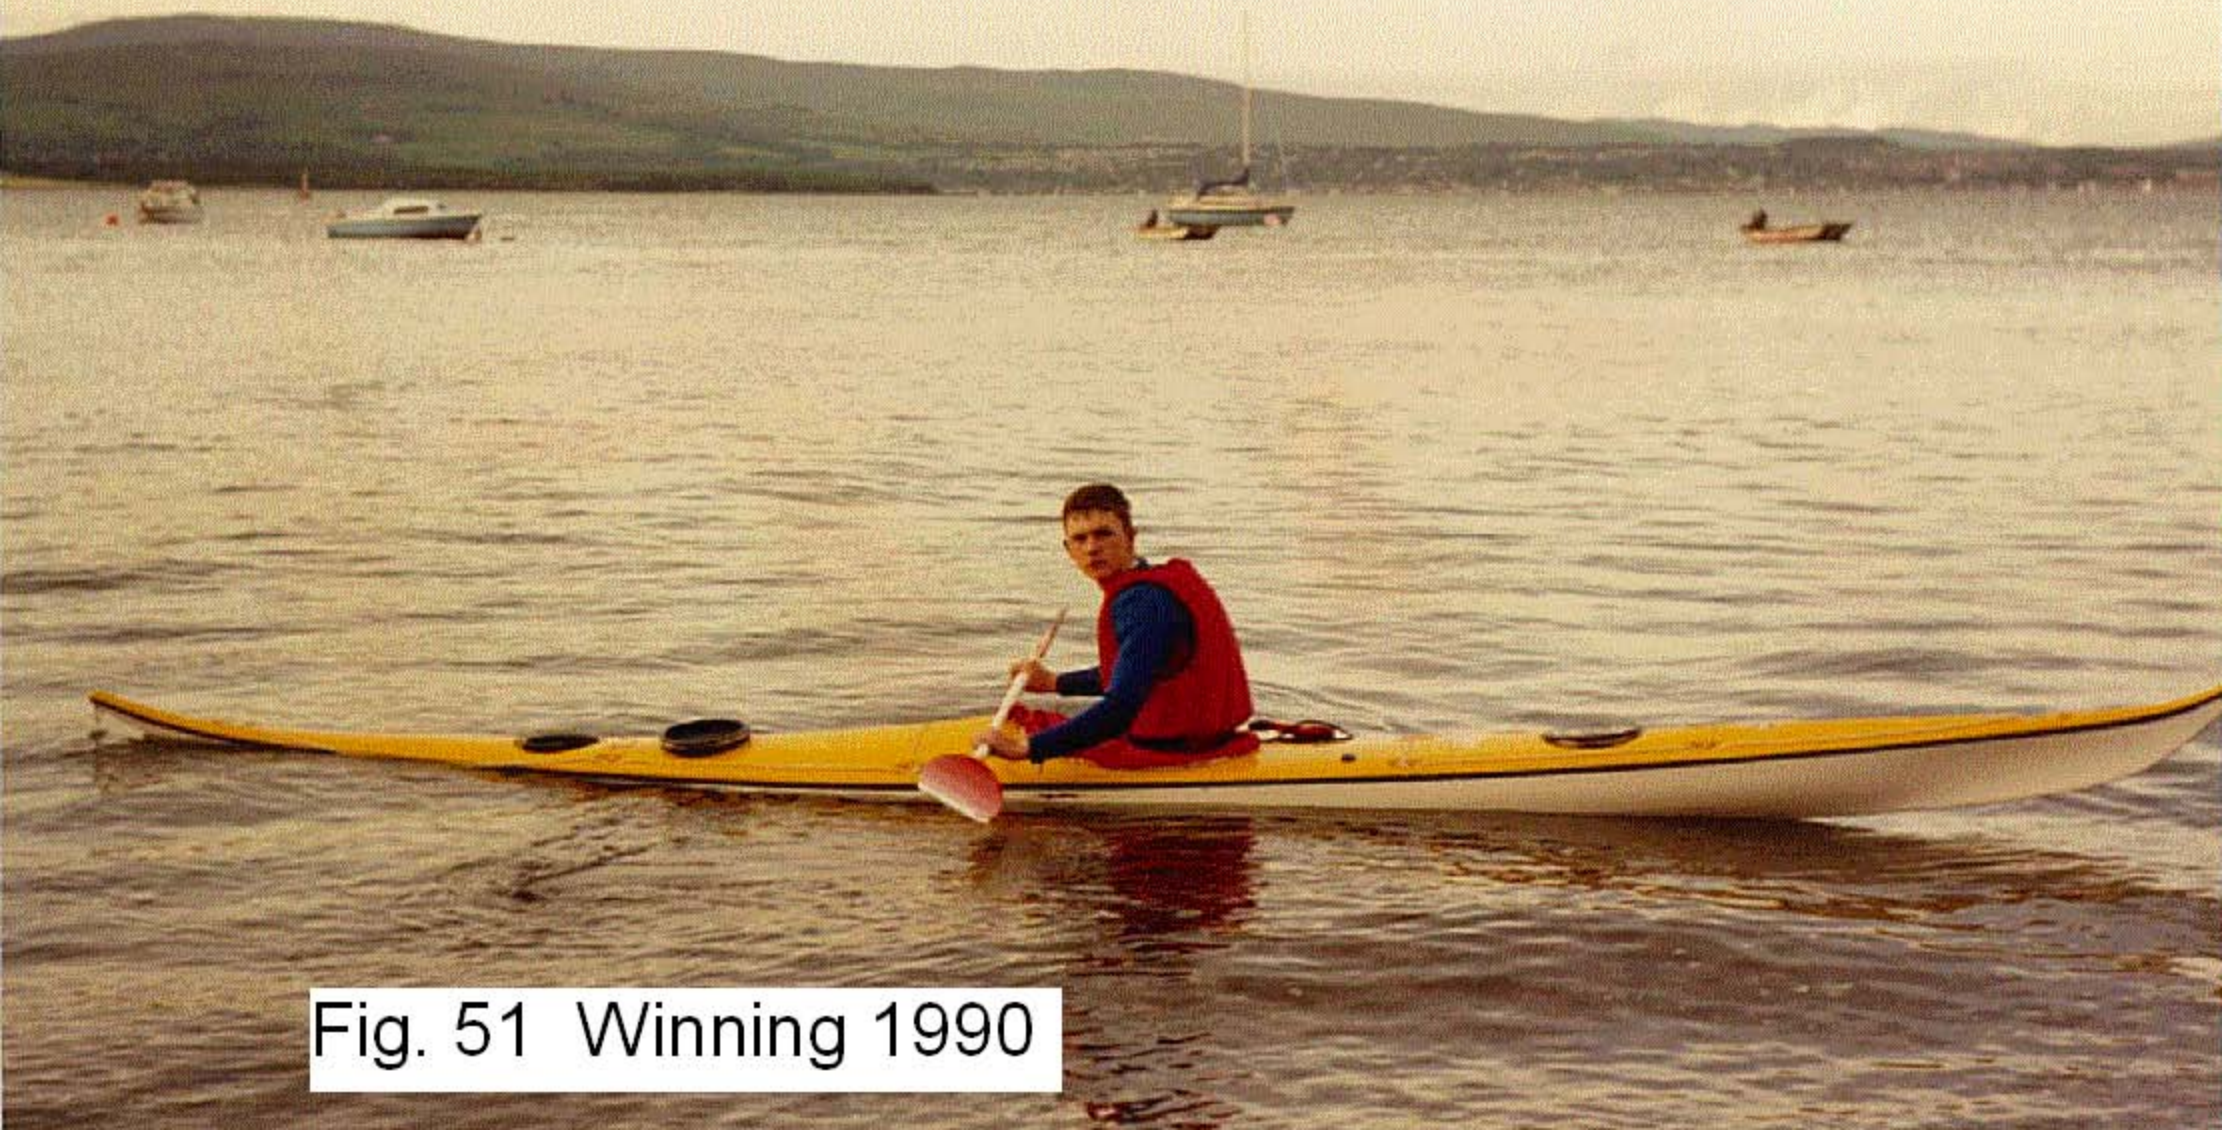
Fig. 51 Winning 1990

Nordkapp >55 litres in bow compartment 30.v.90
(full), cockpit empty

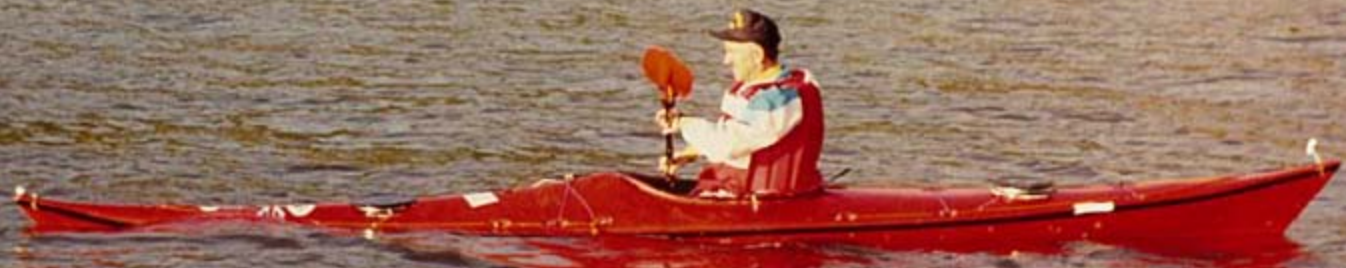
Fig. 62 Winning 1990

Hebrides 1 75 litres in fore compartment 4/vi/90
no fitted buoyancy blocks

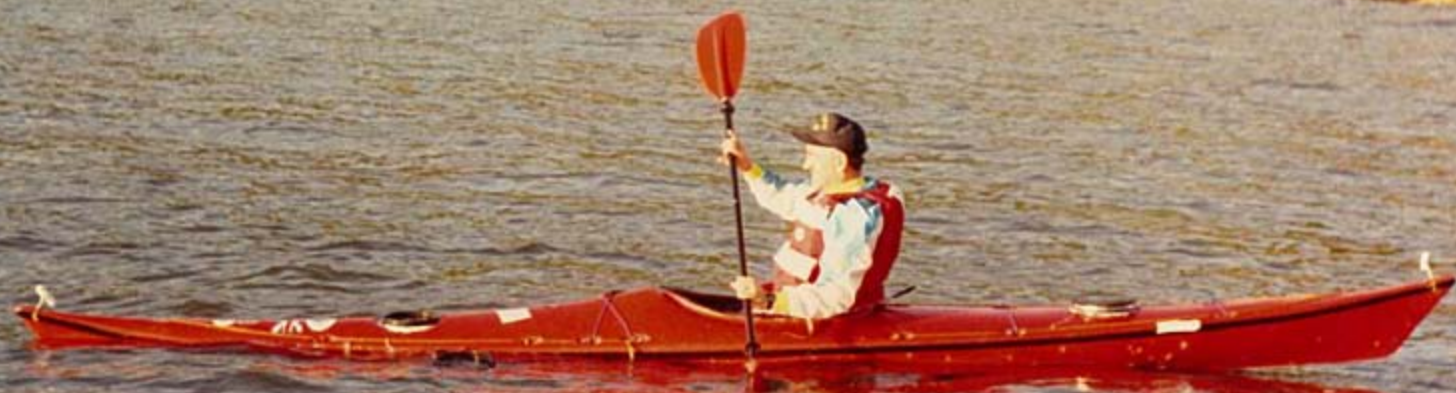
Fig. 63 Winning 1990

>75 litres Fig. 63, Hebrides 1. Boat rocked, air released, small extra amount of water in. No change in handling.

Hebrides 1 >75 litres in fore compartment 4/vi/90
no fitted buoyancy blocks

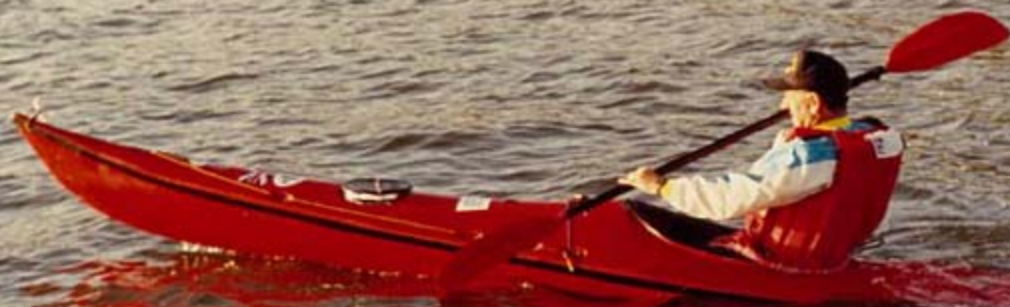
Fig. 64 Winning 1990

90 litres Fig. 64, Hebrides 1. Aft hold full. Less stable, far less controllable, very hard to turn.

Hebrides 1 90 litres in rear compartment 4/vi/90
no fitted buoyancy blocks

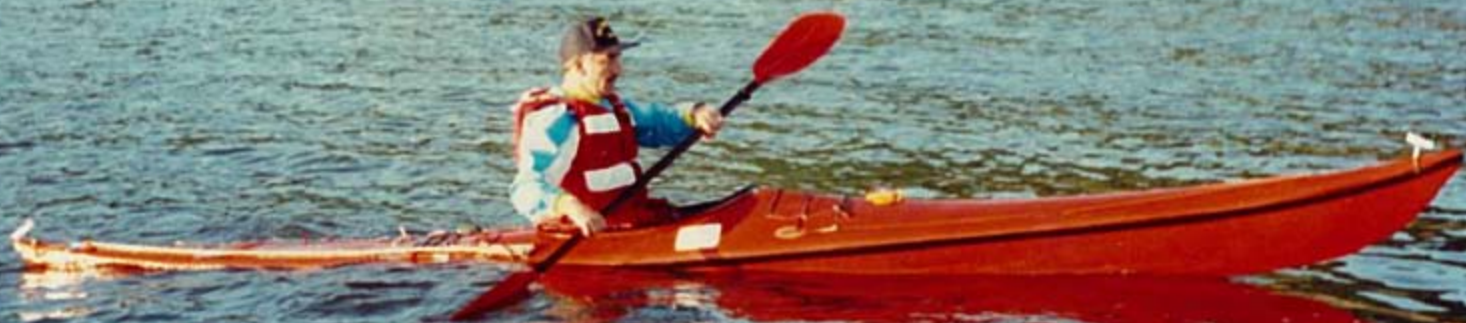
Fig. 66 Winning 1990

?? litres Fig. 66, Hebrides 2. Stern hold full, steadier and more controllable than Hebrides 1.

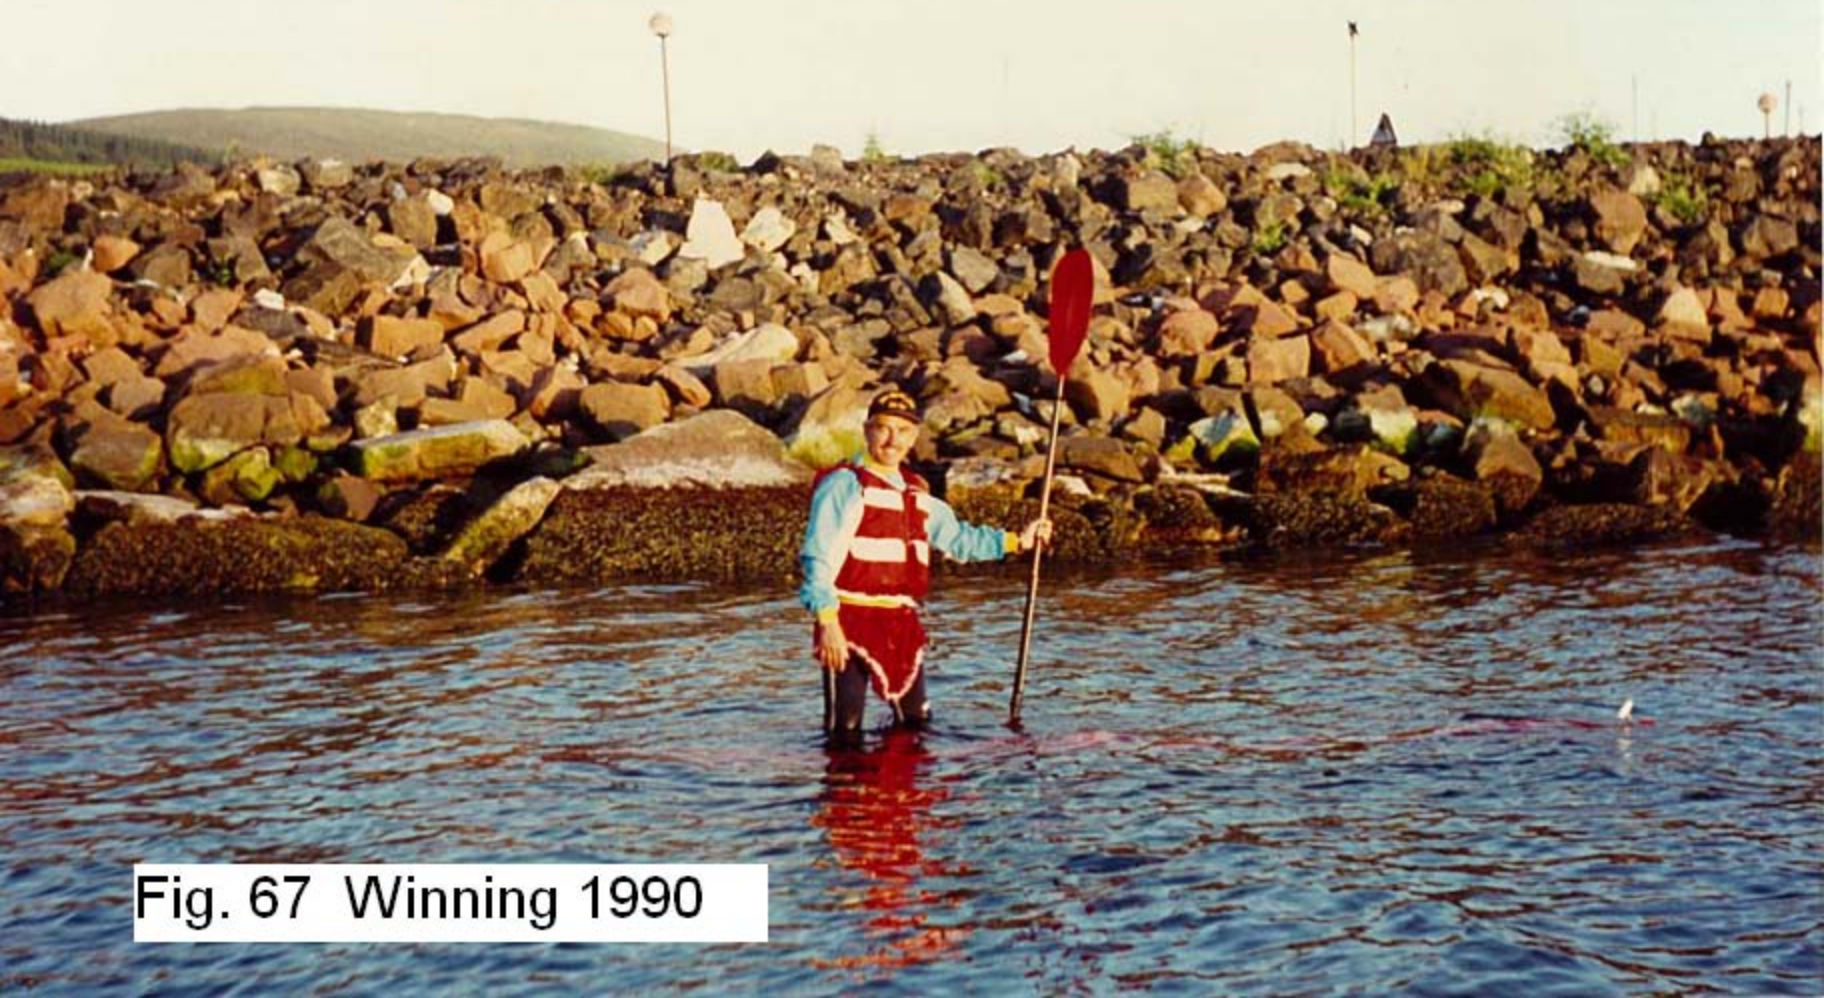
Fig. 67 Winning 1990

?? litres Fig. 67, Hebrides 1. Hatches off, flooded, sunk.

Hebrides 1 Flooded hull and cockpit
no fitted bouyancy blocks - kayak sunk

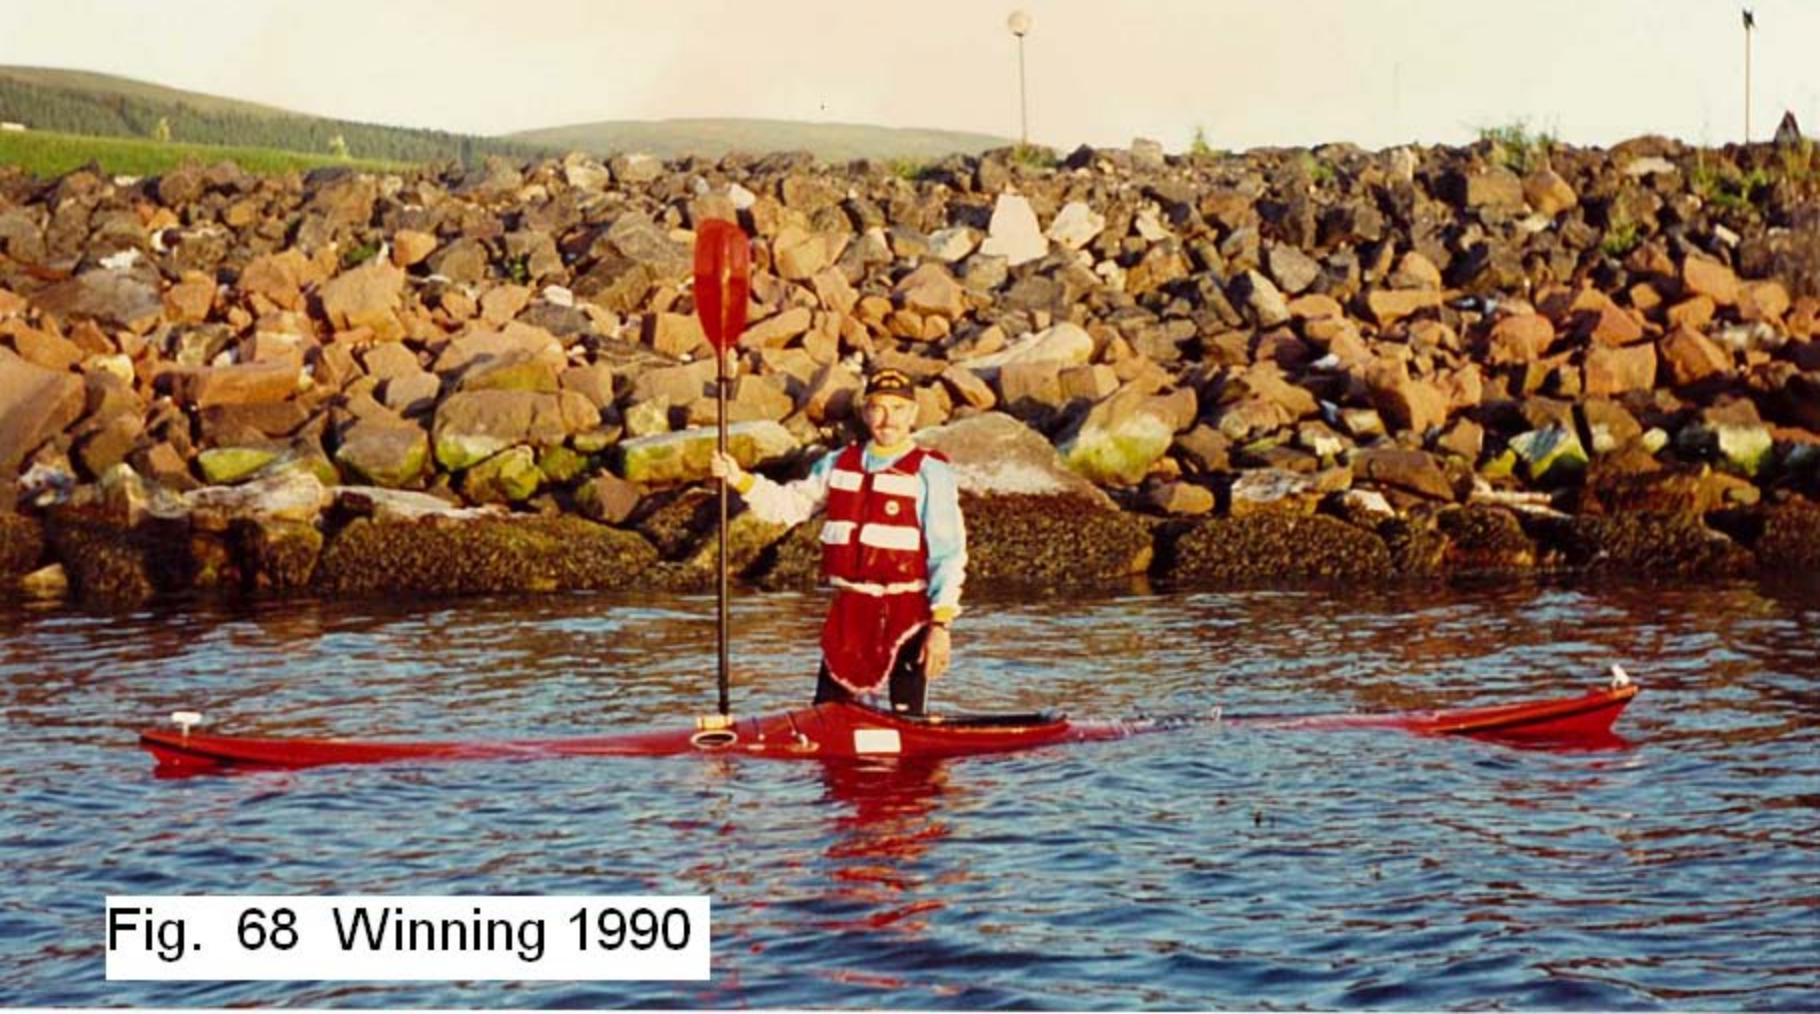
Fig. 68 Winning 1990

?? litres Fig. 68, Hebrides 2. Hatches off, flooded, floating.

Hebrides 2 Flooded hull and cockpit
fitted buoyancy blocks providing flotation

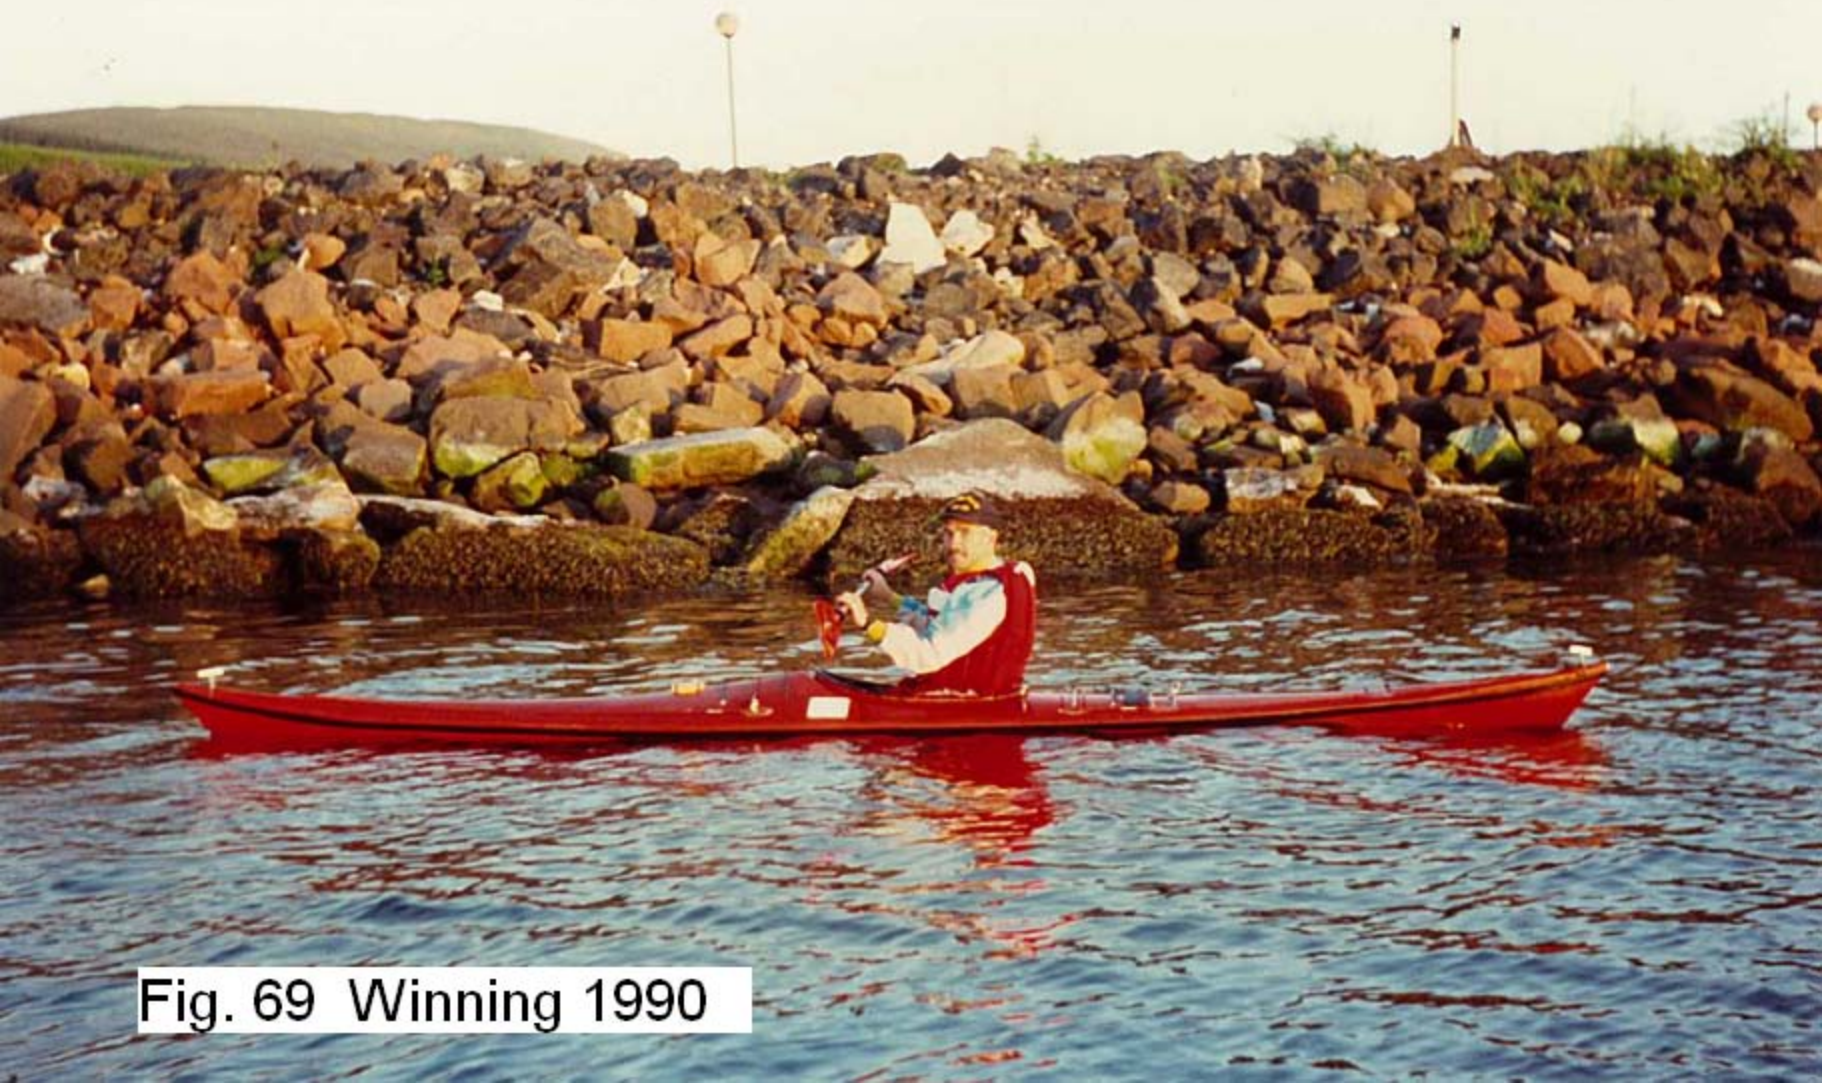
Fig. 69 Winning 1990

?? litres Fig. 69, Hebrides 2. Cockpit only flooded, heavy but paddleable.

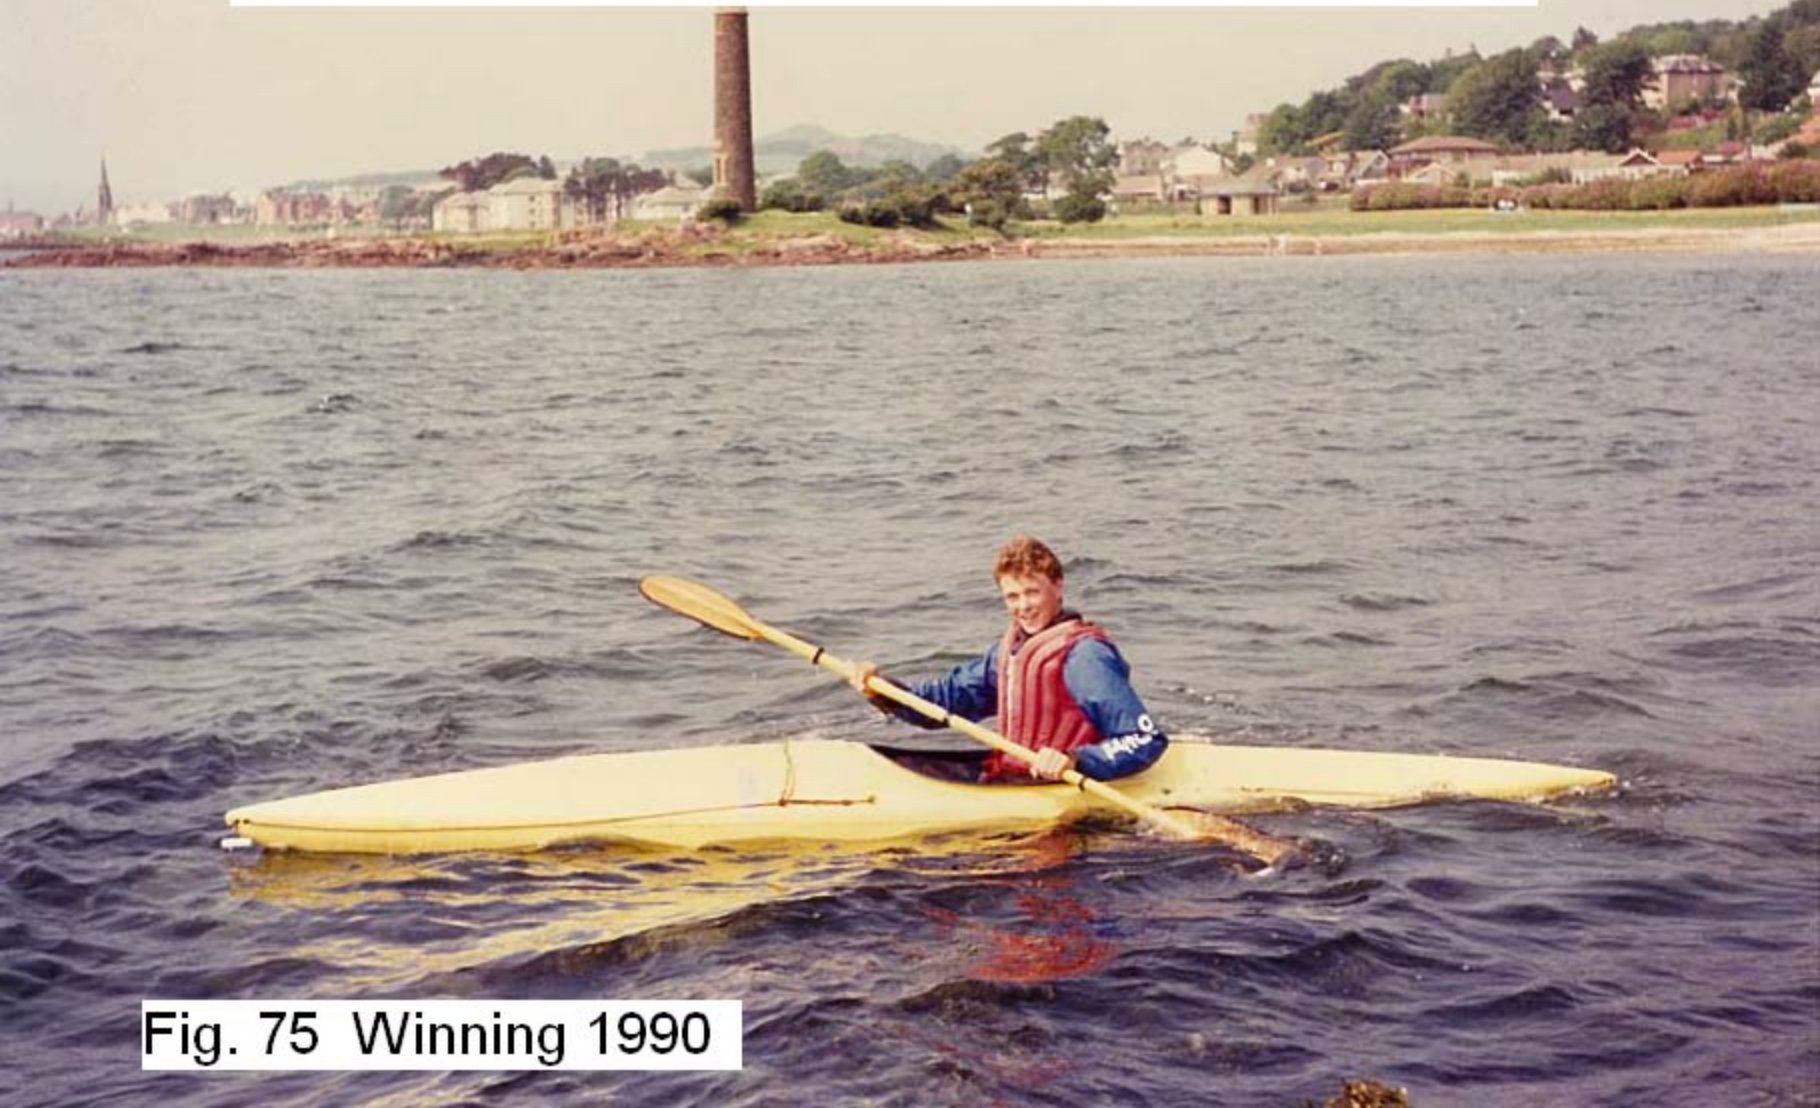
Fig. 75 Winning 1990

- 0 litres Fig. 70, very manoeuvrable and easy to paddle.
- 20 litres Fig. 71, slightly heavier to paddle.
- 40 litres Fig. 72, beginning to feel tippy.
- 60 litres Fig. 73, same as stage 3 only more so.
- 80 litres Fig. 74, ditto.
- 100 litres Fig. 75, paddler feels very unstable.
- 120 litres Fig. 76, as stage 6 (100 litres) but more so becoming much harder to turn but keeping course in conditions.
- 140 litres Fig. 77, becoming stern heavy.
- 160 litres Fig. 78, paddler getting very nervous.
- 180 litres Fig. 79, getting more stable again.
- 200 litres Fig. 80, kayak has slow roll which paddler can predict.
- 200 litres +C Fig. 81, kayak afloat, bow submerged. This paddler would have capsized soon. Could not go anywhere in this condition.
